GROUP	MODEL
СНА	2017MY Sorento (UMa)
NUMBER	DATE
068	June, 2016

TECHNICAL SERVICE BULLETIN

SUBJECT: SERVICE ACTION: TIGHTEN POWER TAILGATE

BALL STUD (SA 232)

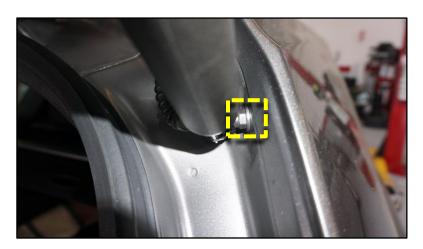
This bulletin provides the procedure for tightening the right tailgate spindle attachment ball stud, on <u>select</u> UMa Sorento models, produced from May 16, 2016 through May 26, 2016, which may not have been torqued to specification by the factory, and may exhibit an unusual noise when operating the power tailgate. To correct this condition, verify and, if necessary, tighten the ball stud, as described in this bulletin. Kia is requesting the completion of this Service Action on all affected vehicles, <u>including dealer stock</u>, prior to delivery. Before conducting the procedure, verify the vehicle is included in the list of affected VINs.

Using an open-ended 12mm wrench, verify the ball stud is securely attached to the body. If the ball stud is loose, tighten approximately ¼ of a turn, or until snug to the body.
