GROUP BOD	MODEL 2006 ~ 2008MY Optima(MG)
	NUMBER 135	DATE June 2016
TECHNICAL SERVICE BULLETIN		
SUBJECT: FRONT PASSENGER OCS SENSOR MAT DIAGNOSIS AND REPLACEMENT

This bulletin provides information related to the replacement of the front passenger Occupant Classification System (OCS) sensor mat in 2006 ~ 2008 MY Optima (MG) vehicles. If the sensor mat is not working properly, the airbag warning light on the cluster will illuminate and **DTC(s) B1447, B1448, B1449 and/or B1450** may be stored. If the airbag warning light is illuminated and one or more of the above DTCs are stored, follow the repair procedure outlined in this bulletin to replace the OCS mat.

FRONT PASSENGER OCS SENSOR MAT DIAGNOSIS AND REPLACEMENT

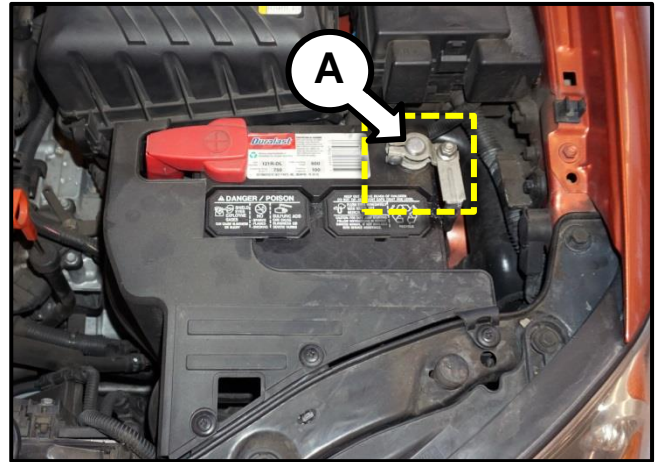
1. Record customer's radio presets.
2. Disconnect Negative (-) terminal (A) from the battery. **NOTE: make sure voltage is bled off before proceeding.**

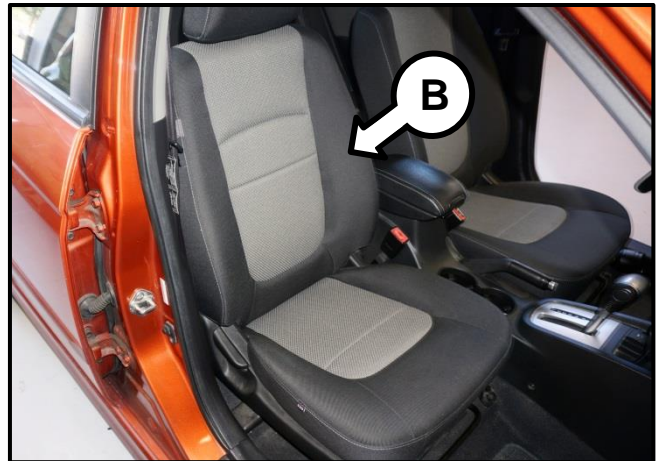
3. Remove the passenger seat assembly (B) by referring to the applicable Service Manual on KGIS.

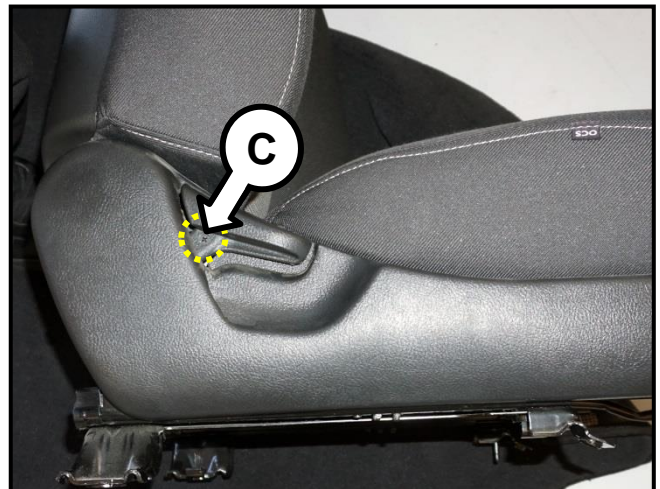
4. Remove one (1) screw (C) securing the seat back release lever cover and remove the cover from the lever.

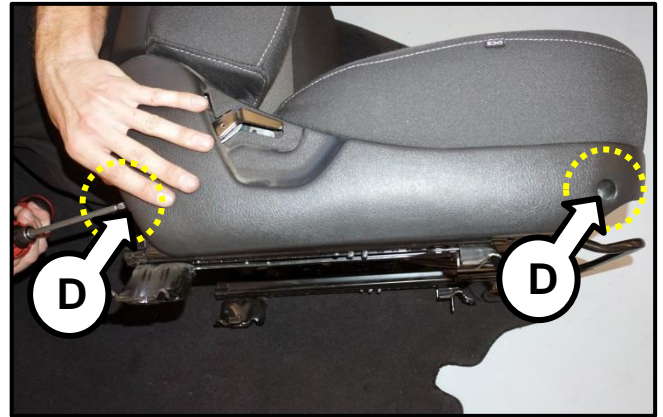
5. Remove two (2) screws (D) securing the seat side cover to the seat frame and remove the side cover.

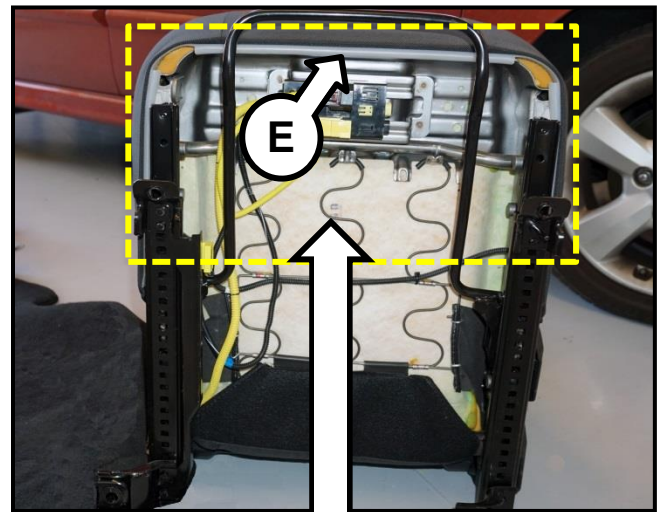
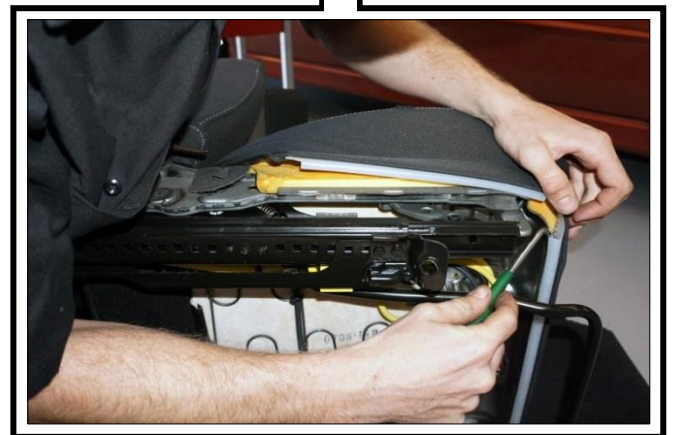
6. Carefully undo the seat cover plastic hooks (E) running across the front of the seat.

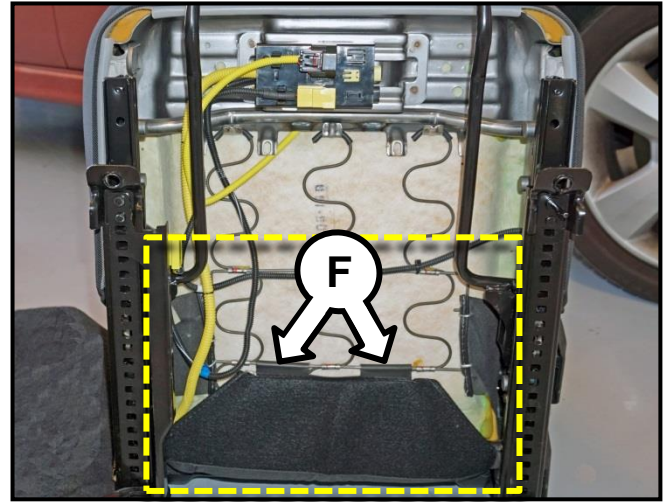
7. Undo two (2) plastic hooks (F) securing the rear seat cover attachment panel.

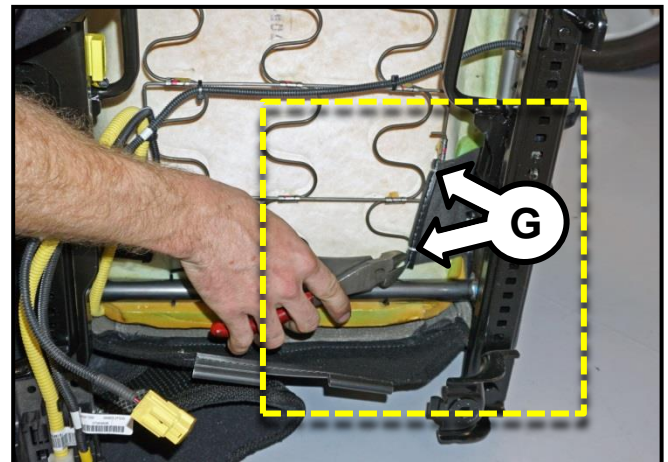
8. Use a pair of side cutters to remove two (2) hog rings (G) from the right side seat cover attachment panel, as shown.

Replace with new hog rings (P/N: 88627 11201). To install the new hog rings, use the Hog Ring Pliers (P/N 09880 4F000A) or equivalent.

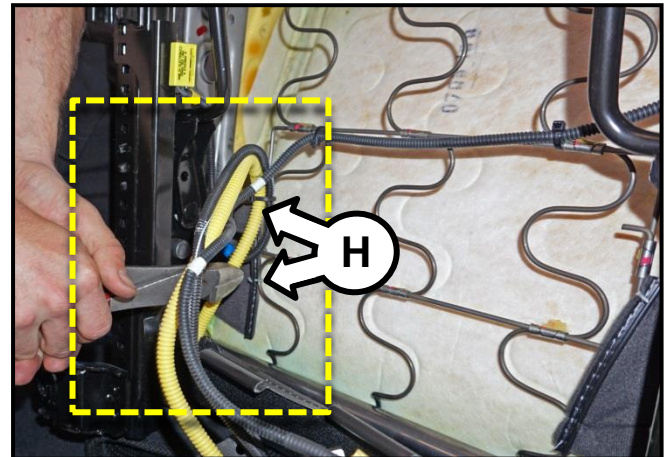
9. Use a pair of side cutters to remove two (2) hog rings (H) from the left side seat cover attachment panel, as shown.

Replace with new hog rings (P/N: 88627 11201). To install the new hog rings, use the Hog Ring Pliers (P/N 09880 4F000A) or equivalent.

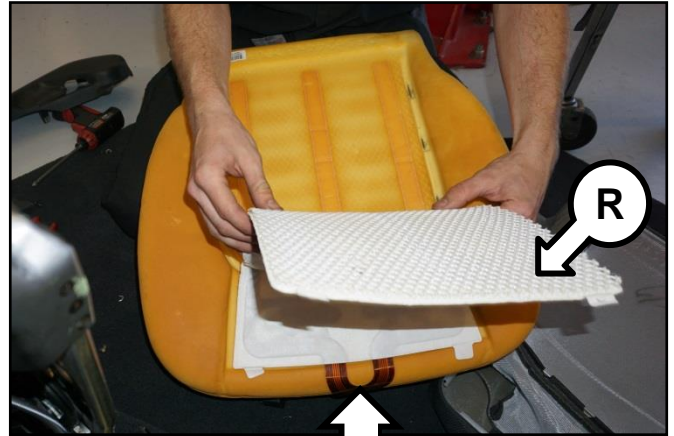
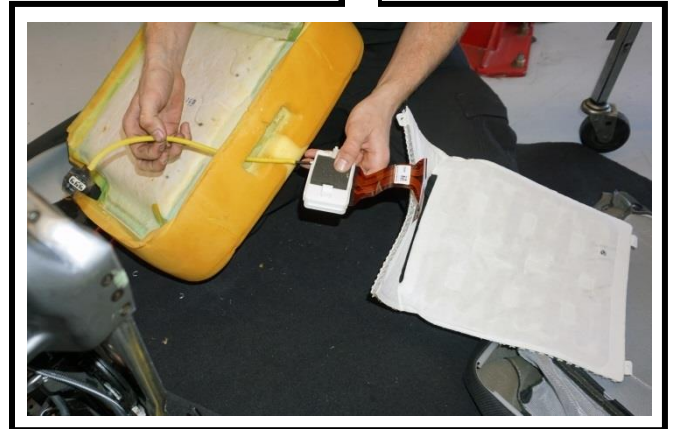
18. Remove the original OCS mat (R) and harness from the seat cushion, as shown.

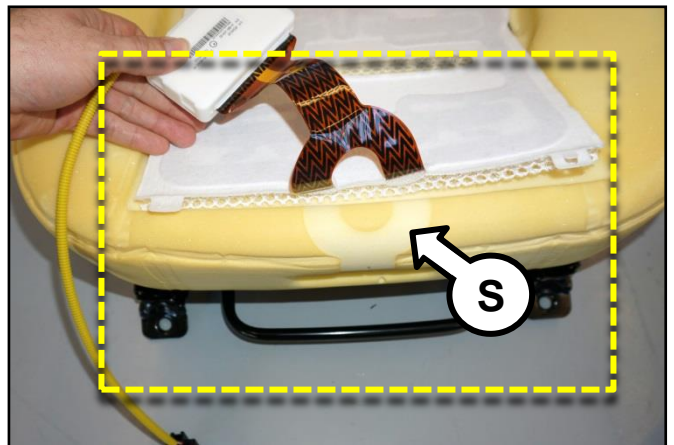
19. Place the replacement OCS mat on the lower cushion and note the indentation in the foam (S). This indentation should be used to align the replacement mat with the seat cushion.

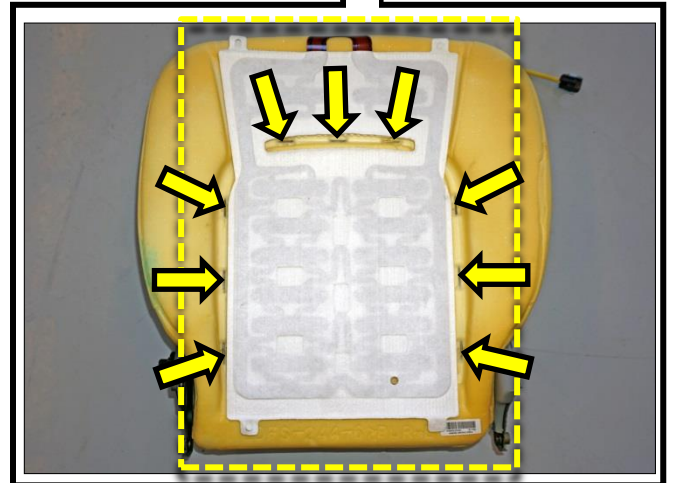
21. Place the OCS mat on top of the seat and examine the placement mat. **NOTE: make sure the OCS mat does NOT obstruct access to any of the nine (9) seat cover attachment points, as shown.**

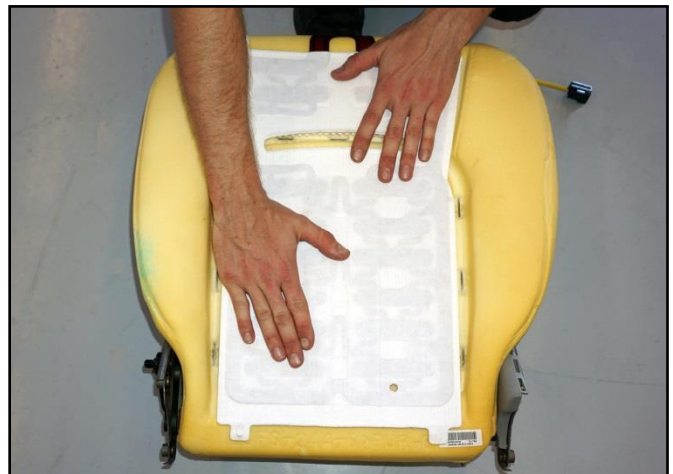
22. Press down, as shown, to ensure the OCS mat is firmly adhered in place.
