GROUP <b>BOD</b>	MODEL <b>2008~2011MY Rio (JB)</b>
NUMBER <b>140</b>	DATE <b>June 2016</b>

## TECHNICAL SERVICE BULLETIN

**SUBJECT:** FRONT PASSENGER OCS SENSOR MAT DIAGNOSIS  
AND REPLACEMENT

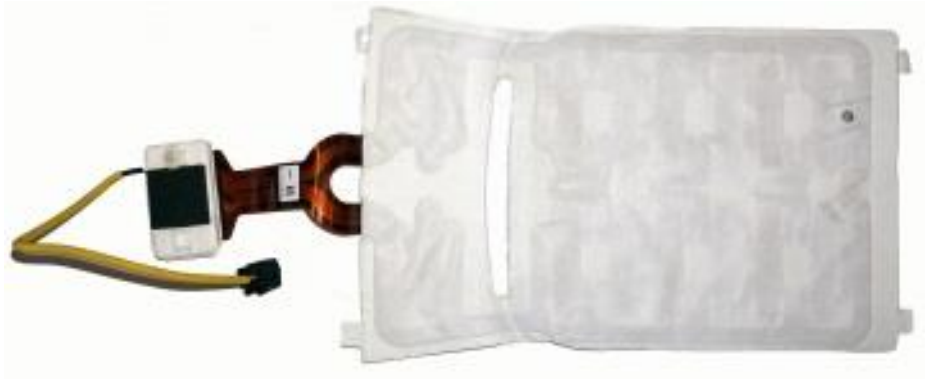
Standard OCS Mat  
Applied Through 3/2/2010

This bulletin provides information related to the replacement of the front passenger Occupant Classification System (OCS) sensor mat in 2008~2011MY Rio (JB) vehicles. If the sensor mat is not working properly, the airbag warning light on the cluster will illuminate and **DTC(s) B1447, B1448, B1449 and/or B1450** may be stored. If the airbag warning light is illuminated and one or more of the above DTCs are stored, follow the repair procedure outlined in this bulletin to replace the OCS mat.
