GROUP ENG	MODEL 2016MY Optima (JFa) Sorento (UMa), w/2.4L GDI
	NUMBER 158	DATE July 2016

TECHNICAL SERVICE BULLETIN

SUBJECT: VCM LOGIC IMPROVEMENT - DTC P200A00 (SA 240)

DTC P200A00 - Intake Manifold Runner Performance

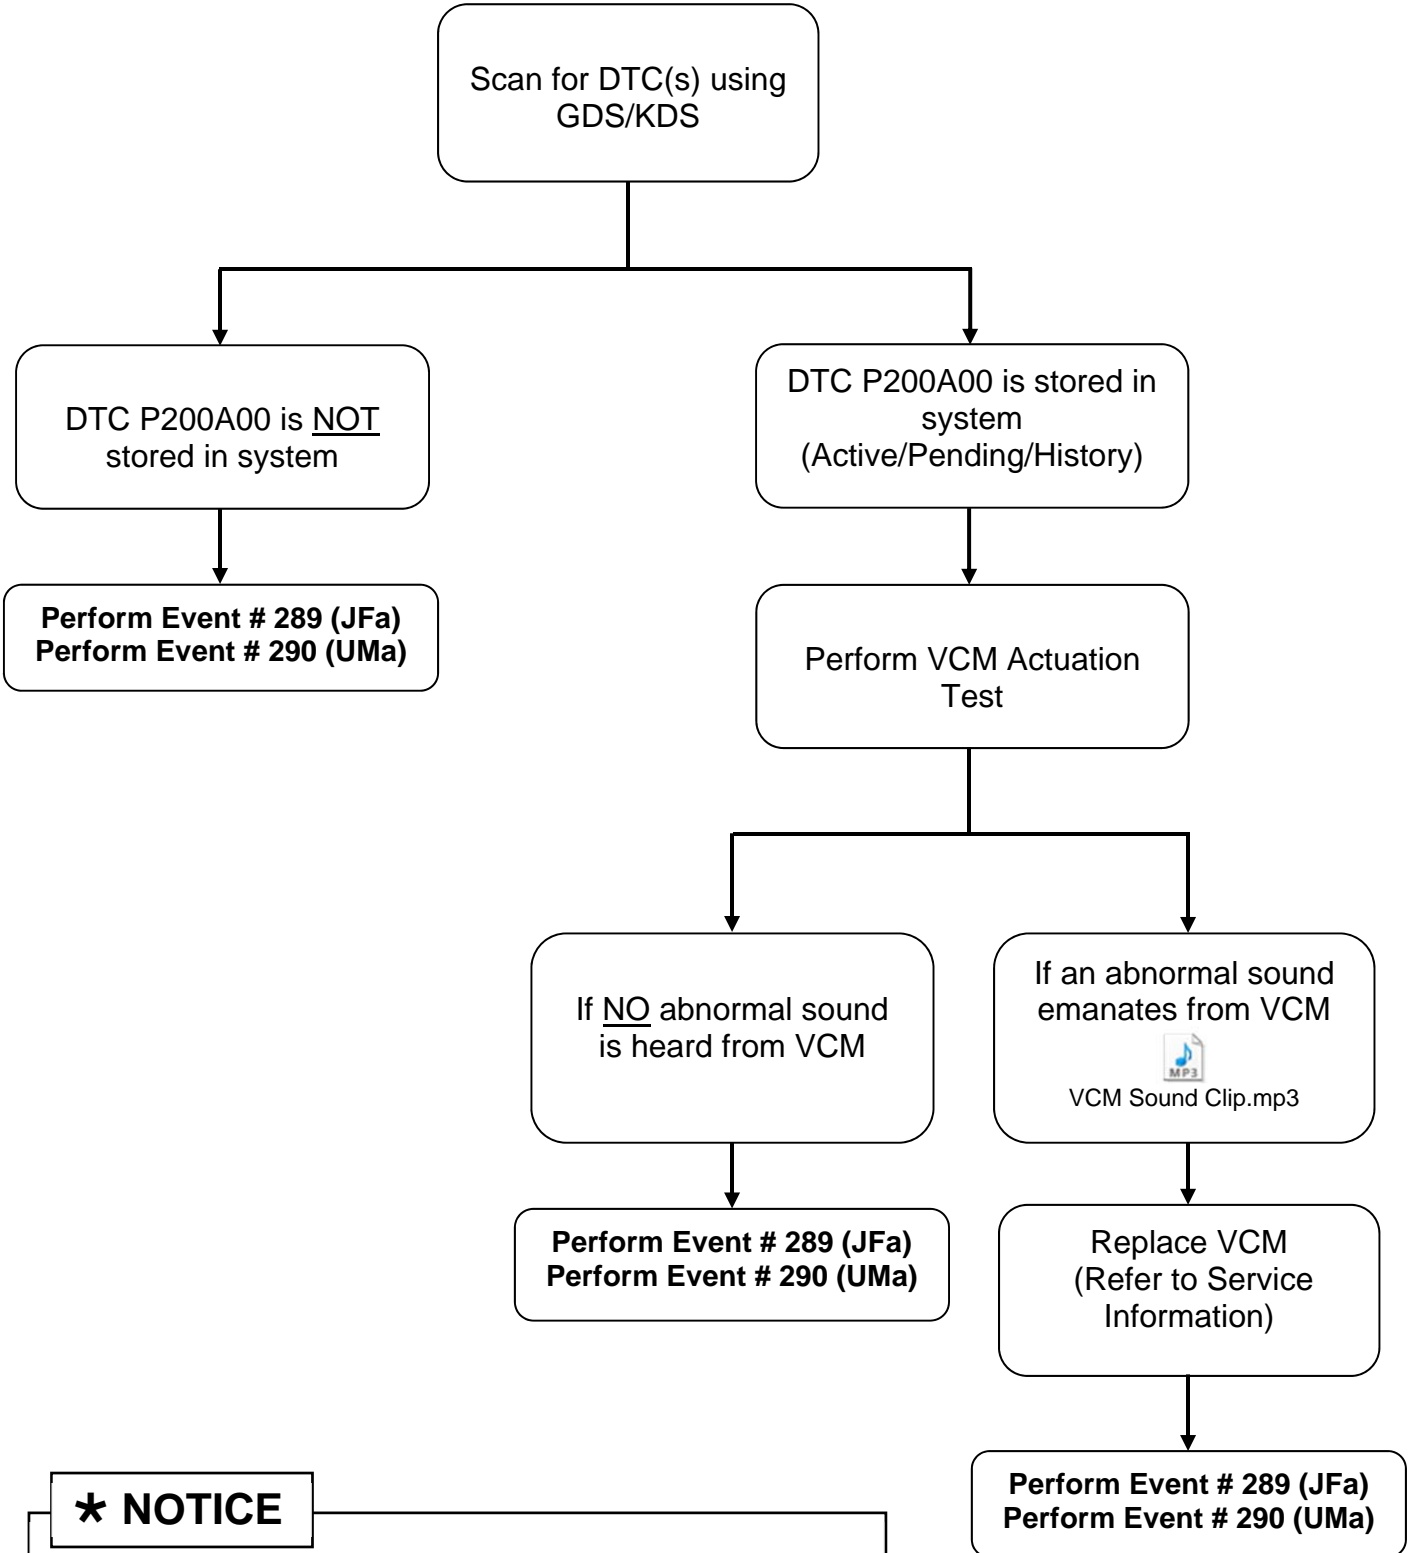
Diagnostic Flowchart:

This bulletin provides information related to the ECM software upgrade and inspection of the VCM motor of some 2016MY Optima (JFa) vehicles, produced from August 28, 2015 through February 15, 2016, and some 2016MY Sorento (UMa) vehicles, produced from November 17, 2014 through February 3, 2016, which may experience a malfunction indicator lamp (MIL) illuminated with the Electronic Control Module (ECM) system-related DTC: P200A00. To correct this condition, the ECM should be reprogrammed using the GDS/KDS download, as described in this bulletin, and, if necessary, replacement of the Variable Charge Motion Actuator (VCMA). Do not replace the intake manifold for this concern. Before performing this procedure, verify that the VIN falls within the production ranges by consulting the table on page 8. For confirmation that the latest reflash has been performed to the vehicle you are working on, verify ROM ID using the tables in this TSB.

Do not replace the intake manifold for this concern. Any associated claims for intake manifold replacement are subject to review and chargeback.
