HYUNDAI NEW THINKING. NEW POSSIBILITIES. Technical Service Bulletin	GROUP AUTOMATIC TRANSMISSION	NUMBER 16-AT-013
	DATE DECEMBER 2016	MODEL GENESIS SEDAN (BH/DH), GENESIS G80 (DH) GENESIS COUPE (BK) EQUUS (VI) GENESIS G90 (HI)
SUBJECT:	AUTOMATIC TRANSMISSION INPUT/OUTPUT SPEED SENSOR DTC P0717, P0721, P0722 & P0791

This TSB supersedes TSB 12-AT-024 to include 2017 Genesis G80 and Genesis G90 and update the Warranty Information.

Description: Do not replace the transmission for the DTC listed below. Instead, follow the repair procedure and replace the E-Module.

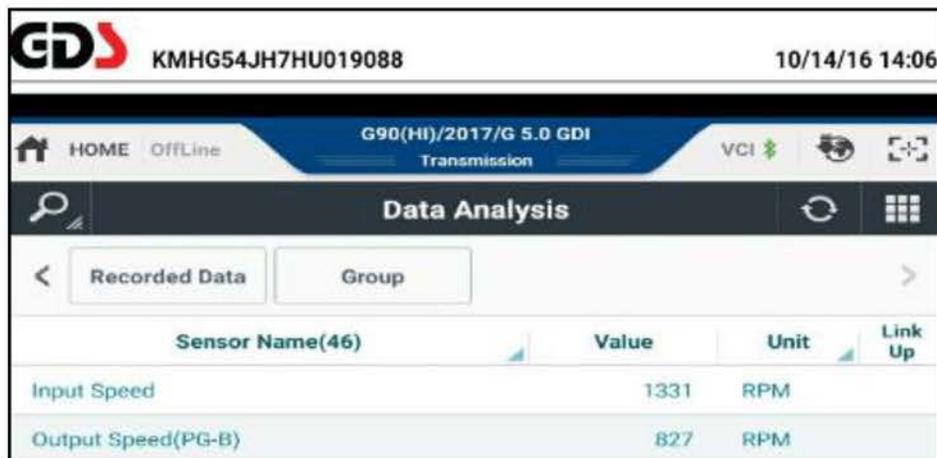
1. Attach a GDS and select **DTC Analysis** and **A/T** menu. Record the DTC and description. Delete the DTC.
2. From the GDS home screen, select **Data Analysis** and **A/T** menu and the parameters shown below. If the input speed sensor and output speed sensors show:
 - Continuous and changing output while driving, the wiring **currently** has no open/short circuits. Go to Step 4.
 - No continuous and changing output, go to Step 3.
