GROUP BOD	MODEL 2016MY Optima (JFa)
	NUMBER 147	DATE August 2016
TECHNICAL SERVICE BULLETIN		
SUBJECT: SUNROOF POPPING NOISE REPAIR

SUBJECT: SUNROOF POPPING NOISE REPAIR

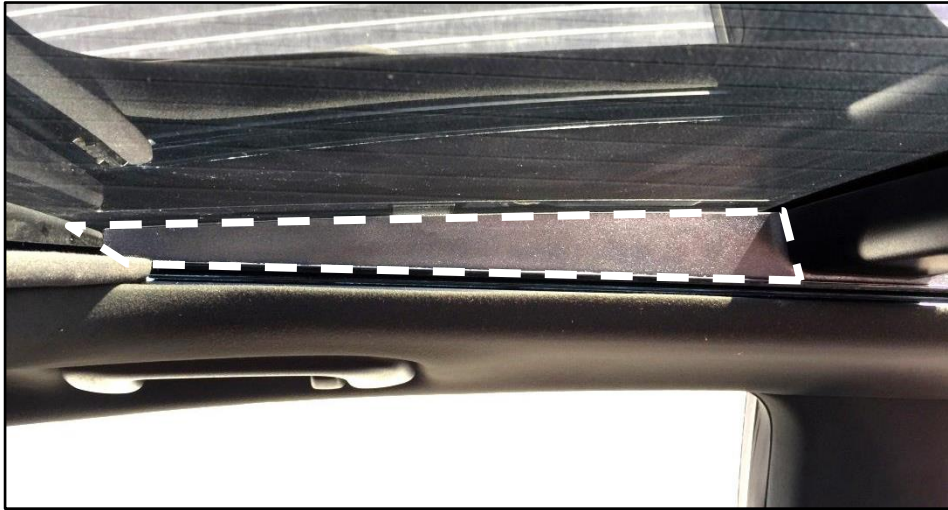
This bulletin provides information on some 2016MY Optima (JFa) vehicles, produced from September 28, 2015 to February 23, 2016, which may experience a pop or click noise when driving over bumps or turning. This noise is caused by contact between the decorative trim and the sunroof frame as the chassis flexes and is more common as the vehicle heats up, causing thermal expansion of the material. To correct this concern, lubricate the contact areas by referring to the procedure below.
