This bulletin provides information regarding the replacement of the flexible coupling in the Motor Driven Power Steering (MDPS) on some 2011-2014 MY Optima (QF/TF/TFH) vehicles, produced from August 12, 2010 to December 18, 2013. The MDPS unit may experience noise when turning the steering wheel left or right, especially while the vehicle is stopped. Kia's analysis has identified that this condition occurs mainly in extremely high humidity states adjacent to warm ocean waters due to the wear of the flexible coupling in the MDPS, after extended usage over years. The extremely high humidity states adjacent to warm ocean waters include: Alabama, Florida, Georgia, Hawaii, Louisiana, Mississippi, North Carolina, South Carolina, and Texas.

## SUBJECT: MDPS FLEXIBLE COUPLING REPLACEMENT (CS 1604)

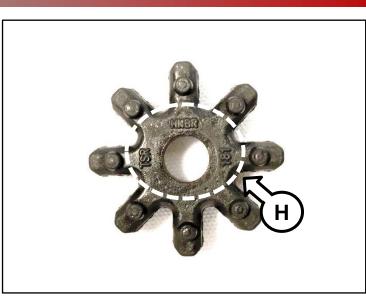
The new improved flexible coupling has "HNBR" embossed on the coupling.

9. Install the new improved flexible coupling.

When assembling, position the flexible coupling so that the embossed markings (H) are facing upward.
