GROUP BOD	MODEL 2014-2015MY Optima (QF)
	NUMBER 143	DATE August 2016
TECHNICAL SERVICE BULLETIN		
SUBJECT: COMBINATION LAMP WATER INTRUSION

This bulletin provides the procedure to install additional foam gaskets in both rear tail lamps on 2014-2015MY Optima (QF) vehicles, when either of the lamp housings may indicate water inside.

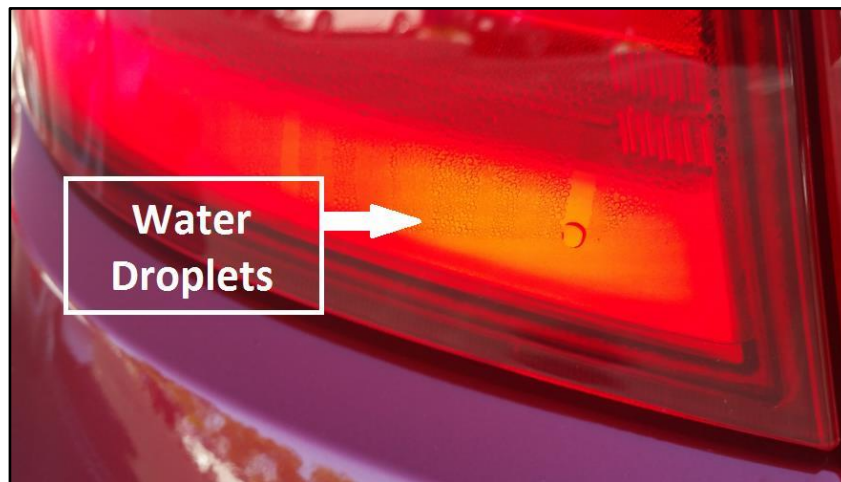
On some 2014-2015MY Optima (QF) vehicles, customers may complain about water droplets forming inside the rear tail lamp housing following a rainstorm or after washing their vehicle. These water droplets are more visible at night and the quantity of water present is more than just a thin film of condensation, which may not easily evaporate. This concern is caused by a gap between the tail lamp housing seal and vehicle body, which allows water to infiltrate into the tail lamp. To resolve this concern, order additional foam gaskets and install them between the left and right tail lamps and the body of the vehicle, as outlined below.

To enhance customer satisfaction, this bulletin outlines the installation and repair of BOTH sides (Left and Right) of the vehicle, even when only one side is affected.
