**HYUNDAI**NEW THINKING.
NEW POSSIBILITIES.**Technical Service Bulletin**

16-01-050

Sonata (LFa)**SUBJECT:** TOP ALTERNATOR MOUNTING BOLT REPLACEMENT (SERVICE CAMPAIGN TTT)*** IMPORTANT******* Dealer Stock and Retail Vehicles *****

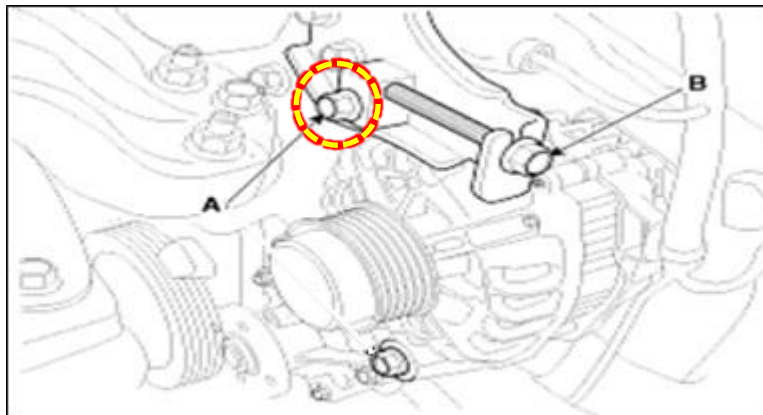
Description: Certain Sonata vehicles equipped with the 1.6L Turbo engine have a manual alternator belt tensioner system. The top alternator mounting bolt (A in the diagram) may break over time if it is tightened over specification and could result in illumination of the battery warning light and/or the engine overheating in some cases. This bulletin describes the procedure to replace the top alternator mounting bolt.
