SERVICE BULLETIN

APPLICABILITY: 2005-09MY Legacy and Outback Models **NUMBER:** 12-197-16

SUBJECT: Melting / Sticky Dashboards / Instrument Panel (IP) **DATE:** 02/25/16

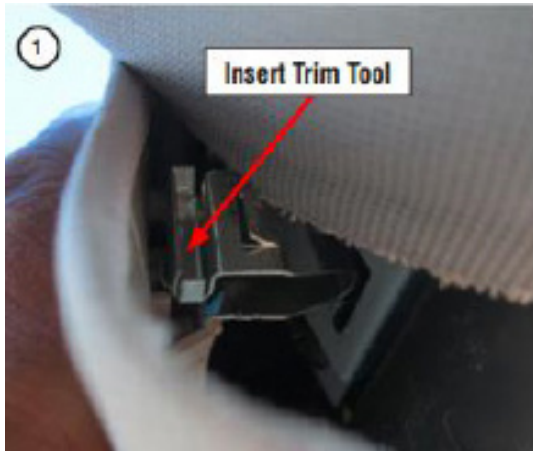
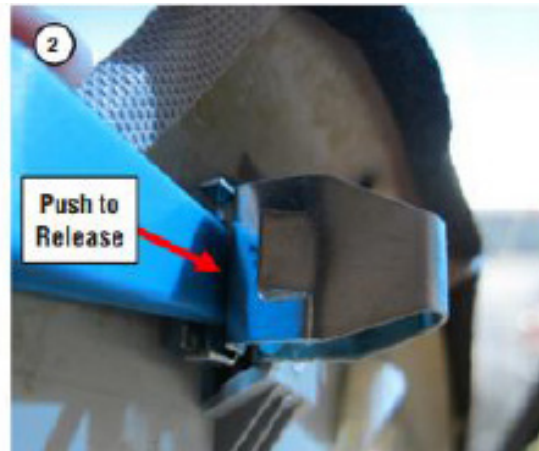
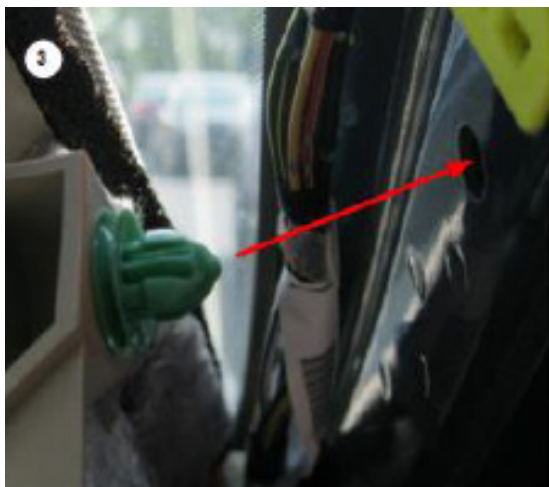
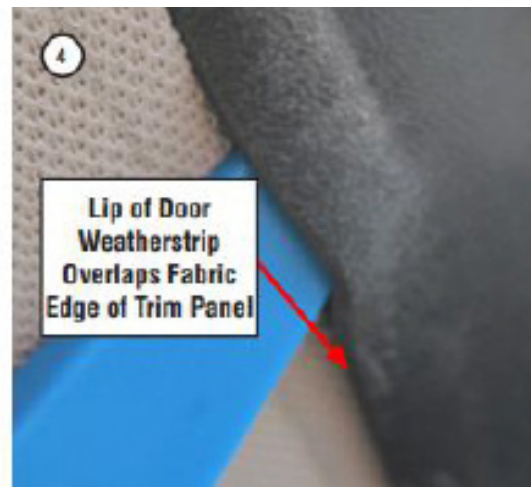
- When removing the “A” pillar trim, be **VERY CAREFUL** not to damage the upper metal retaining clip (see photos below). The clip is located just below where the trim panel meets the head liner. If the metal retaining clip becomes damaged or separated from the trim panel, the “A” pillar trim panel **MUST** be replaced as the clip is not available separately. DO NOT attempt to straighten or reuse the clip if it becomes damaged. Use a plastic trim tool to push down (1 & 2) and release the upper portion of the metal clip from the body. Be careful to not pull the trim panel open any further than necessary to gain access for releasing the clip. There is also a plastic retaining clip (3) in the lower portion of the trim panel which will release easily once the upper retaining clip is loose. At reassembly and using a plastic trim tool, make sure the inner lip of the door weather strip overlaps the outer fabric edge of the trim panel (4) to help secure it.

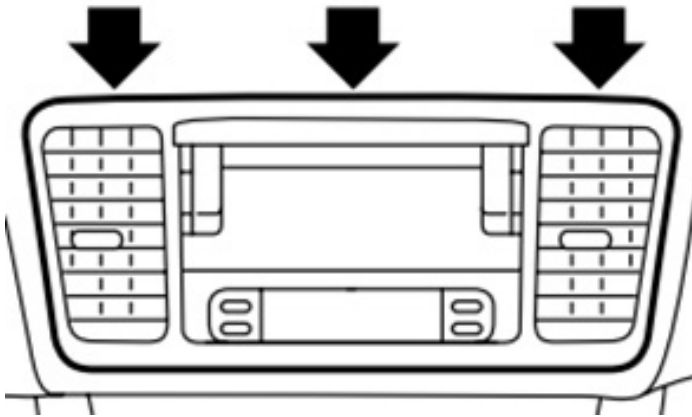
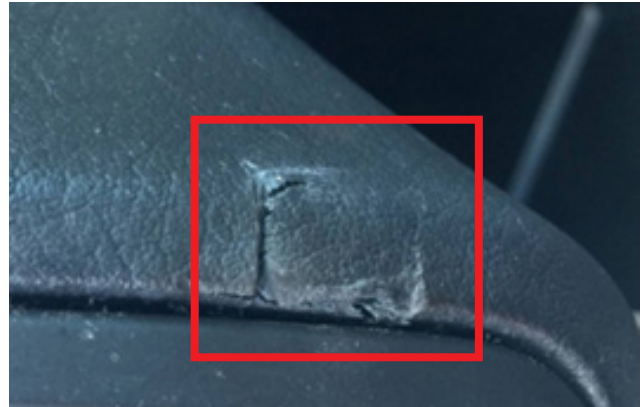
- When removing the center vent / storage box assembly, **CAREFULLY** release the 3 retaining claws shown in the illustration below using a plastic trim tool. Always support the trim tool against the IP (example: a second trim tool placed horizontally between the first tool and the IP) to distribute the prying force and avoid damage as shown in the example photo. Remember to disconnect (and reconnect) the trip computer's wiring harness connector.

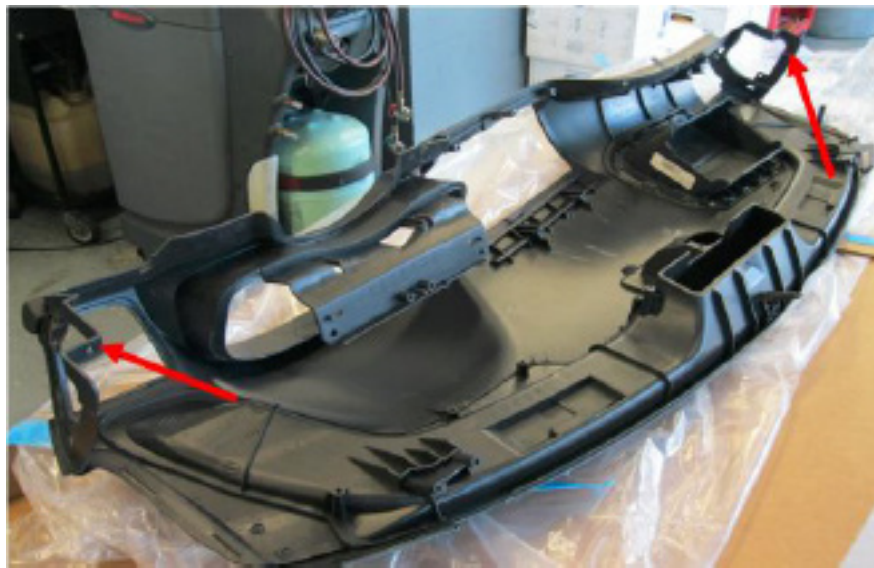
- Always use caution when removing the new IP from the plastic shipping bag. Pay close attention to the mounting brackets on each end of the new IP as indicated in the photo below. They can easily be broken if the heavy plastic shipping bag is removed too hastily.

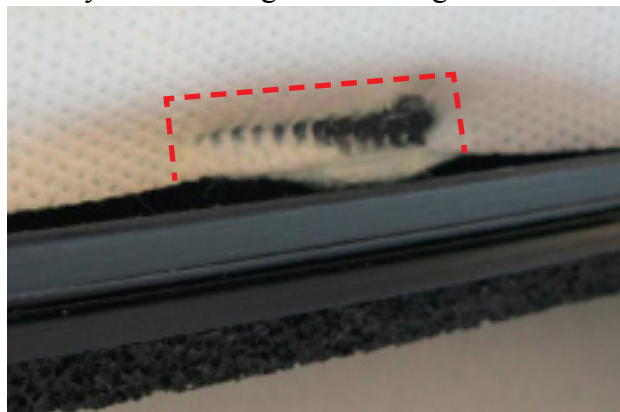
- As shown in the photo above, the replacement IP does not include the white insulation material. Although the ductwork does the bulk of holding the insulation in proper position, there are a few places where it is heat-fused as shown in the photo below to the original part. **CAREFULLY** cut around the fuse point with a small utility knife or scissor to release it then pull the insulation away from the original IP taking care to not tear it.

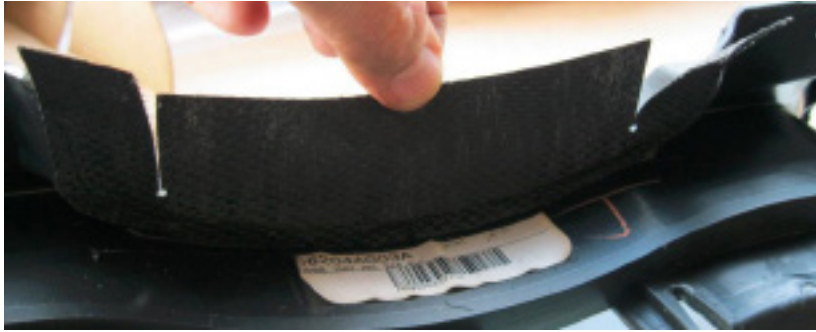
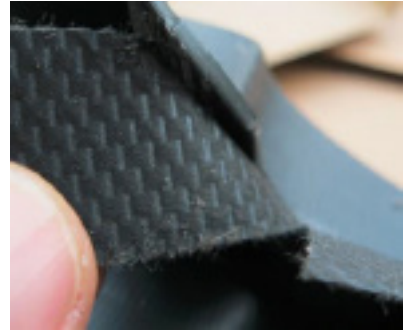
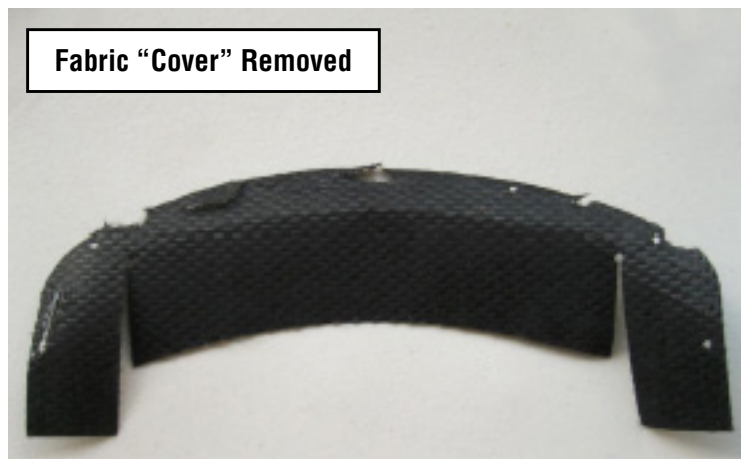
- There is a small piece of fabric-type material which acts as a “cover” for the gap between the top of the steering column and the underside of the combination meter area of the IP. This small trim piece must also be **VERY CAREFULLY** removed and transferred to the new IP. A small hobbyist knife or equivalent carefully worked in between the material and IP to break the glue bond works well. **PATIENCE** is the key!

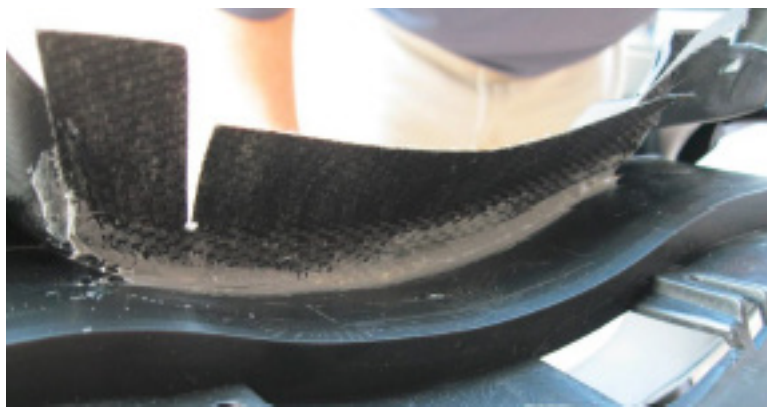
- Once the cover is removed, a **VERY** small amount of black or clear silicone sealer / adhesive works well to “tack” it into position on the new IP. Once in place, a small “fillet” of black or clear silicone can be applied from the back side as shown below to fully secure it in place. (Gray was used for photo.)

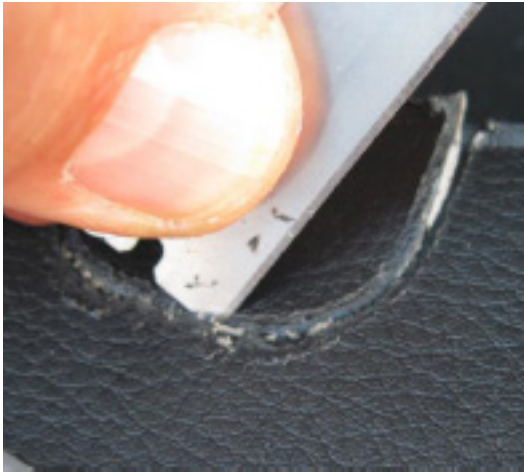
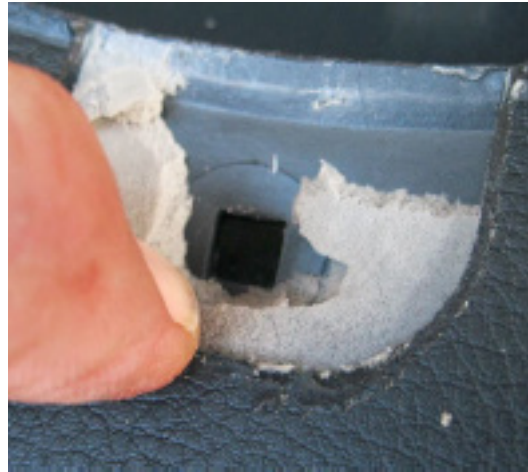
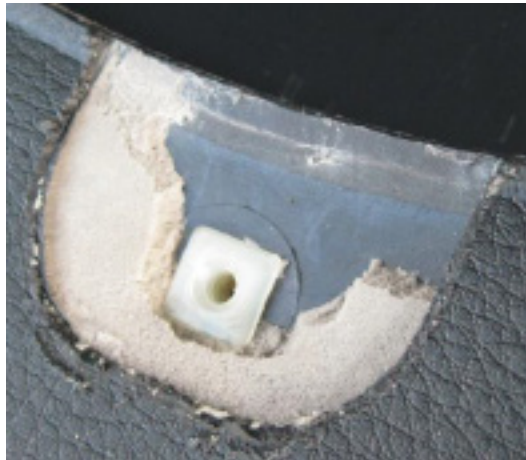
- **VERY CAREFULLY** using the molded-in groove as a guide, trim the IP as shown to gain access to the square hole for the combination meter top retaining screw clip. After cutting, peel away the trim surface then the foam underneath it to access the square hole for the clip.

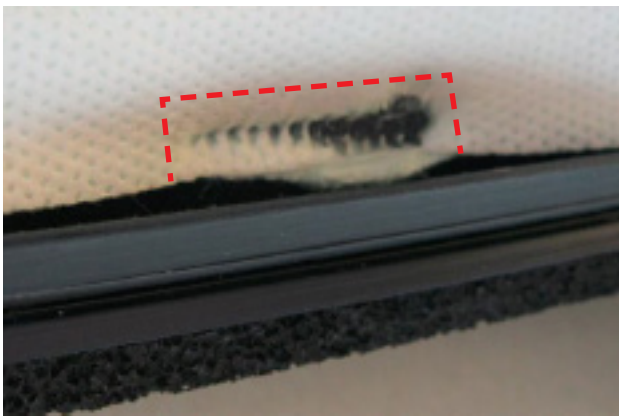
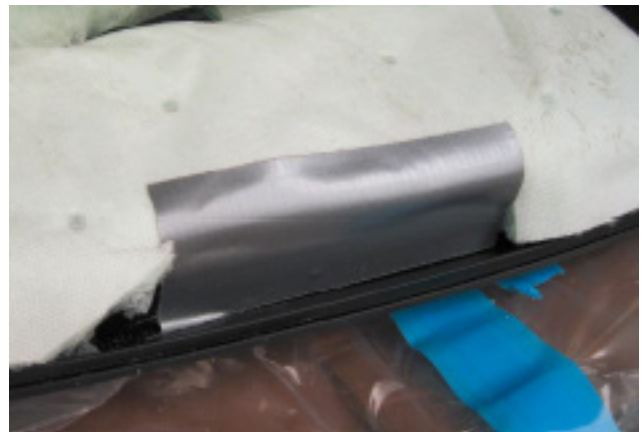
- Along the front edge, (closest to the windshield), there are 2 places where the insulation is heat-fused to the IP. Using a sharp scissor, cut the fuse points off the insulation and use tape to secure it to the new IP as shown below.

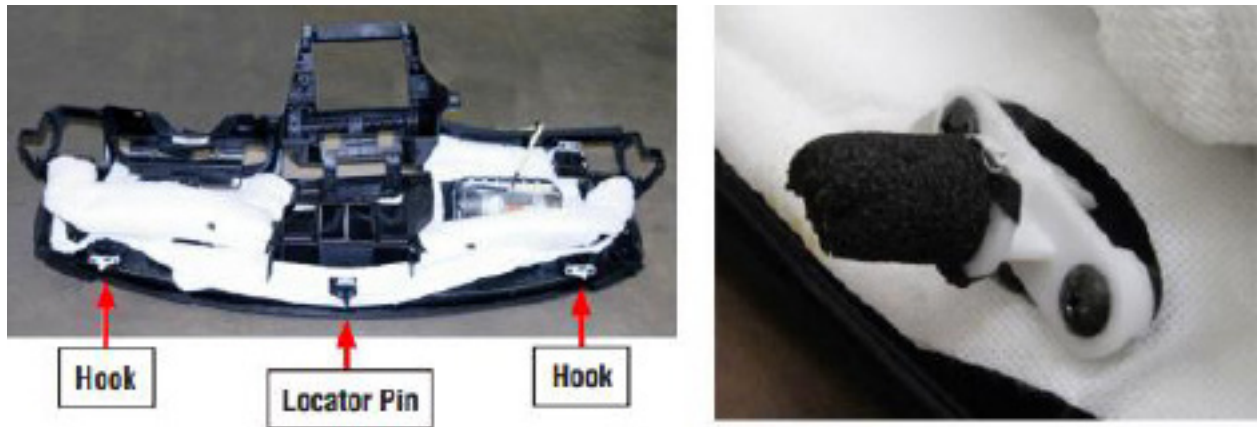
- Before installing the new IP, to eliminate a possible source of a rattling sound, wrap both hooks and the center locator pin with non-woven material, p.n. SOA963W110 (or an equivalent self-adhesive foam) as shown in the photos below.
