Bulletin No.: 14520A  
Date: March 2016

# Service Bulletin

**SUBJECT:** Special Coverage Adjustment – Fractured Leaf Springs

**MODELS:** 2008-2009 Chevrolet Silverado LD  
2008-2009 GMC Sierra LD  
Currently Registered or Previously Registered in Maine, New Hampshire, New York, Vermont and Canada

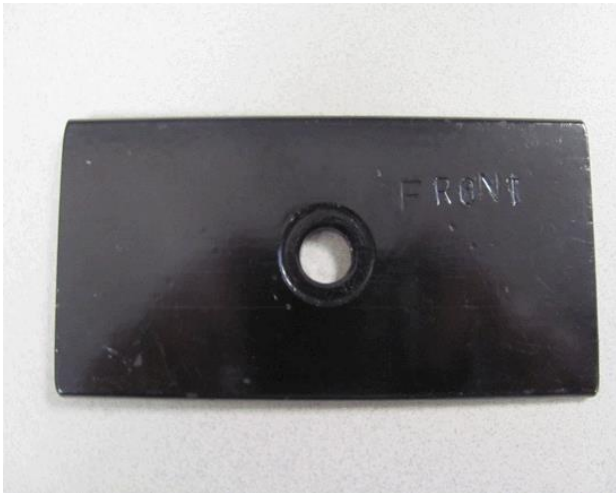
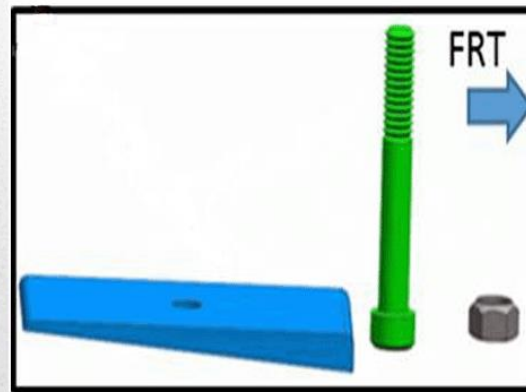
4372465

**Caution:** Incorrect orientation of the shim will cause an improper driveline angle of the rear axle.
