Service Bulletin

SUBJECT: Service Update for Inventory and Customer Vehicles
Incorrect Vacuum Pump Fastening Stud Can Lead to Chafing
Expires with Base Warranty

MODELS: 2016 Buick Cascada
Equipped with 1.6L Engine (RPO LWC)

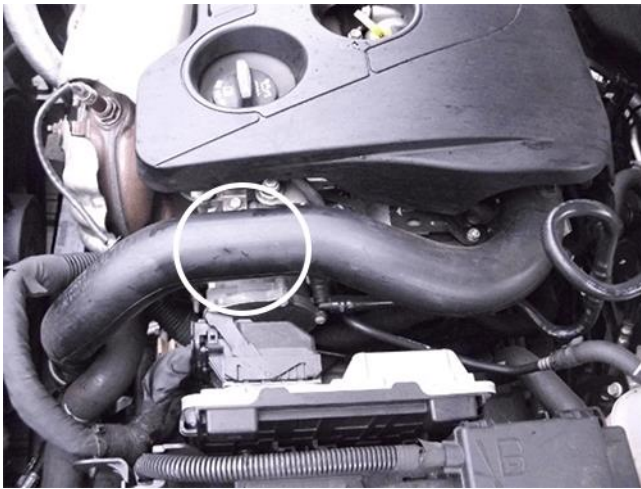
4454182

This bulletin provides a service procedure to replace the upper vacuum pump stud with a fastening bolt on **certain** 2016 model year Buick Cascada vehicles equipped with a 1.6L engine (RPO LWC). These vehicles may have a chafing condition of the charge air cooler outlet air hose on the upper vacuum pump stud.
