Service Bulletin

SUBJECT: Special Coverage Adjustment - Excessive Engine Oil Consumption

**MODELS: 2011 Chevrolet Equinox
2011 GMC Terrain
Equipped with 2.4L Engine (LAF)**

Subject: 15285C – Special Coverage Adjustment
Excessive Engine Oil Consumption
Revised Warranty Transaction Information

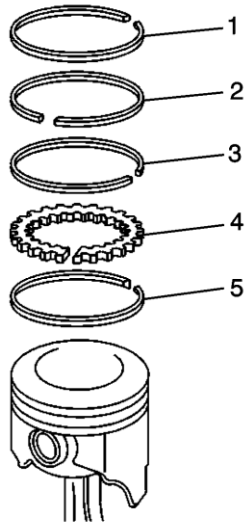
2146346

Note: The repair is to replace the pistons and rings. In some cases the bore surface may not have a uniform look to the finish (zebra stripes) as shown in Technical Service Bulletin 13-06-01-003F. As a result, some technicians may question whether the engine should be repaired or replaced. After careful evaluation, GM Powertrain has determined that the new pistons and rings will perform correctly in bores that have this appearance so engine replacement should not be necessary. The cylinder bores do not need any machine or honing work performed on them. Refer to Technical Service Bulletin 13-06-01-003F for more information.

- Engine Replacement
 - Technical Service Bulletin 13-06-01-003F
 - Piston and Connecting Rod Disassemble
 - Piston and Connecting Rod Assemble
 - Piston, Connecting Rod, and Bearing Installation (LAF, LAT, LE5, LE9, LEA, or LUK)
1. Remove the engine from the vehicle.
 2. Remove the pistons from the engine.
 3. Remove the pistons from the connecting rods.
 4. Discard the pistons and piston rings.
 5. Install the new piston rings onto the new pistons.
 6. Install the new pistons onto the connecting rods.
 7. Assemble the engine.
 8. Install the engine into the vehicle.
