GM Bulletin No.: 15118A
Date: March 2016

SUBJECT: Service Update for Inventory and Customer Vehicles
Engine Block Heater Cord
Expires with Base Warranty

MODELS: 2015 Chevrolet Colorado
2015 GMC Canyon
Equipped with Engine Block Heater (RPO K05)

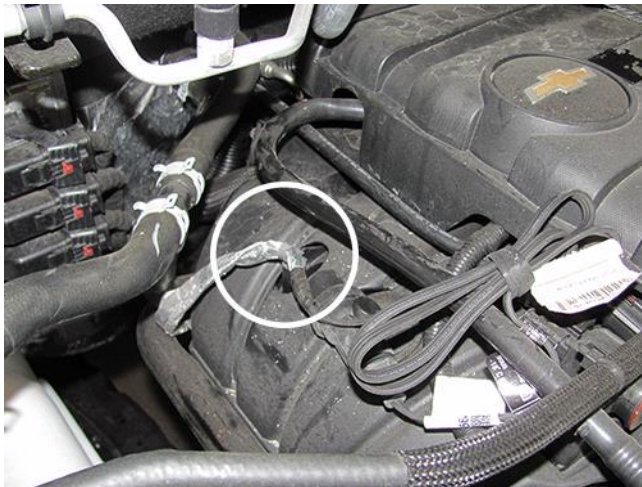
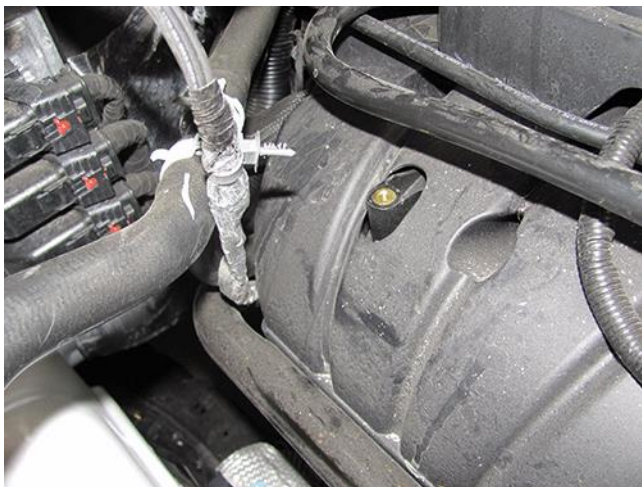
1. Open the hood and install fender covers.
2. Inspect the coolant heater cord for any damage.
 - If any damage is found, replace the coolant heater cord. Refer to *Coolant Heater Cord Replacement* in SI, and then proceed to step 3 to reroute the cord.
 - If no damage is found, continue to step 3.
