# Service Bulletin

**SUBJECT:** Service Update for Inventory and Customer Vehicles  
Parking Brake Cable Rubbing Noise  
Expires March 31, 2018

**MODELS:** 2016 Chevrolet Spark

Subject: 30670 - Service Update  
Parking Brake Cable Rubbing Noise

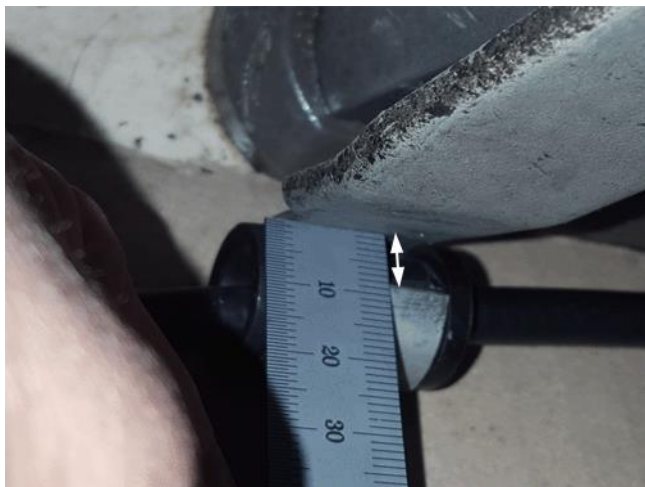
4451821

This bulletin provides a service procedure to adjust the gap of the parking cable mounting clamp on **certain** 2016 model year Chevrolet Spark vehicles. These vehicles may have a squeaking noise coming from the rear underbody due to hard contact between the parking brake cable and mounting clamp when driving on rough roads, or passing over a speed bump under cold conditions.

3. Open the gap of parking brake cable mounting clamp from 4mm to 8mm using pliers and trim remover or equivalent as shown.
