Telematics Control Unit

Retailer Service Action

Reference: PC454
Date: June 29, 2016

PC454 – Q70 Telematics Control Unit Replacement

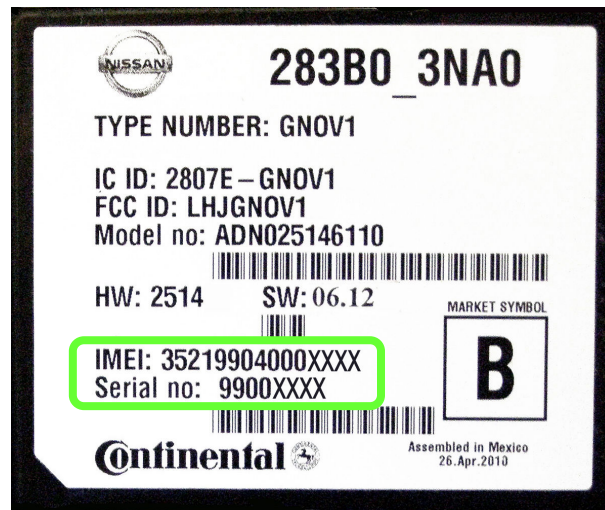
Figure 13

LABEL ON TCU

1. Collect and have ready the following information:
 - VIN.
 - International Mobile Equipment Identity Number (IMEI) of the original TCU. This number is located on the TCU.
 - IMEI Number of the replacement TCU. This number is located on the TCU.
 - Serial Number of the replacement TCU. This number is located on the TCU.

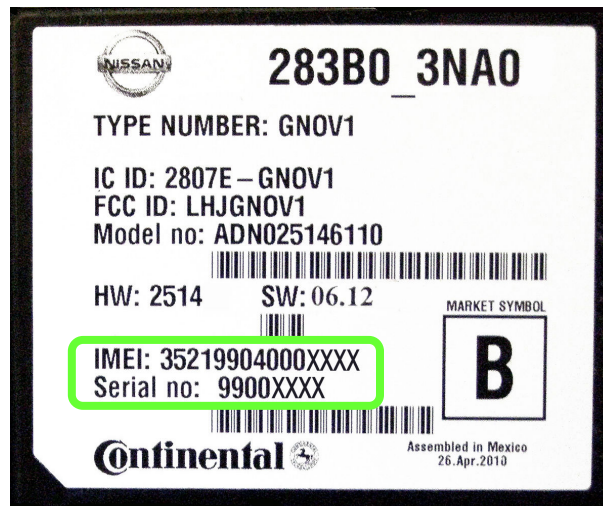
Figure 48

LABEL ON TCU

1. Collect and have ready the following information:
 - VIN.
 - International Mobile Equipment Identity Number (IMEI) of the original TCU. This number is located on the TCU.
 - IMEI Number of the replacement TCU. This number is located on the TCU.
 - Serial Number of the replacement TCU. This number is located on the TCU.

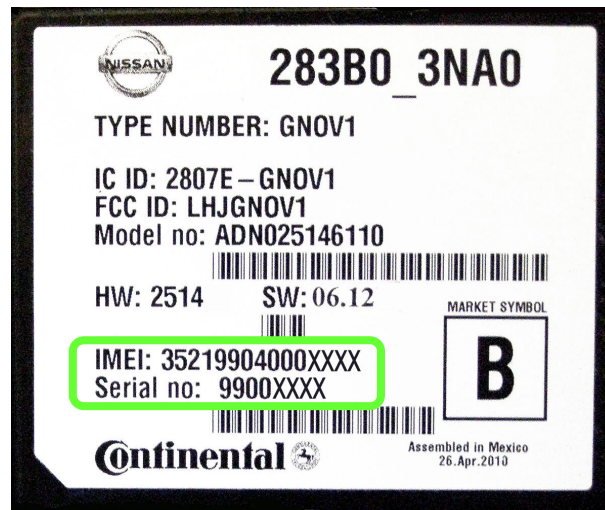
Figure 13

LABEL ON TCU

1. Collect and have ready the following information:
 - VIN.
 - International Mobile Equipment Identity Number (IMEI) of the original TCU. This number is located on the TCU.
 - IMEI Number of the replacement TCU. This number is located on the TCU.
 - Serial Number of the replacement TCU. This number is located on the TCU.
