MODEL
2017MY
Sorento (UMa)

NUMBER
116

DATE
September 2016

SUBJECT: SERVICE ACTION: LANE DEPARTURE WARNING
SYSTEM DTC C180508 (SA243)

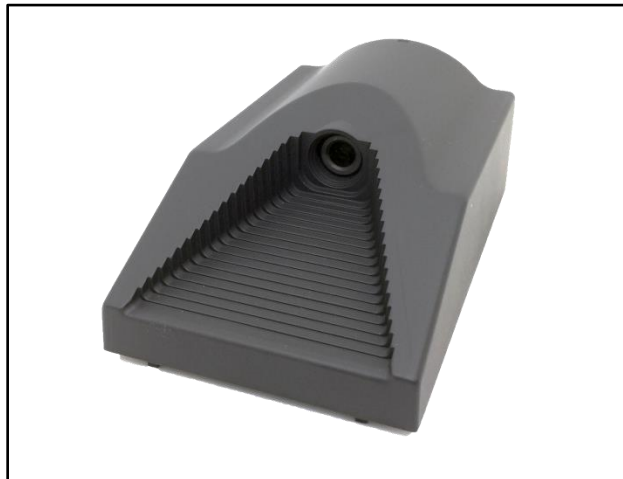
This bulletin provides information related to the Lane Departure Warning System (LDWS) on some 2017MY Sorento (UMa) vehicles, produced from April 5, 2016 to September 10, 2016, which may exhibit a LDWS malfunction with DTC: C180508 and/or an unsecured LDWS camera. Follow the procedure below to inspect and if necessary, reattach the LDWS camera and/or calibrate the LDWS.

C180508: LKAS CAN Signal Error

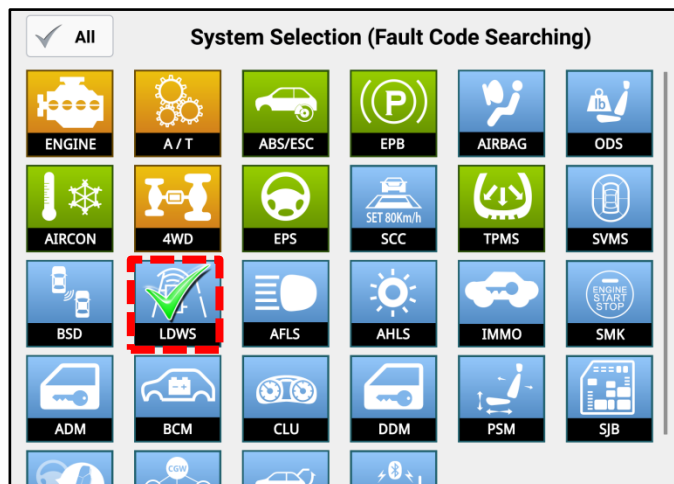
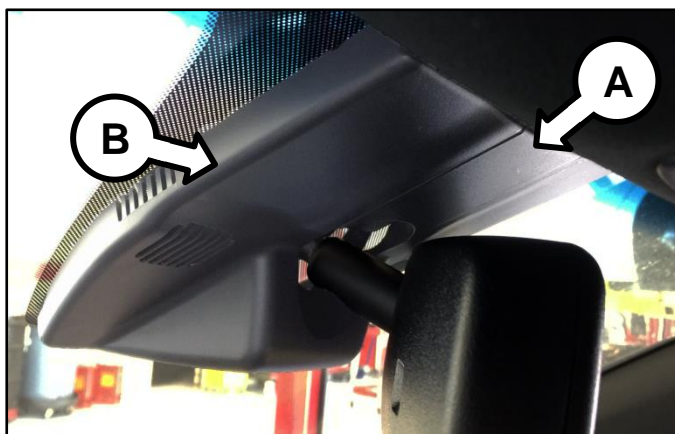
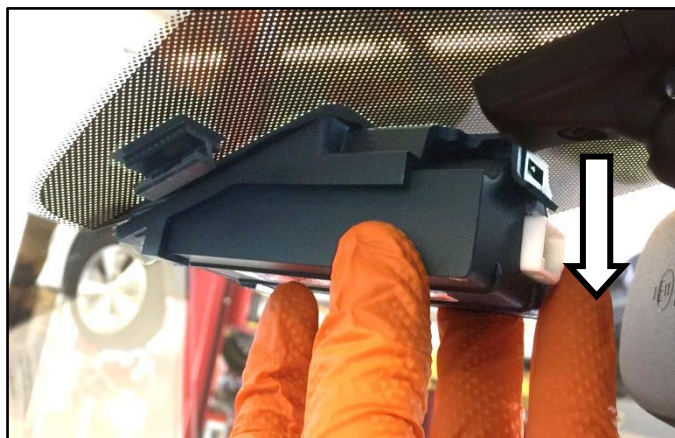
2. Remove the LDWS center cover (A) and outer cover (B) then lightly pull down on the camera to inspect the mounting of the LDWS camera.

- If the camera **is** properly mounted, no further action is required. Reinstall covers in reverse order of removal.
- If the camera **is NOT** properly mounted, proceed to the Reattachment and Calibration Procedure on page 4.

Covers (A) and (B) are clipped in. Carefully pull down at the edges to remove.
