MODEL
2014~2016MY
Cadenza (VG)
2014~2015MY
Sorento (XMa) w/
3.3L GDI

NUMBER
148 (Rev 4, 9/20/2016)

TECHNICAL SERVICE BULLETIN

SUBJECT: CHATTER/RATTLE NOISE FROM ENGINE AFTER COLD SOAK

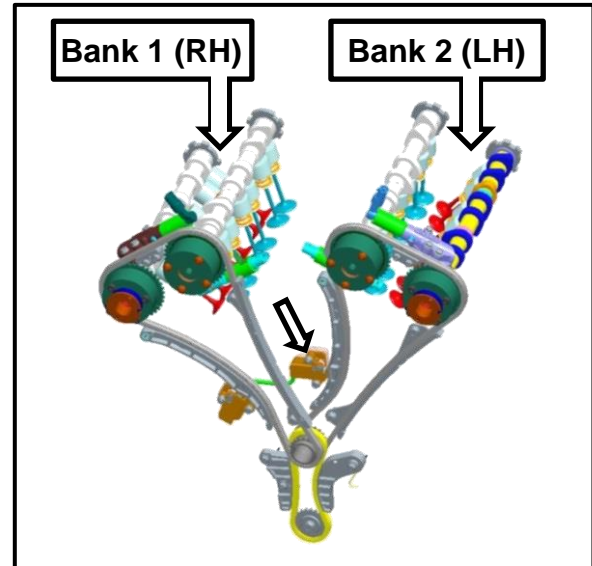
This Service procedure should **ONLY** be performed on engine bank 2 (LH), as shown.

1. Refer to the “Engine Mechanical System → Timing System → Timing Chain” section in the applicable Workshop Manual on KGIS, to install the improved timing chain tensioner.
2. For XMa vehicles, confirm that the latest intake CVVT is installed by referencing the part number shown on page 3 of this bulletin.

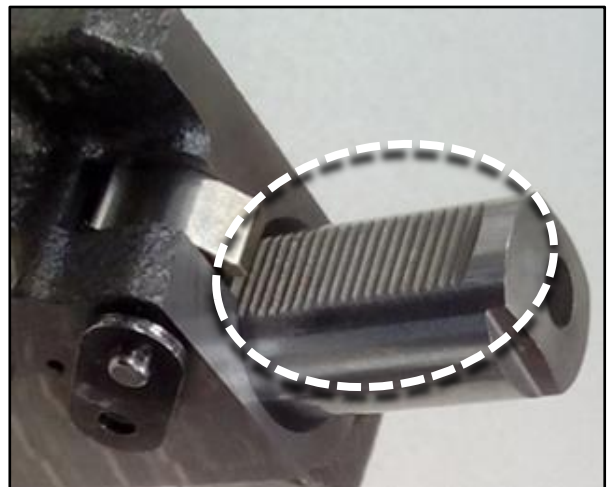
New tensioner design with finer pitch on teeth (1.5mm)

Refer to the “Engine Mechanical System → Cylinder Head Assembly → CVVT & Camshaft” section in the applicable Workshop Manual on KGIS, to replace the intake CVVT.

Torque the intake CVVT retaining bolt with hand tools and a torque wrench. Do NOT use power/air tools.

**Tightening torque:
47.4 - 56.4 lb·ft (64.7 - 76.5 Nm)**

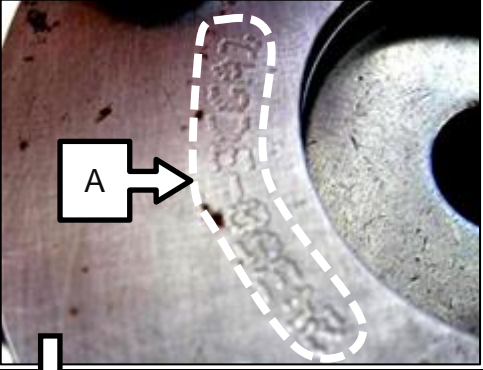
Check the part number (A) engraved in the metal to identify the previous type and new one.
