Service Bulletin

Bulletin No:	02-010/16
KNOCKING / SQUEAKING NOISE FROM FRONT SHOCK ABSORBER, CREAK- ING NOISE FROM FRONT LOWER ARM BUSHING	Last Issued:	03/10/2016

This bulletin supersedes the previously issued bulletin(s) listed below: The changes are noted in Red beside the change bars.

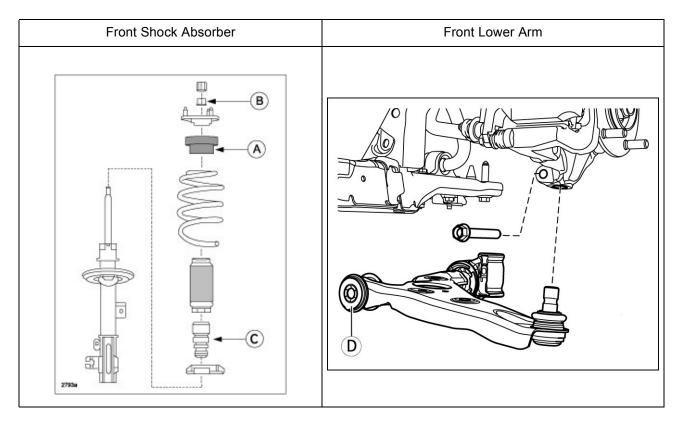
Some vehicles may exhibit a knocking / squeaking noise from the front shock absorber when driving on rough roads and/or when turning the steering wheel while the vehicle is stopped.

- upper front strut bearing (A) damage. (CX-5 and Mazda6)
- stick/slip between the front strut bearing and coil spring. (CX-3, CX-5 and Mazda6)
- the bump stopper (C) may be contacting the strut bearing when the front shock absorber is compressed, causing a popping noise. (Mazda6 only)
- The front lower arm bushing (D) is making a stick-slip noise in wet road conditions. (CX-5 and Mazda6)

- 1. The material and production method of the front strut bearing (A) has been changed. (CX-5 and Mazda6)
- 2. A protector has been installed onto the coil spring. (CX-5 and Mazda6)
- 3. The shape of the bump stopper (C) will be modified in the future. (Mazda6 only)
- 4. The shape of the coil spring has been changed. (CX-3 only)
- 5. Friction of the lower arm bushing has been reduced by adding a dry coating. (CX-5 and Mazda6) NOTE: The piston rod nut (B) requires replacement.
