Subject: CONSOLE MAT WARPING CAUSING POOR APPEARANCE	Bulletin No: 09-019/16
	Last Issued: 03/24/2016

2016 MX-5 vehicles with VINs lower than JM1ND*****103512 (produced before July 9, 2015)

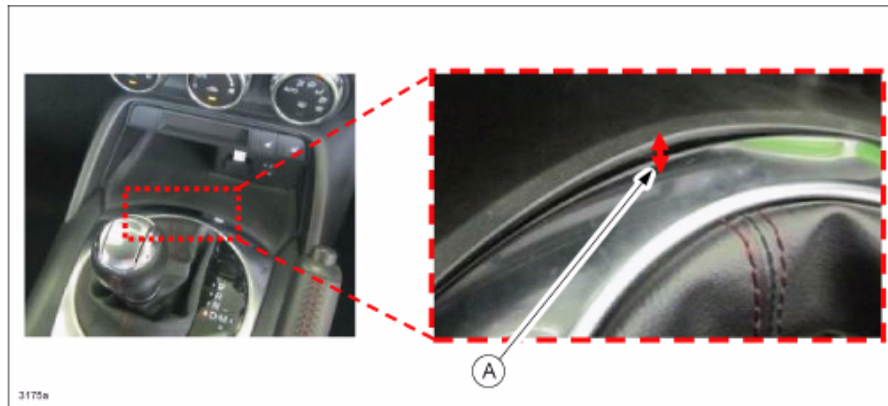
Some vehicles operating in places with high ambient temperatures may exhibit the console mat warping at the center part (A), causing a poor appearance. The console mat is fixed at both ends and warpage of the center part is caused by heat influence.

Customers having this concern should have their vehicle repaired using the following repair procedure.

1. Verify customer concern.
2. Replace the front console box assembly with a modified one according to the instructions on MS3 online or the Workshop Manual (section 09-17 CONSOLE PANEL REMOVAL/INSTALLATION).
3. Verify repair.

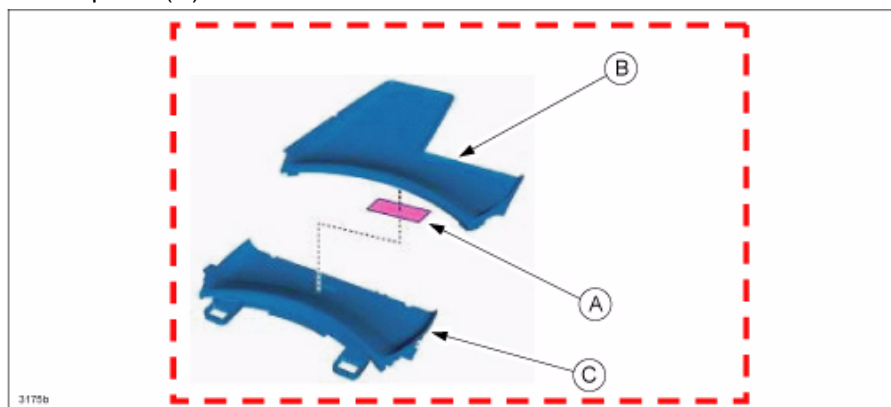
To prevent the console mat from warping, double-sided adhesive tape (A) has been added between the console mat (B) and the console panel (C).
