<b>Subject:</b>  A-PILLAR TRIM DISTORTION	<b>Bulletin No:</b> 09-022/16
	<b>Last Issued:</b> 03/31/2016

2013-2016 CX-5 vehicles with VINs lower than JM3KE\*\*\*\*\*730190 (produced before Oct. 15, 2015)

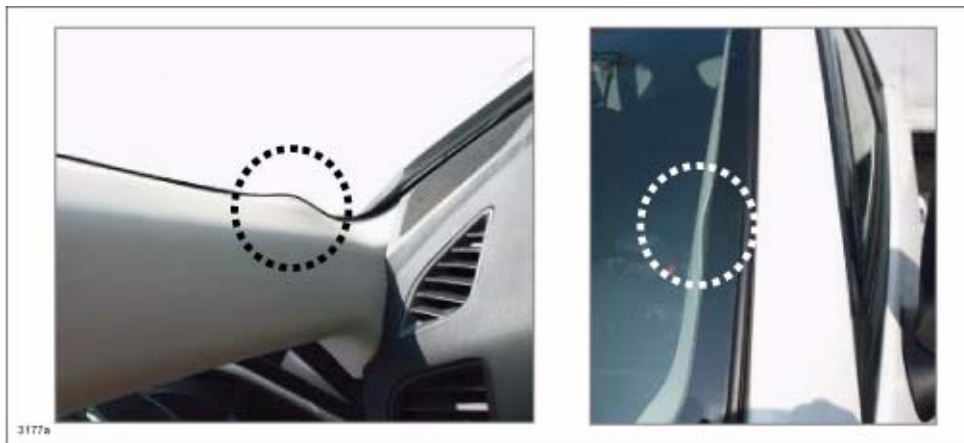
Some customers may complain of the poor appearance of the passenger and/or driver side A-pillar trim. The lower portion of the trim may become distorted (as shown below) due to high temperatures.

To eliminate this concern, the shape of the body flange has been improved during mass-production to allow sufficient A-pillar clearance.

1. Verify the customer concern.
2. Replace the affected side A-pillar trim(s) with a new modified service part according to the instructions on MS3 online or the Workshop Manual (section 09-17 A-PILLAR TRIM REMOVAL/INSTALLATION).
3. Verify the repair.

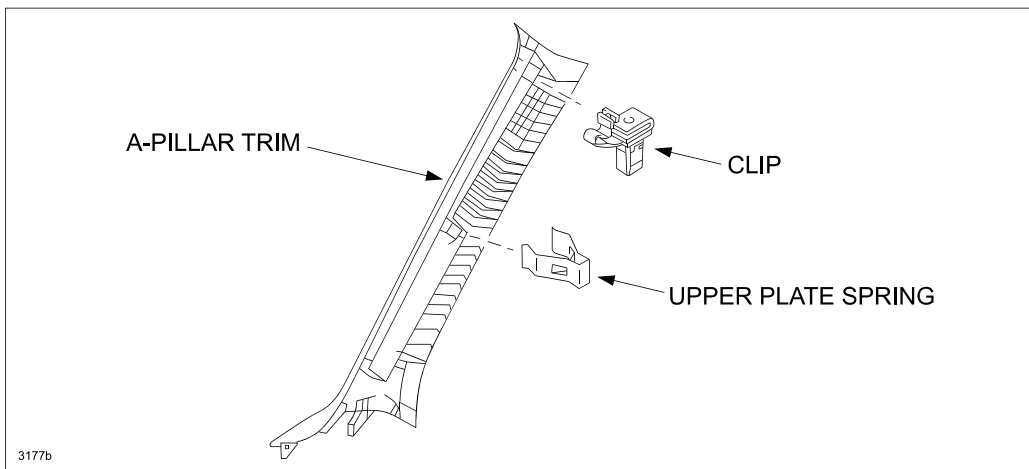
- The new service part has an aluminum reinforcement attached to the back side of the trim.
- The A-pillar trim comes with a clip and upper plate spring.
