Technical Service Bulletin

37 No gear selected after start-stop event

37 16 72 2040747/3 December 20, 2016. Supersedes Technical Service Bulletin Group 37 number 16-63 dated April 25, 2016 for reasons listed below.

Model(s)	Year	VIN Range	Vehicle-Specific Equipment
Q5	2014 - 2015	All	3.0L TDI engine

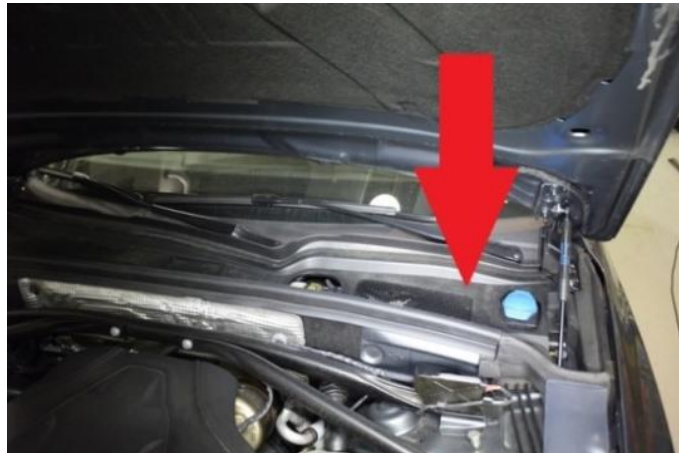
Figure 2. Plenum chamber cover.

2. Remove the plenum chamber cover (Figure 2).

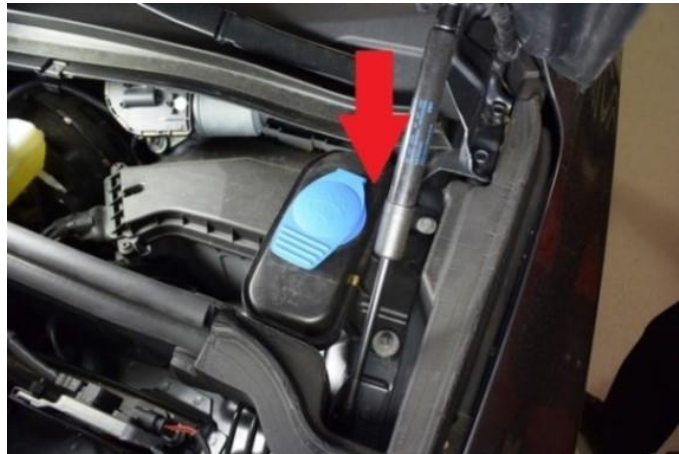
Figure 3. Washer fluid filler reservoir filler tube.

3. Remove the washer fluid reservoir filler tube (Figure 3) using the instructions in the Elsa Repair Manual.

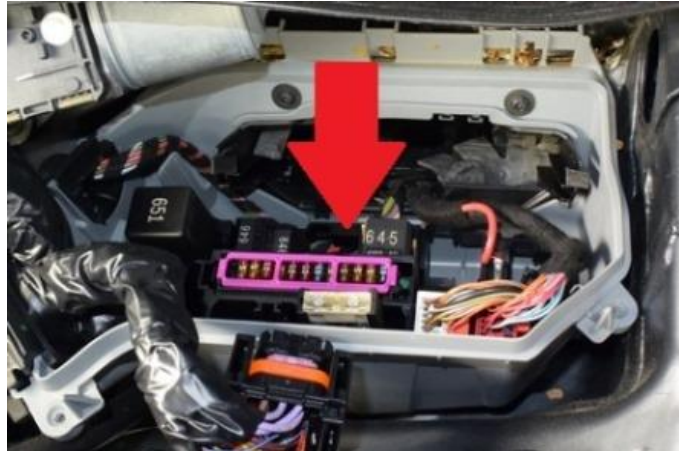
Figure 4. Fuse panel B -SB- in the E-box

4. Remove fuse panel B -SB- in the E-box (Figure 4 and Figure 5) using the instructions in the Elsa repair manual.

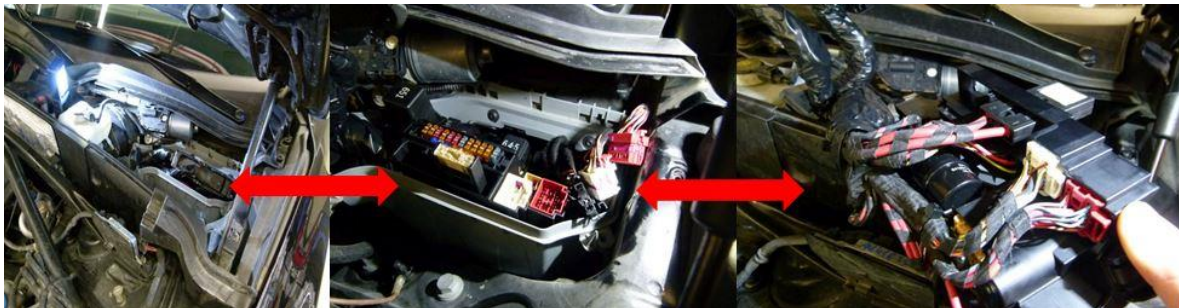
Figure 5. Removal of fuse panel B -SB- in the E-box

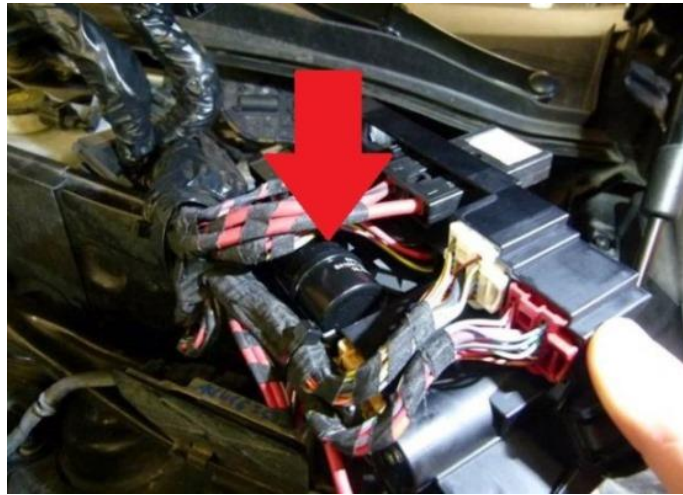
Figure 6. Suppression condenser.

5. Cut the cable tie that holds the suppression condenser to fuse panel B - SB- (Figure 6 and Figure 7).

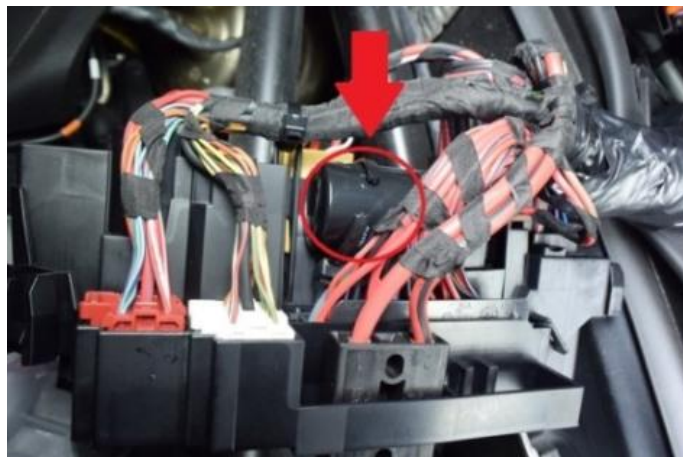
Figure 7. Cable tie that has been cut.

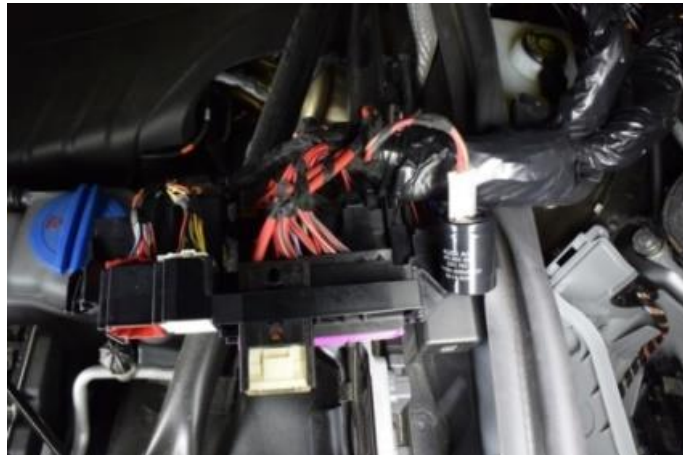
Figure 8. Suppression condenser removed from fuse panel B -SB-.

- Slide the suppression condenser out of fuse panel B -SB- (Figure 8). Leave the wiring connected to the suppression condenser.

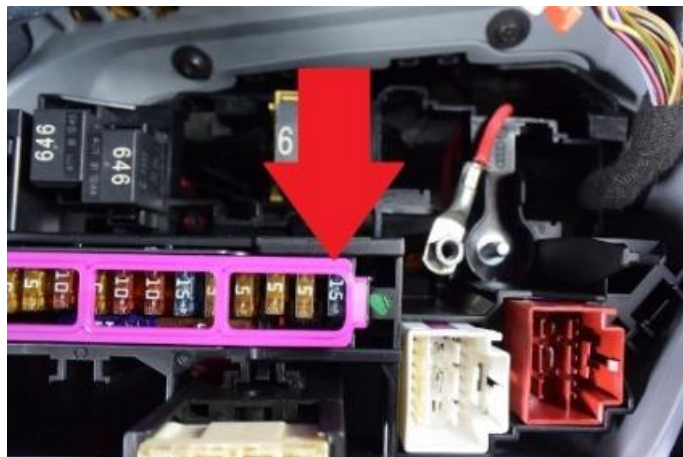
Figure 9. Purple fuse cover to be removed.

- Remove the purple fuse cover from the fuse block (Figure 9).

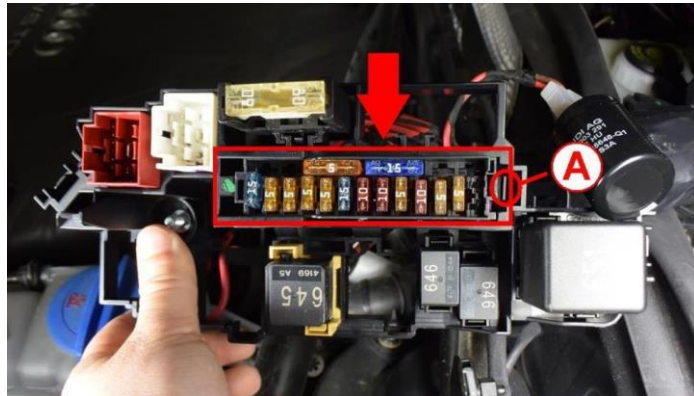
Figure 10. Fuse block ST1 with tab for removal (A).

8. Release tab and remove fuse block ST1 from fuse panel B -SB- (Figure 10). It will push through the bottom of the panel.

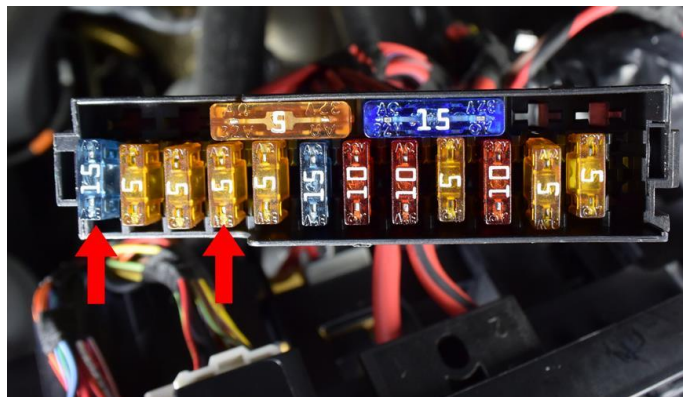
Figure 11. Fuses SB1 and SB4.

9. Remove fuses SB1 and SB4 from the fuse block (Figure 11).
Save the fuses for later reinstallation.

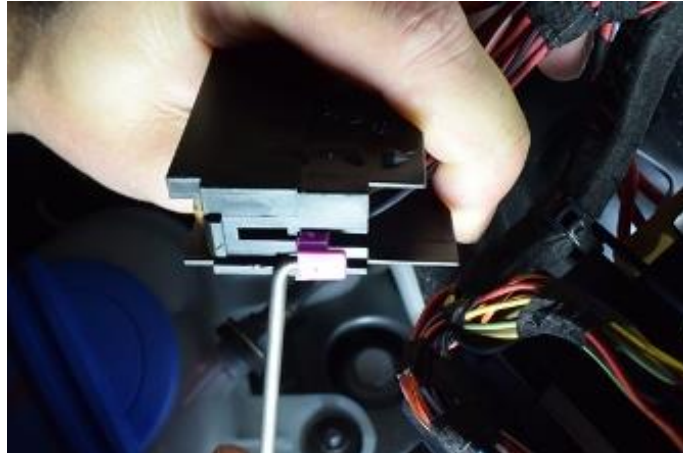
Figure 12. Terminal lock.

10. Completely remove the terminal lock from the fuse block (Figure 12).

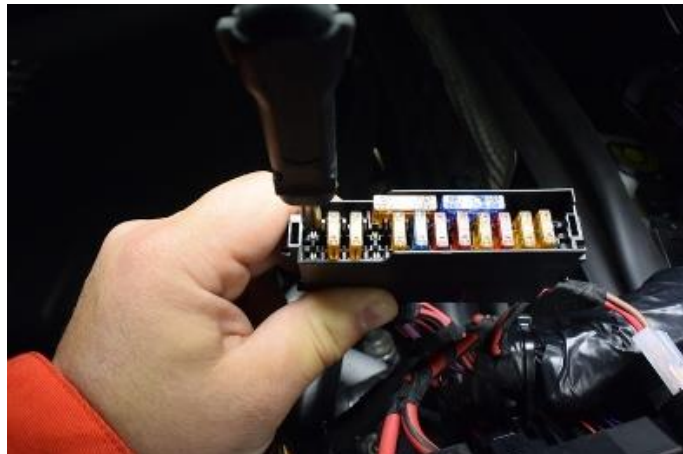
Figure 13. Using special tool VAS 1978/18.

11. Using special tool VAS 1978/18 (wiring terminal removal tool), remove the battery power feed terminal for fuses SB1 and SB4 (Figure 13 through Figure 17).

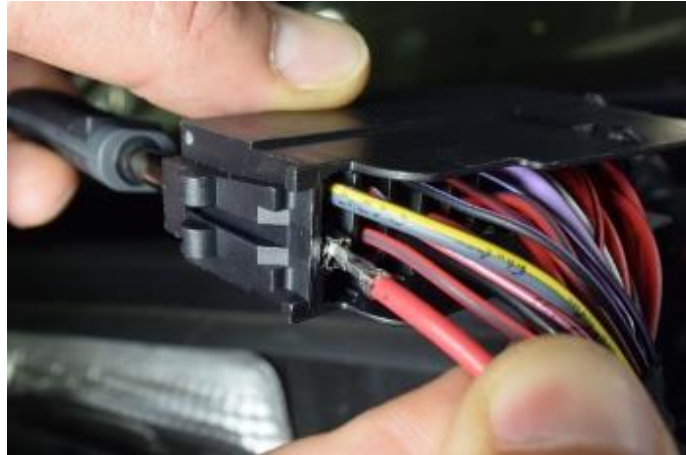
Figure 14. SB1 battery power feed wire.

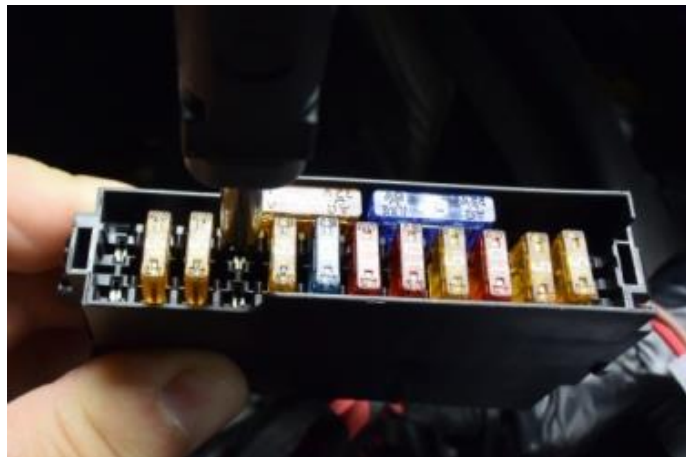
Figure 15. SB4 battery power feed wire terminal.

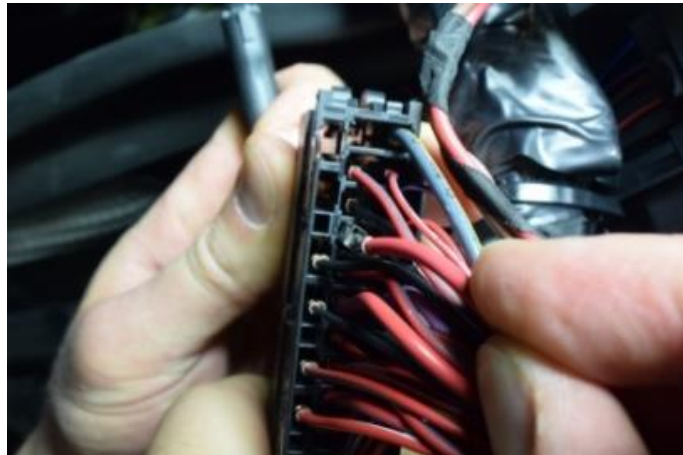
Figure 16. SB4 battery power feed wire.

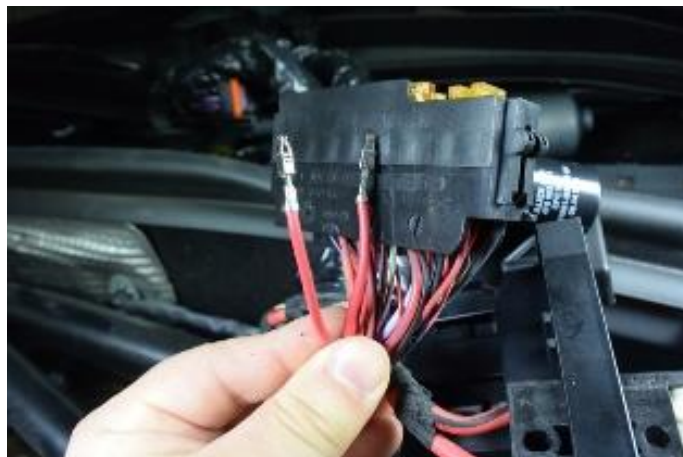
Figure 17. Both power feed wires removed.

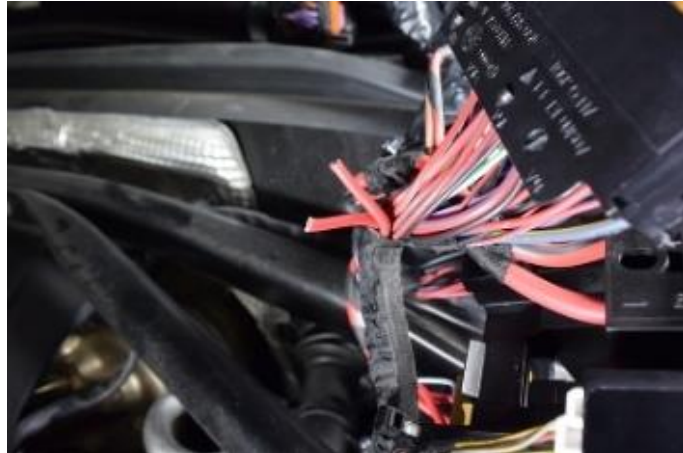
Figure 18. Cut wire ends.

12. When both wires are removed, cut the terminal ends off, as they will no longer be used (Figure 18). Leave at least a half inch of wire for the next steps

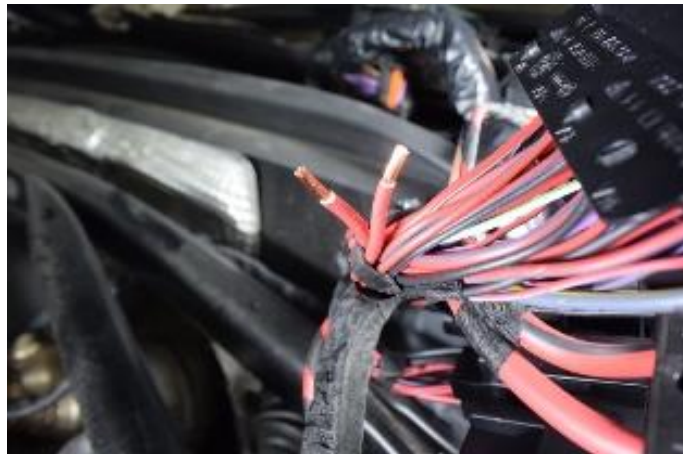
Figure 19. Stripped wire ends.

13. Strip the wire ends (Figure 19), then install two butt connectors (000 979 942) from the VAS 1978 wiring repair kit (Figure 20).

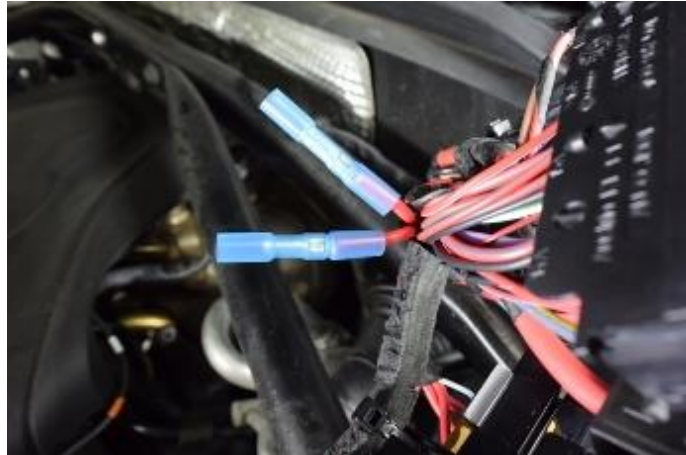
Figure 20. Installed crimped butt connectors.

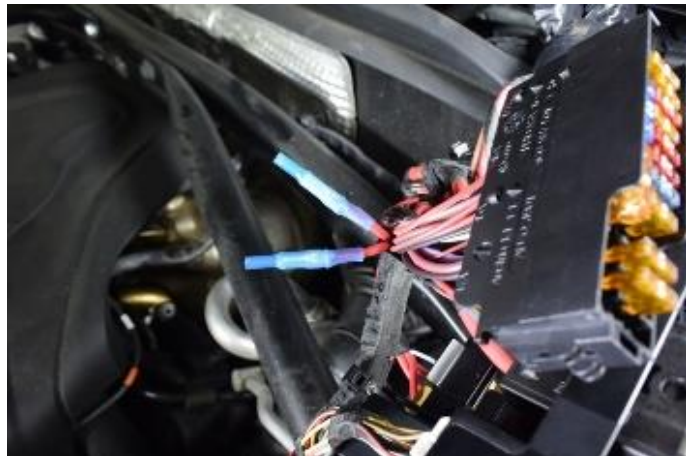
Figure 21. Heat-shrink the butt connectors.

14. Heat-shrink the butt connectors to protect the wire ends (Figure 21).

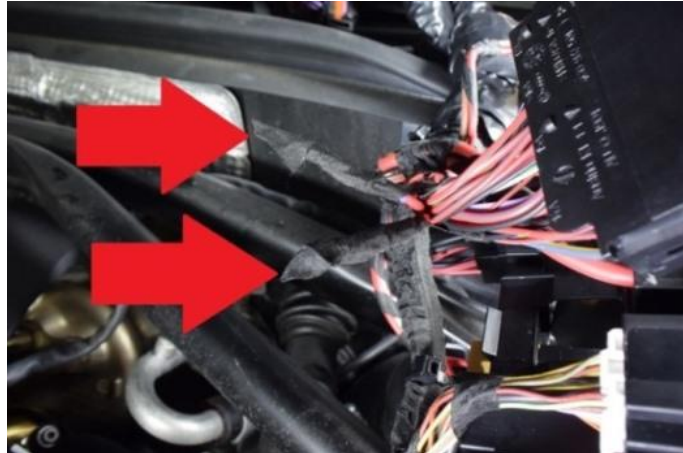
Figure 22. Butt connectors taped for protection.

15. Use cloth wrapping tape (N 105 920 02) to cover the butt connectors completely for protection (Figure 22).

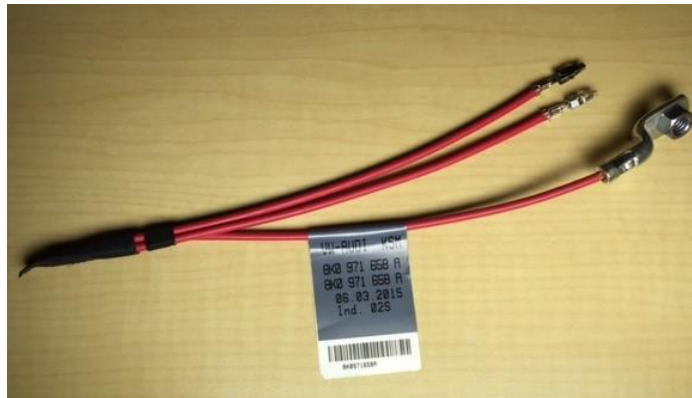
Figure 23. New battery power feed wiring.

16. Using the repair harness (8K0 971 658 A), install the new battery power feed wiring into the SB1 and SB4 terminal locations in the fuse block (Figure 23 and Figure 24).

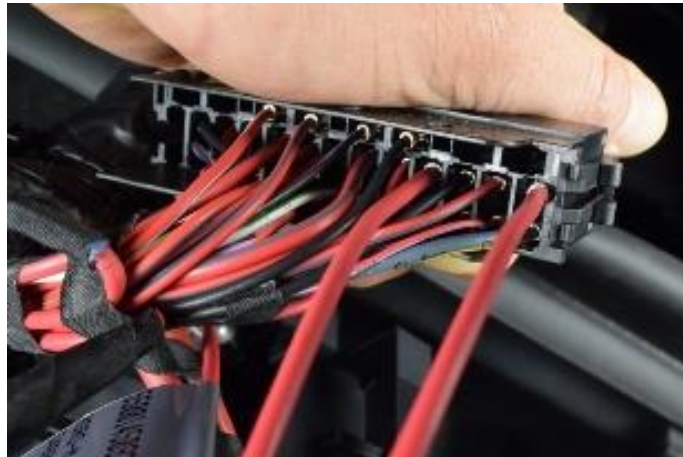
Figure 24. New battery power feed wiring installed into fuse block.

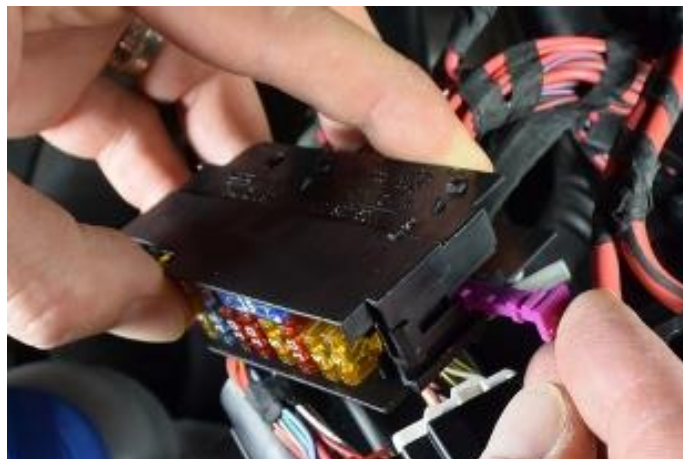
Figure 25. Reinstalling the terminal lock in to the fuse block.

17. Reinstall the terminal lock into the fuse block (Figure 25).

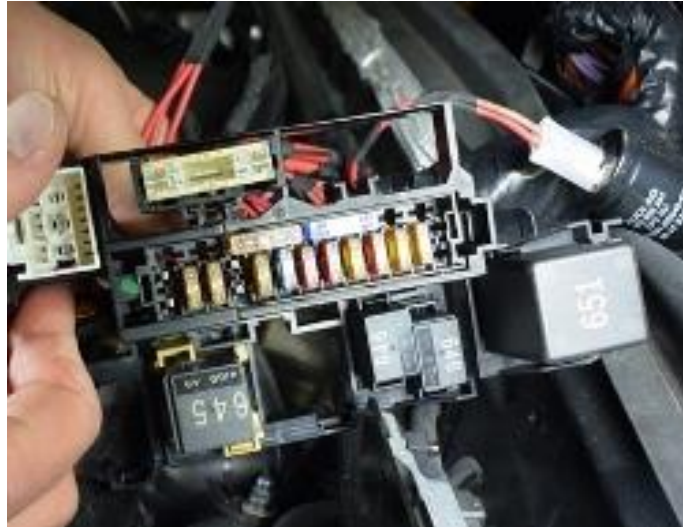
Figure 26. Reinstalling the fuse block into fuse panel B - SB-.

18. Reinstall the fuse block into fuse panel B - SB- (Figure 26).

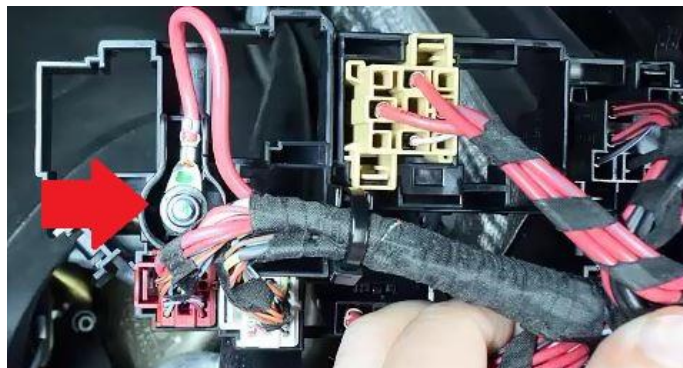
Figure 27. 10mm nut to be removed from the bottom of fuse panel B -SB-.

19. Remove the 10mm nut from the bottom of fuse panel B -SB- (Figure 27). Do not uninstall the wire that is connected to the treaded post.

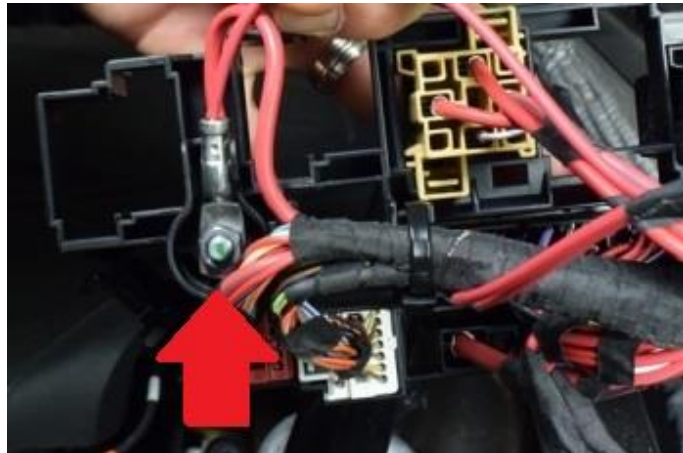
Figure 28. Repair harness installed to power post.

20. Install the repair harness onto the power post (Figure 28) and tighten the 10mm hex nut to 9 Nm.

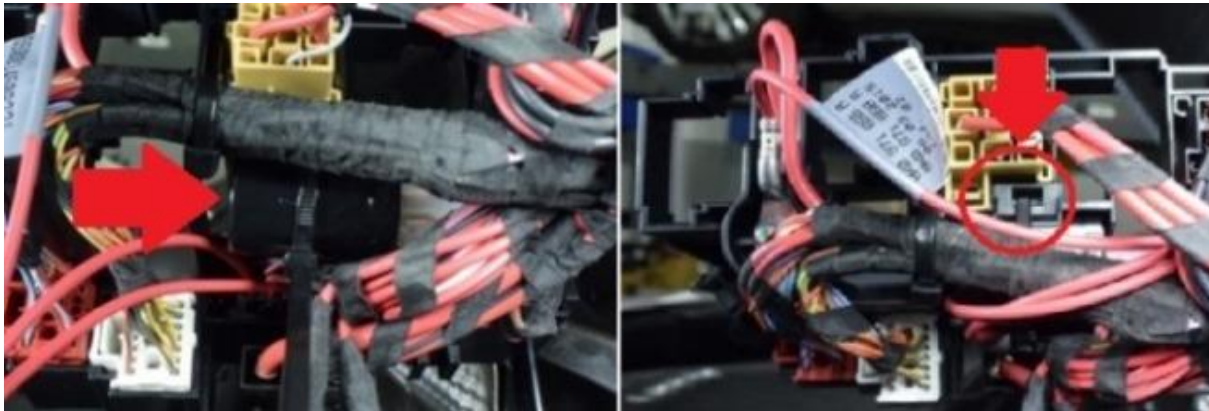
Figure 29. Suppression condenser secured with cable tie.

21. Reinstall the suppression condenser into the bottom fuse panel B -SB- and secure it with a new cable tie (N 020 904 08) (Figure 29).

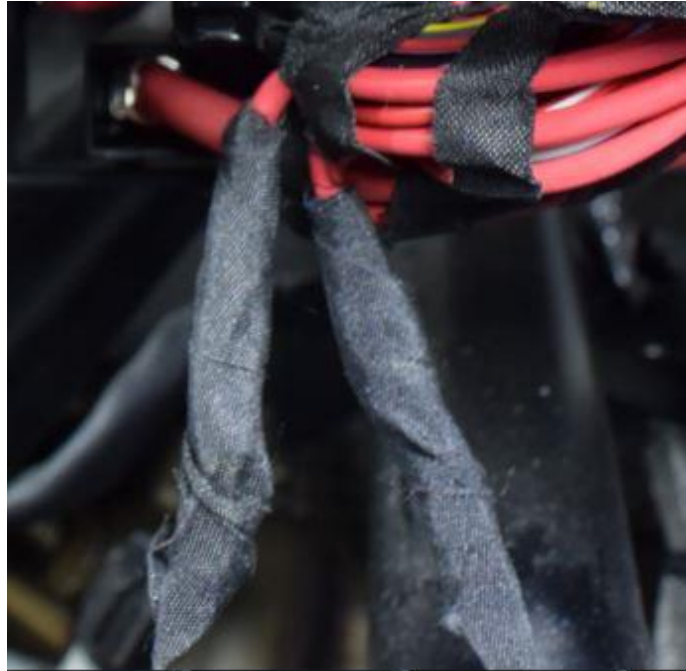
Figure 30. Original power wires.

22. Fold the original power wires (Figure 30) back onto the harness.

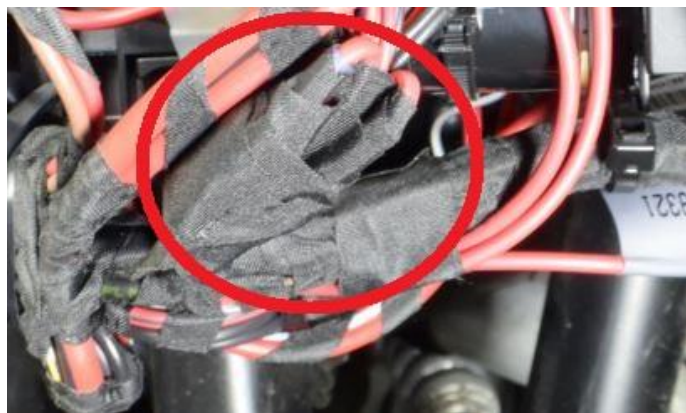
Figure 31. Original power wires that have been folded back into the harness and taped.

23. Use cloth wrapping tape (N 105 920 02) to wrap the original power wires to the harness (Figure 31).

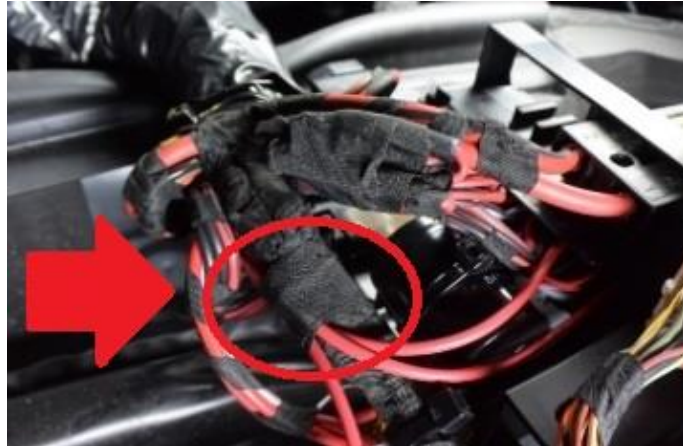
Figure 32. Repair harness secured.

24. Use cloth wrapping tape (N 105 920 02) to secure the newly-installed repair harness to the main harness (Figure 32).

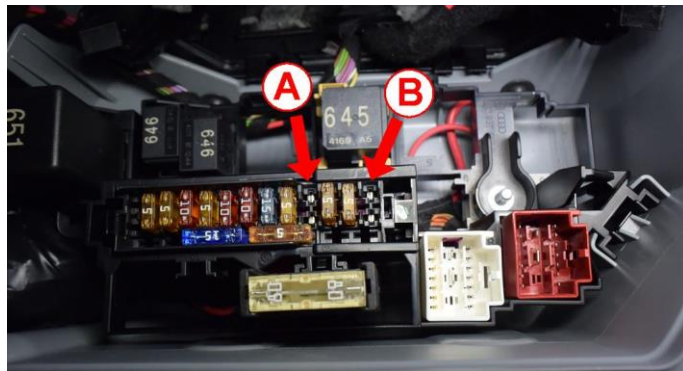
Figure 33. Fuse panel B -SB- showing 5 amp (A) and 15 amp (B).

25. Reinstall the removed fuses (SB1 and SB4) and the purple fuse cover.
Install fuse panel B -SB- in the E-box (Figure 33) using the instructions in the Elsa repair manual.
