Technical Service Bulletin

37 Selector lever malfunction (DTC P17EE00 - release button implausible signal)

37 16 66 2043817/2 June 14, 2016. Supersedes Technical Service Bulletin Group 37 number 16-62 dated April 5, 2016 for reasons listed below.

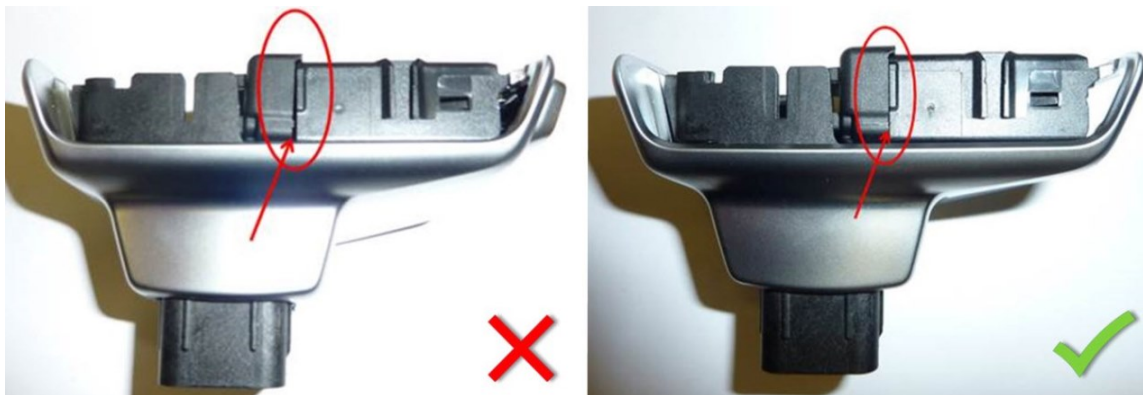
1. Installation of switch cover is incorrect.
2. Clearance of the release button is excessive

Figure 1. Incorrectly-installed (left) and correctly-installed (right) cover.

1. Remove the upper selector lever handle (the leather-covered section) according to the Elsa repair manual.
2. Check the attachment of the cover of the release button sensors in the front of the shifter to determine if it is correctly installed (Figure 1).

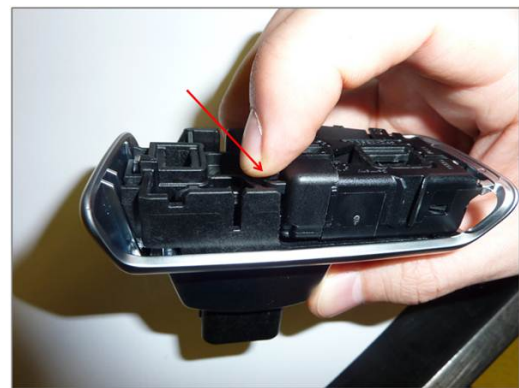
Figure 2. Apply force to fully install the cover.

- Push the cover into the correct position by applying force, as shown (Figure 2). A clicking noise confirms the attachment in the lower retaining lug.
- After the attachment is made, confirm that the gap between the two parts matches the image (Figure 2), and that the release button clicks when operated.
- Delete the fault, then reinstall the upper selector lever handle.

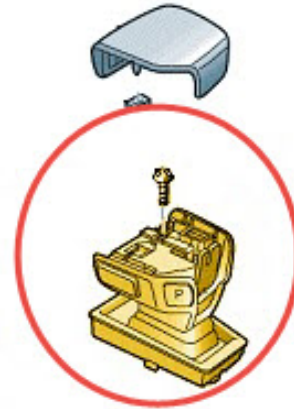
Figure 3. Lower shift lever handle (circled).

- Replace the lower shift lever handle (Figure 3). (Note that the part must be ordered based on vehicle VIN due to available color options.)
