Technical Service Bulletin

20 Vehicle does not start; fuel pressure below specification (DTC P0087)

20 16 73 2044478/1 July 5, 2016.

Model(s)	Year	VIN Range	Vehicle-Specific Equipment
A4	2017	000001 - 020055	Not Applicable

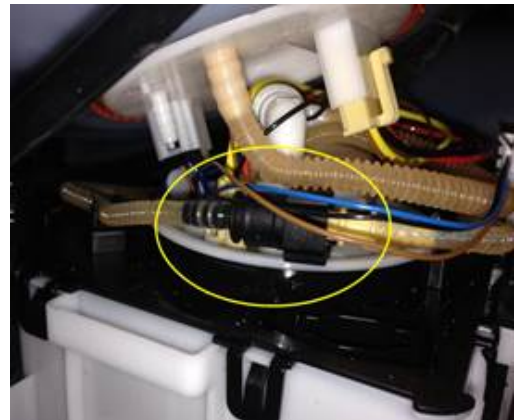
3. Identify the fuel line inside of the tank (Figure 1). The line may be partially or completely disconnected.

Figure 1. Fuel line.

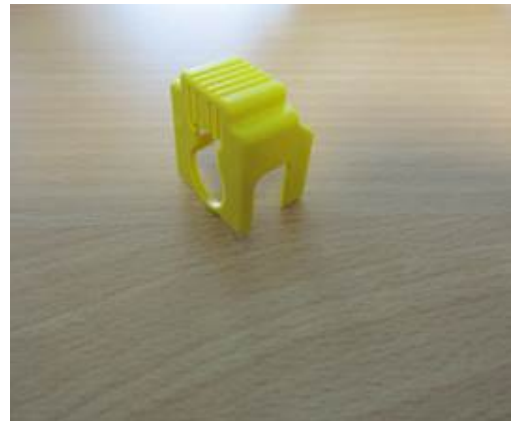
Figure 2. Yellow securing clip.

4. Install the yellow securing clip (part number 8W0201250) straight onto the black connector (Figure 2 and Figure 3). Make sure that the release tabs of the black connector are locked through the “window” of the securing clip (Figure 4).

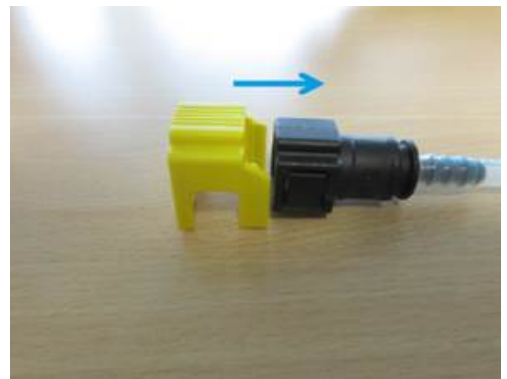
Figure 3. Installation direction of the securing clip.

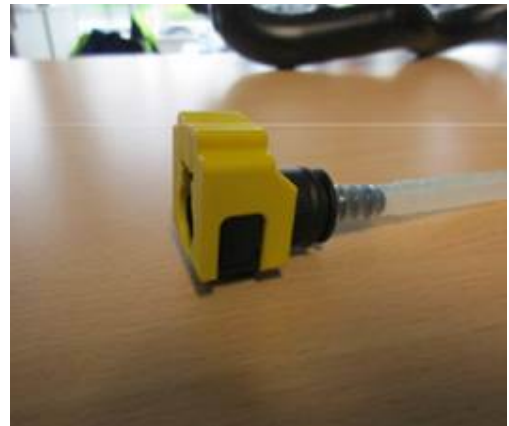
Figure 4. Securing clip correctly installed with the release tabs locked in place.

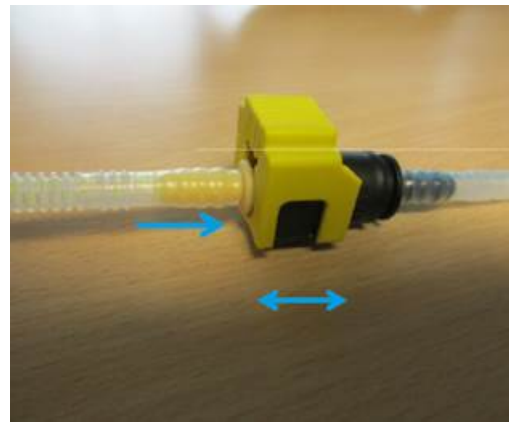
Figure 5. Insert the male end into the black connector.

5. Insert the male end of the line into the black connector, then push the yellow securing clip down (Figure 5 and Figure 6).

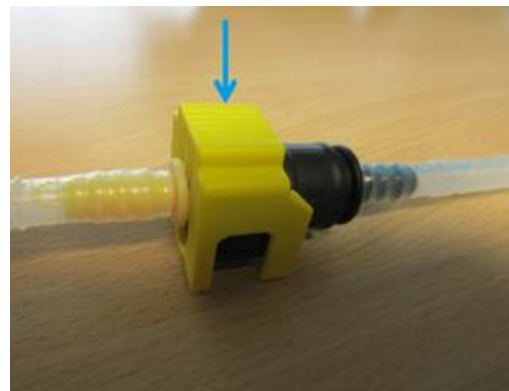
Figure 6. Push the yellow securing clip down.

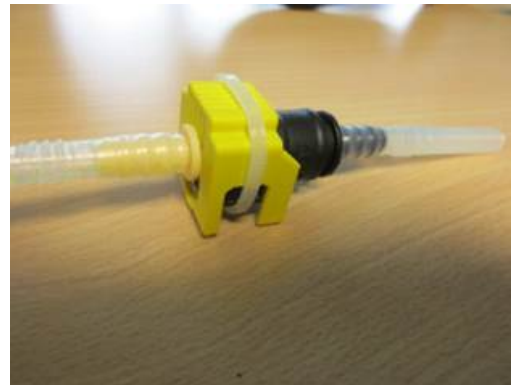
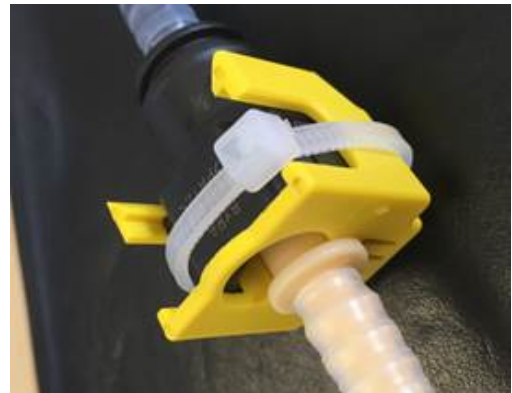
Figure 7. Cable tie installation.

Figure 8. Cable tie installation.

6. Install a cable tie as shown (Figure 7 and Figure 8).

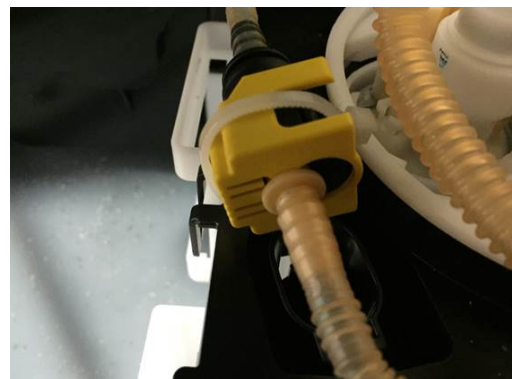
Figure 9. Placement of the fuel line.

7. Place the line on top of the fuel pump assembly box (Figure 9).
