RECALL CAMPAIGN BULLETIN

NTB16-073

VOLUNTARY EMISSIONS RECALL CAMPAIGN ECM REPROGRAMMING

CAMPAIGN ID #: R1620

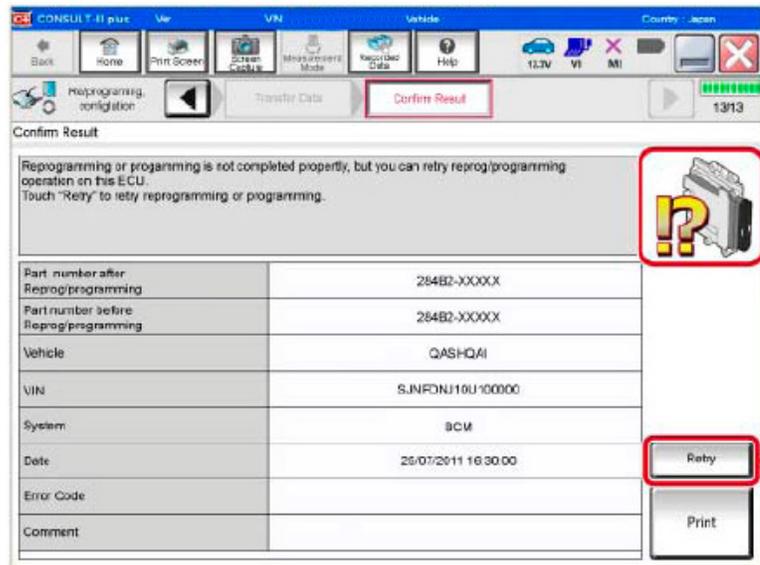
Figure 20

If reprogramming does not complete and the “!?” icon displays as shown in Figure 20:

- Check battery voltage (12.0–15.5 V).
- Ignition is ON, engine OFF.
- External Bluetooth® devices are OFF.
- All electrical loads are OFF.
- **Select retry and follow the on screen instructions.**
- “Retry” may not go through on first attempt and can be selected more than once.

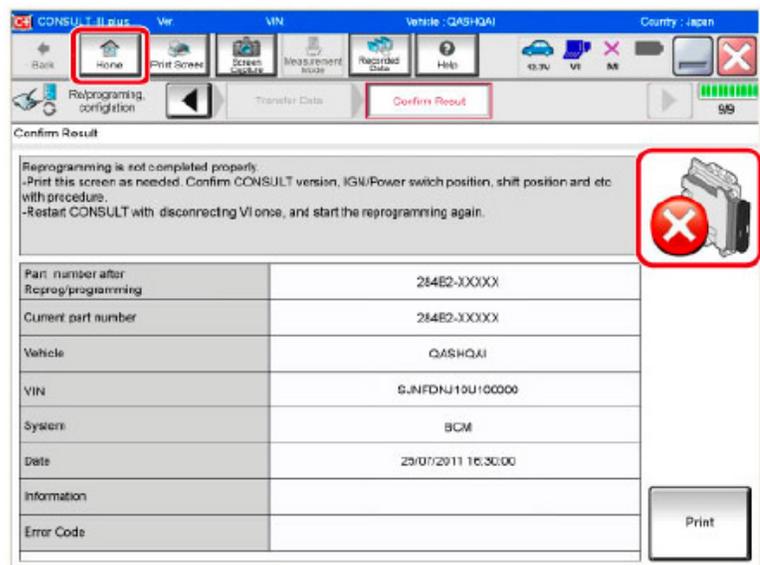
Figure 21

If reprogramming does not complete and the “X” icon displays as shown in Figure 21:

- Check battery voltage (12.0 – 15.5 V).
- CONSULT A/C adapter is plugged in.
- Ignition is ON, engine OFF.
- Transmission is in Park.
- All C-III plus / VI cables are securely connected.
- All C-III plus updates are installed.
- **Select Home, and restart the reprogram procedure from the beginning.**
