Technical Service Bulletin

SUBJECT:		No: TSB-16-11-001	
ROCKER COVER OIL LEAK		DATE: August, 2016	
		MODEL: 2014-16 Outlander	
CIRCULATE TO:	<input type="checkbox"/> GENERAL MANAGER	<input checked="" type="checkbox"/> PARTS MANAGER	<input checked="" type="checkbox"/> TECHNICIAN
<input checked="" type="checkbox"/> SERVICE ADVISOR	<input checked="" type="checkbox"/> SERVICE MANAGER	<input checked="" type="checkbox"/> WARRANTY PROCESSOR	<input type="checkbox"/> SALES MANAGER

PURPOSE

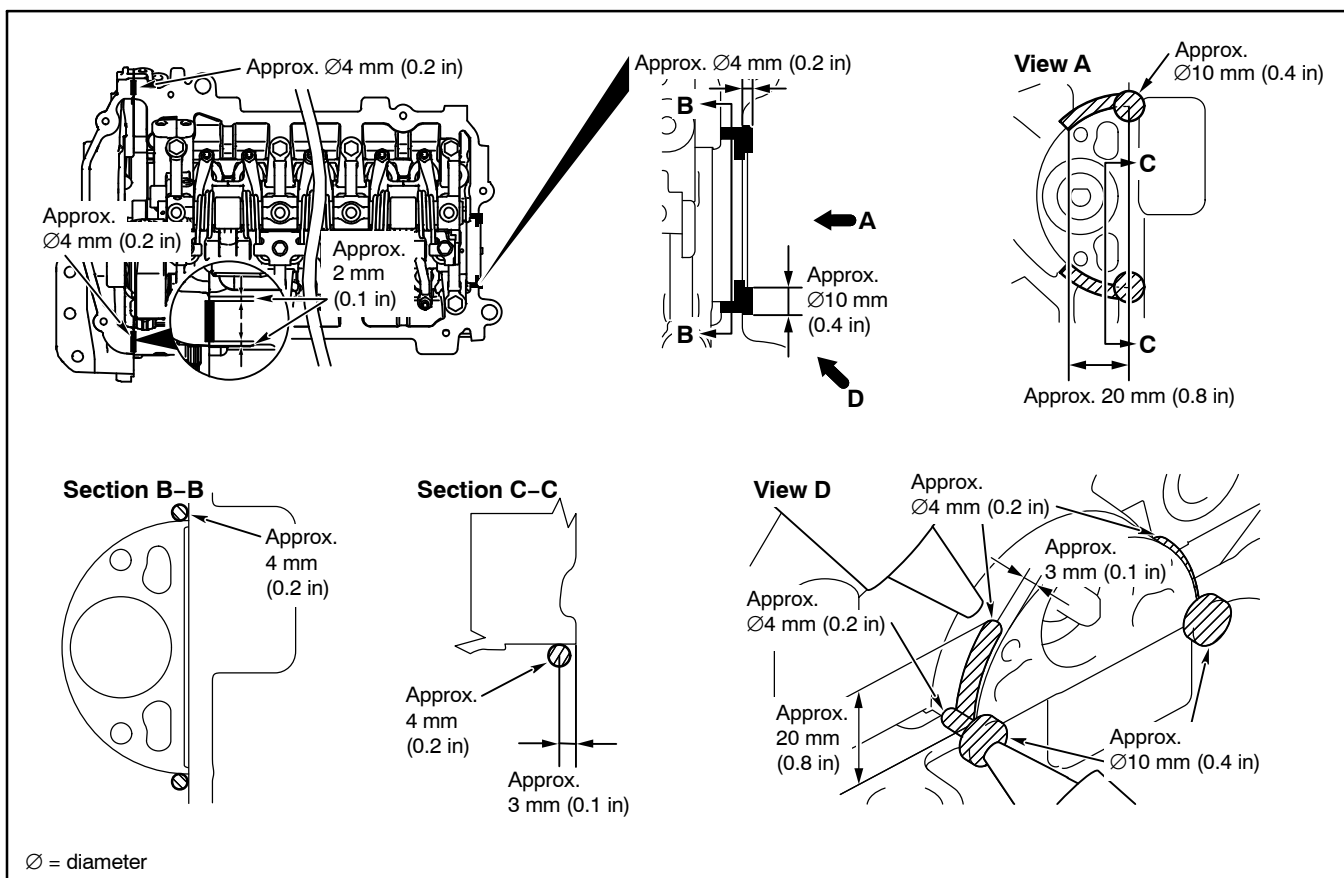
Some vehicles may exhibit an oil leak from the rocker cover. This may be caused by an insufficient quantity of FIPG (Formed in Place Gasket) applied during production. This TSB provides guidelines for reinstalling the rocker cover, including proper application of FIPG, when replacing the rocker cover gasket in the event of an oil leak.

b. Apply liquid gasket at rear of engine as shown in the illustration below.

- Apply a 4 mm thick bead at the base of the arch.
- Apply a 4 mm diameter bead along the arch, about 3 mm from the edge, to a height of 20 mm above the cylinder head (View D).
- Apply a 10 mm diameter bead at the bottom of the arch as shown (View A).

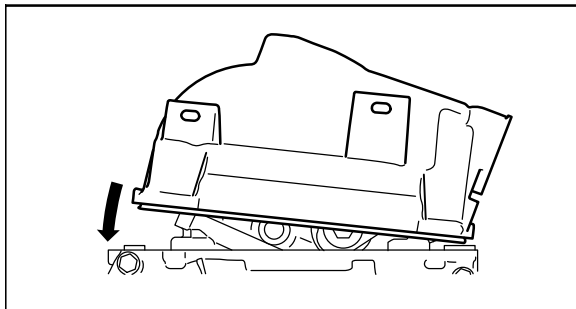
⚠ CAUTION Ensure that the rocker cover is properly seated. If the rocker cover is seated on the cylinder head at a slight diagonal along the spark plug guide, the sealant, which is applied at the joint between the cylinder head and the timing chain case, will be misaligned. This may cause oil leakage.

b. Hold the rocker cover horizontally right before seating it on the cylinder head.
