# Technical Service Bulletin

SUBJECT:			No: <b>TSB-16-51-003</b>
<b>TAILGATE GARNISH CONTACTING REAR COMBINATION LAMPS</b>			DATE: <b>November, 2016</b>
			MODEL: <b>2014-15 Outlander</b>
CIRCULATE TO:	<input type="checkbox"/> GENERAL MANAGER	<input checked="" type="checkbox"/> PARTS MANAGER	<input checked="" type="checkbox"/> TECHNICIAN
<input checked="" type="checkbox"/> SERVICE ADVISOR	<input checked="" type="checkbox"/> SERVICE MANAGER	<input checked="" type="checkbox"/> WARRANTY PROCESSOR	<input type="checkbox"/> SALES MANAGER

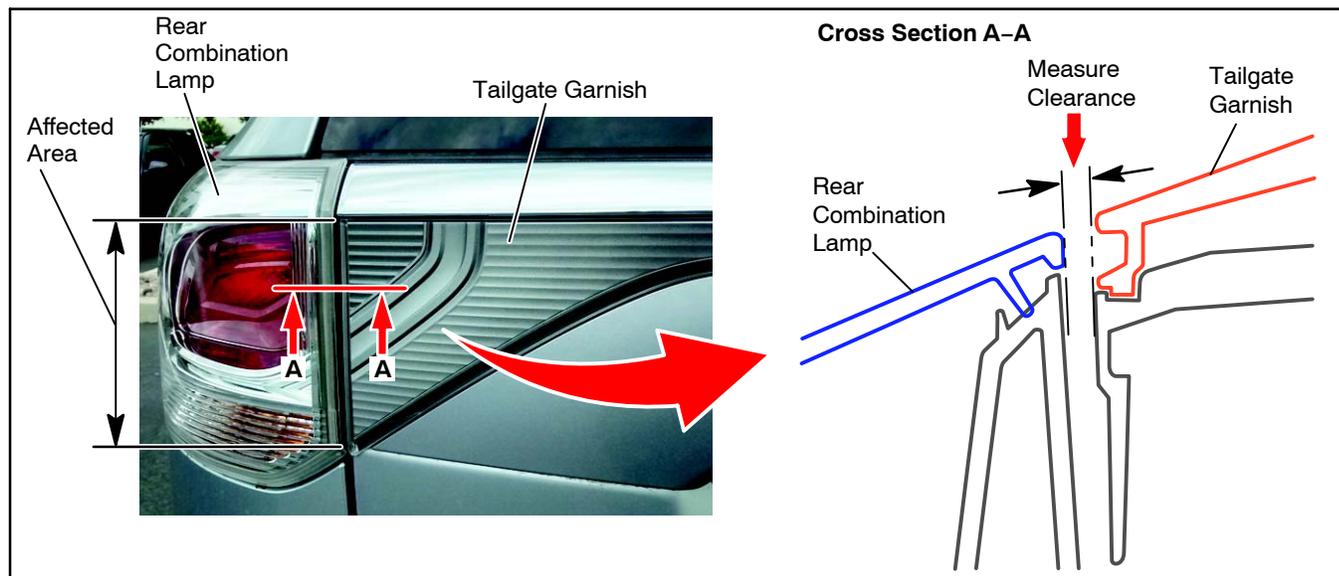
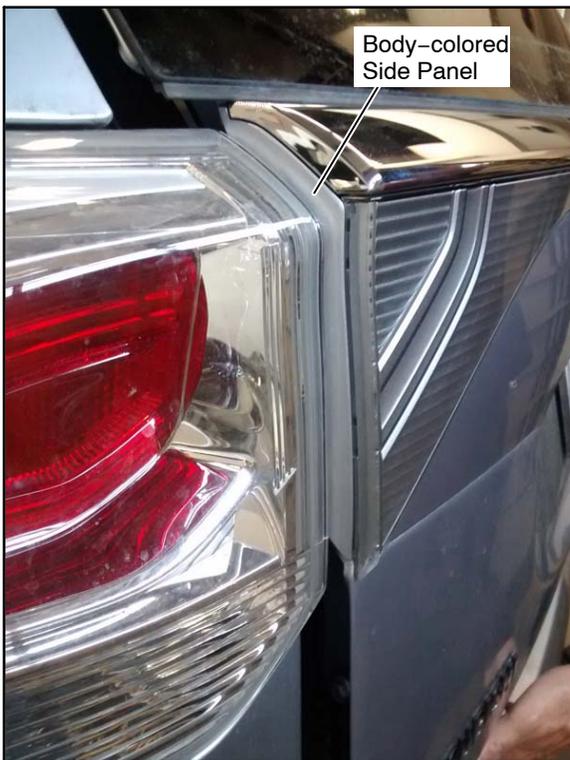
In some vehicles, there is a possibility of the tailgate garnish contacting the rear combination lamps. This may be due to insufficient clearance between the tailgate garnish and the rear combination lamps. Dimensions between the parts may also change due to heat expansion and normal usage. This TSB instructs dealers to replace the tailgate garnish in affected vehicles, how to measure the proper clearance between the tailgate garnish and rear combination lamps, and adjust if necessary.

1. In vehicles where the tailgate garnish is contacting the rear combination lamps as a result of this concern, replace the tailgate garnish with the countermeasure part, following instructions in the Service Manual, Group 51-Exterior -> Liftgate Garnish -> Removal and Installation.
2. Measure the clearance between the tailgate garnish and rear combination lamp in the affected area shown below.

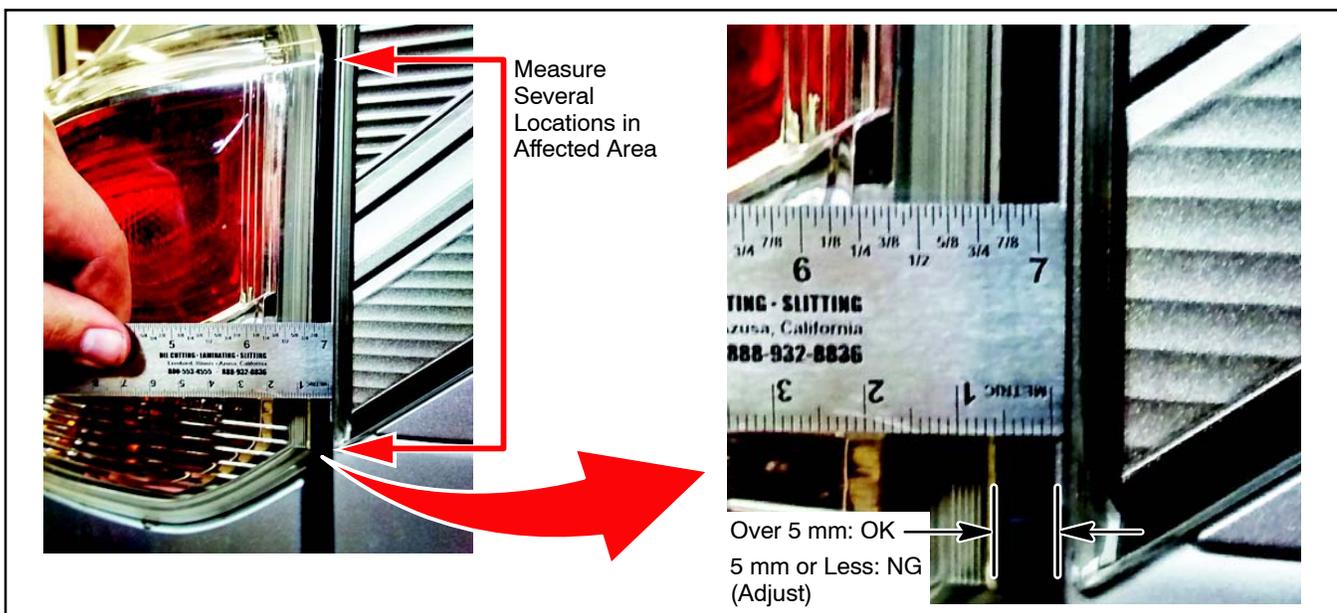
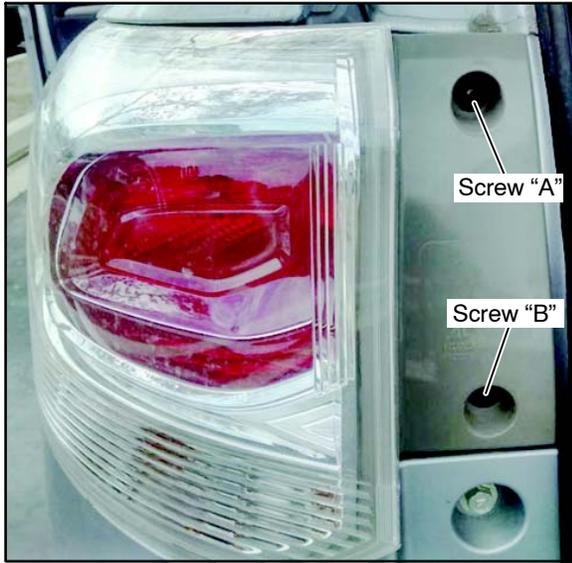
- b. Measure the clearance between the side panel of the tailgate garnish and rear combination lamps in several places along the affected area.
  - If clearance is 5 mm or LESS, go to step 3 to perform adjustment.
  - If clearance is more than 5 mm, no adjustment is needed.

- a. Open the tailgate and hold slightly away from car until the body-colored side panel of the tailgate garnish is visible.
