Technical Service Bulletin

SUBJECT:		No:	TSB-16-35-001
HYDRAULIC UNIT REMOVAL & INSTALLATION: CLAMPING TORQUE OF BRAKE TUBE FLARE NUTS – SMR		DATE:	November, 2016
		MODEL:	2014–16 Outlander, 2014–17 Outlander Sport/RVR
CIRCULATE TO:	<input type="checkbox"/> GENERAL MANAGER	<input checked="" type="checkbox"/> PARTS MANAGER	<input checked="" type="checkbox"/> TECHNICIAN
<input checked="" type="checkbox"/> SERVICE ADVISOR	<input checked="" type="checkbox"/> SERVICE MANAGER	<input type="checkbox"/> WARRANTY PROCESSOR	<input type="checkbox"/> SALES MANAGER

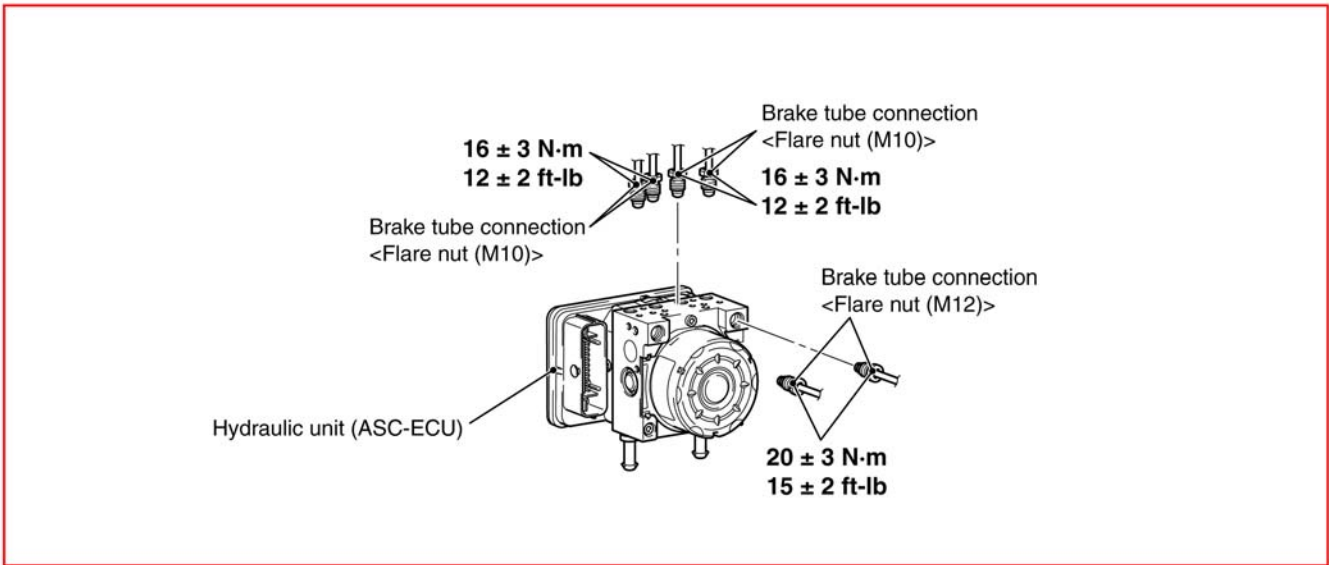
<Correct>

This TSB updates the Service Brakes section of the affected Service Manuals to correct errors in clamping torque of the brake tube flare nuts listed in Hydraulic Unit Removal and Installation in the Active Stability Control System (ASC).

Please make the indicated torque changes of the brake tube flare nuts to the 2014–2016 Outlander and 2014–2017 Outlander Sport/RVR Service Manuals, Group 35–Service Brakes –> 35C–Active Stability Control System (ASC) –> Hydraulic Unit –> Removal and Installation.
