Technical Service Bulletin

SUBJECT: IMPROPER DOOR GLASS FUNCTION			No: TSB-16-42A-001
			DATE: October, 2016
			MODEL: 2013-15 Outlander Sport/RVR
CIRCULATE TO:	<input type="checkbox"/> GENERAL MANAGER	<input checked="" type="checkbox"/> PARTS MANAGER	<input checked="" type="checkbox"/> TECHNICIAN
<input checked="" type="checkbox"/> SERVICE ADVISOR	<input checked="" type="checkbox"/> SERVICE MANAGER	<input checked="" type="checkbox"/> WARRANTY PROCESSOR	<input type="checkbox"/> SALES MANAGER

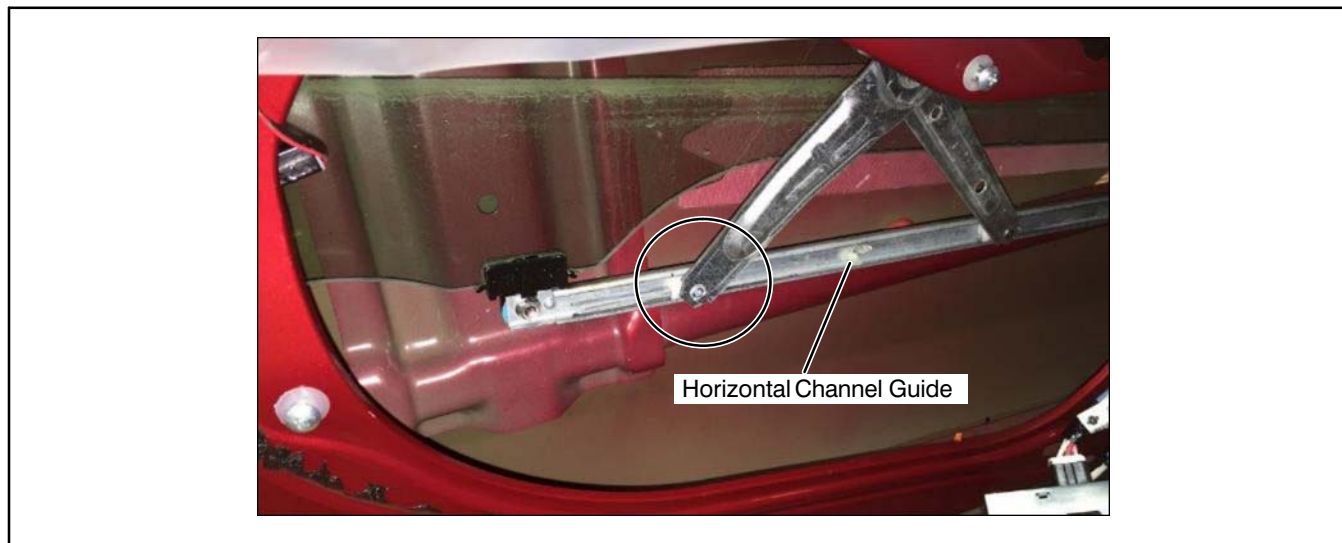
3. Lower the door glass to the fully open position.
4. Clean the surface of the window regulator horizontal channel guide in the circled area shown.

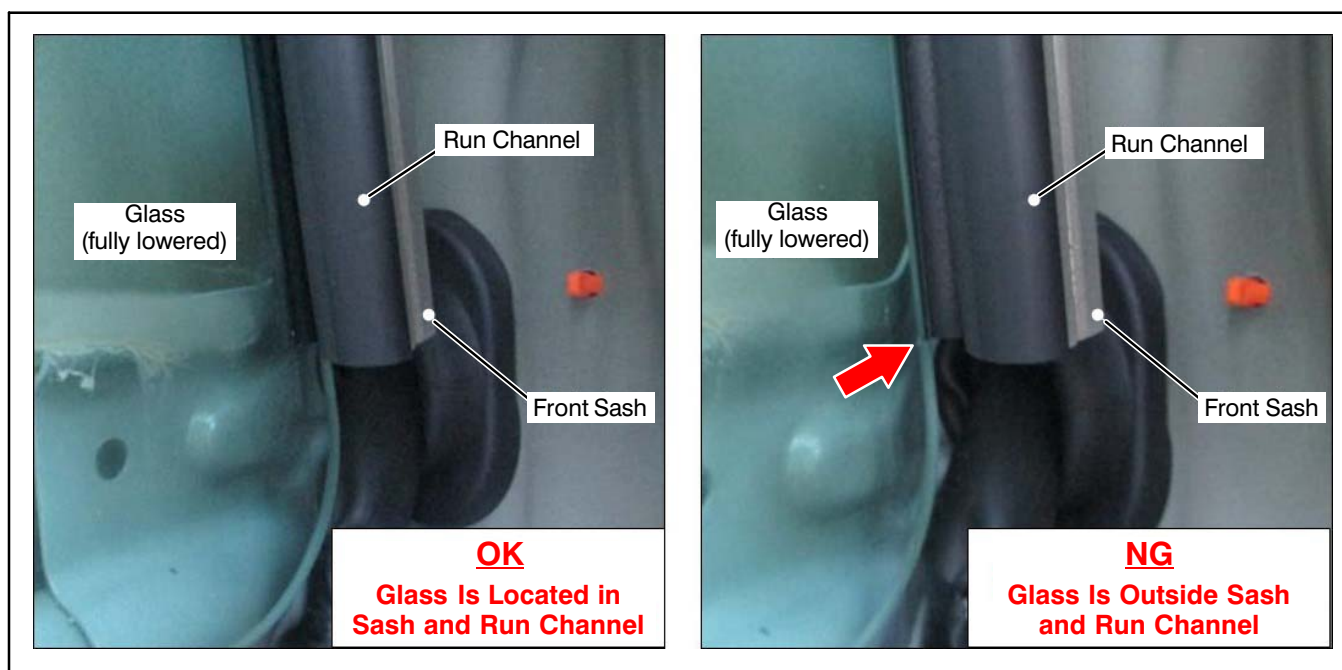
5. Check that the glass is properly inserted into the front run channel, viewing the glass and run channel through the front inner door panel access holes (flashlight required).

If the glass is outside of the run channel, pull rearward on the regulator horizontal channel guide and glass and reposition the front edge of the glass into the front run channel.

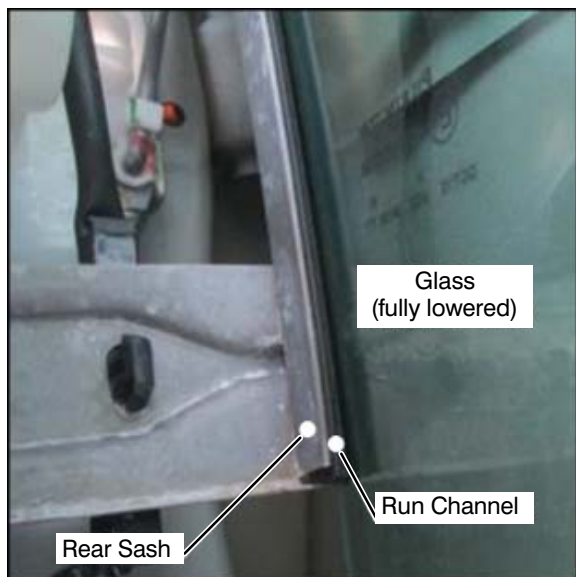
6. Check that the rear vertical run channel is in proper position (as shown) and that the rubber run channel has not slid down out of proper location.

If the rear vertical run channel is out of position, move the window glass up, slide the rubber run channel up into proper location in the rear sash and confirm that the channel will not easily push down, out of position. There is a lip at the bottom edge of the metal sash to stop the rubber run channel from sliding down.

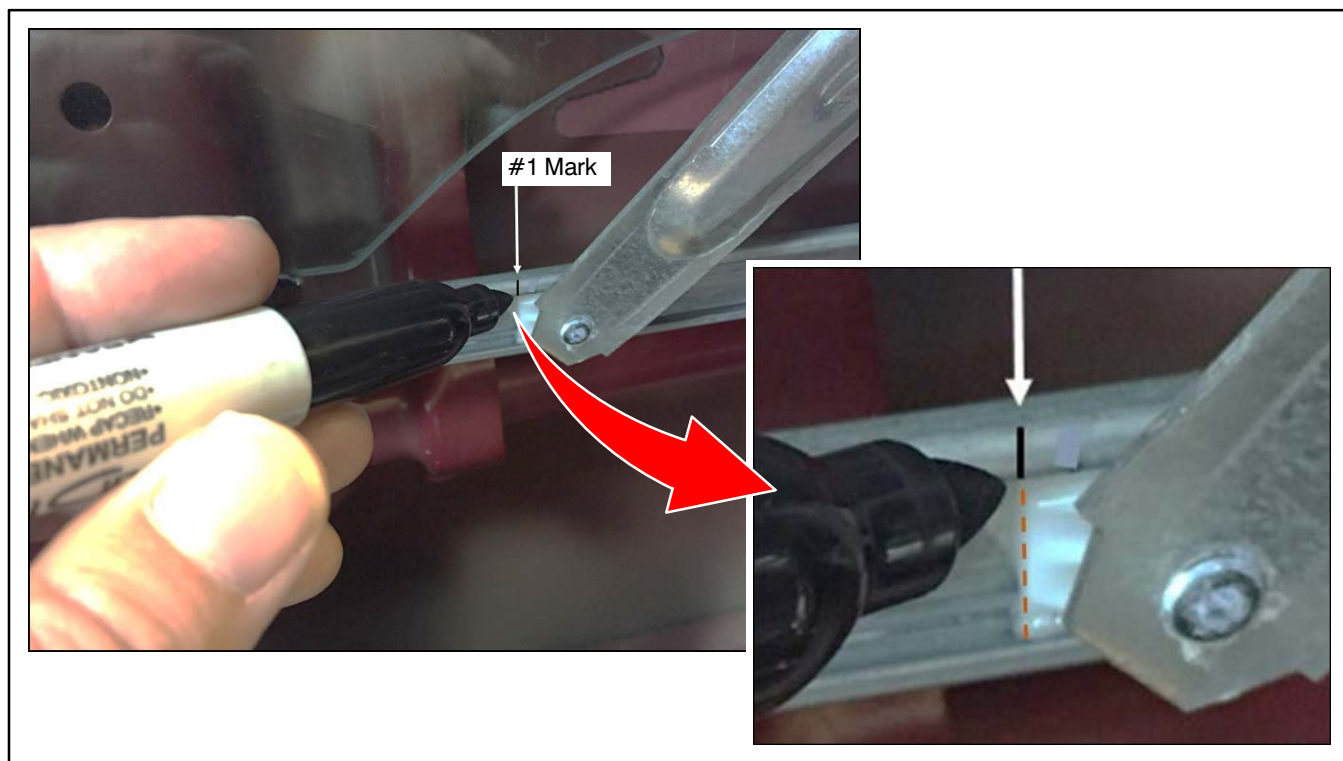
1. Cycle the window glass fully up and then fully down using the window switch.
2. Grip the horizontal channel guide and push the channel guide and glass fully forward, into the front vertical run channel.
3. Release your grip and let the channel and glass return to a relaxed position.
4. Mark the channel above the white slide block rear edge (as shown). This will be the #1 reference mark.

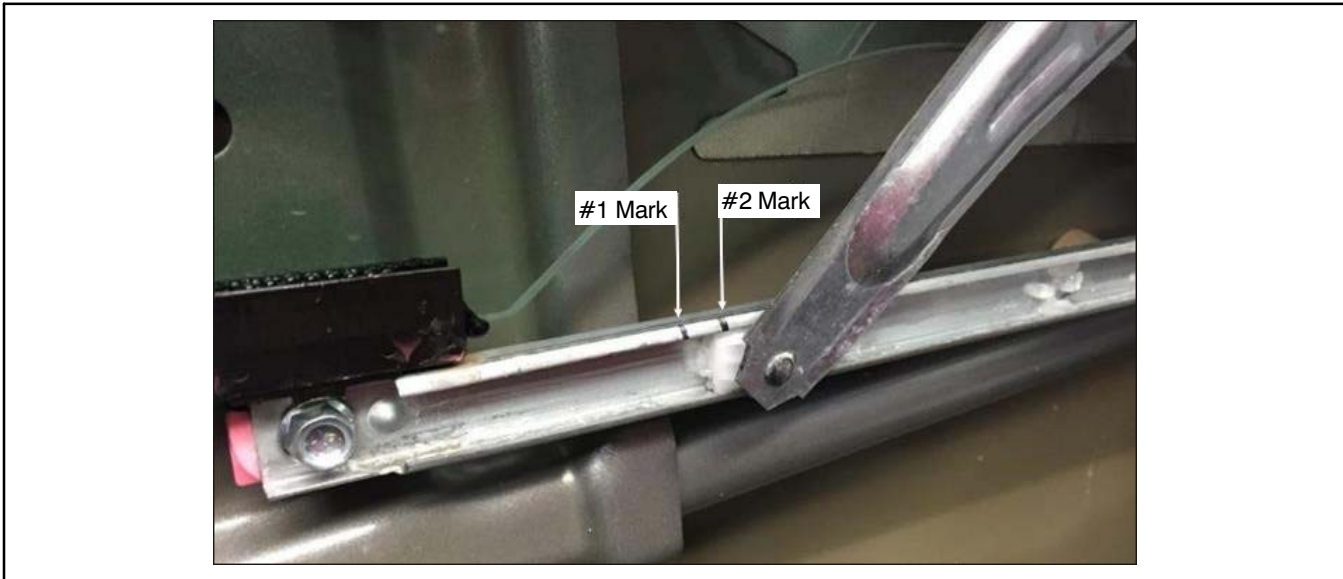
5. Grip the channel guide again and push the channel guide and glass fully rearward, into the rear vertical run channel.
6. Release your grip and let the channel and glass return to a relaxed position.
7. Mark the #2 location on the channel above the white slide block rear edge (as shown).
8. Measure the distance between the #1 and #2 marks. Specification is 2 – 4 mm.
