Technical Service Bulletin

SUBJECT:		No: TSB-16-51-001	
WIND NOISE FROM DOOR MIRROR		DATE: October, 2016	
		MODEL: 2015-16 Lancer models	
CIRCULATE TO:	<input type="checkbox"/> GENERAL MANAGER	<input checked="" type="checkbox"/> PARTS MANAGER	<input checked="" type="checkbox"/> TECHNICIAN
<input checked="" type="checkbox"/> SERVICE ADVISOR	<input checked="" type="checkbox"/> SERVICE MANAGER	<input checked="" type="checkbox"/> WARRANTY PROCESSOR	<input type="checkbox"/> SALES MANAGER

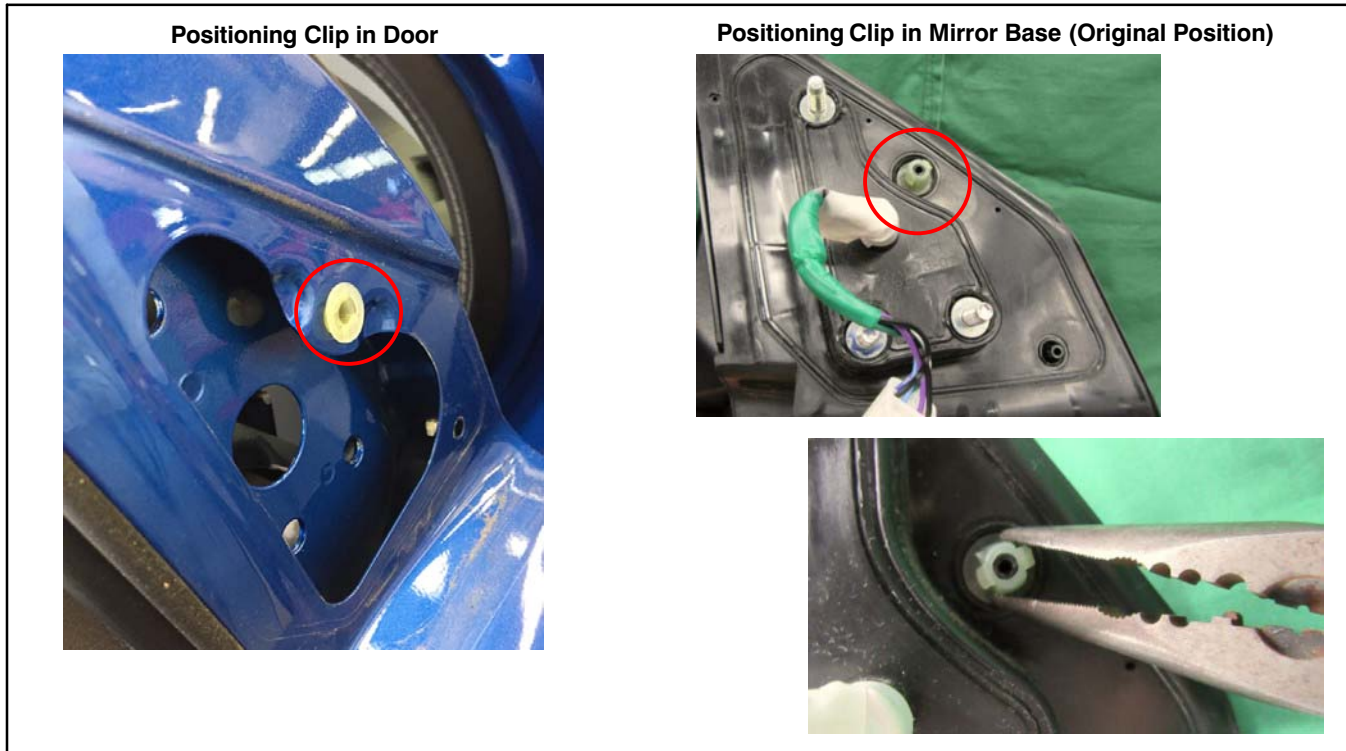
2. Once the door mirror is removed, locate the positioning clip.

NOTE: The positioning clip is often located in the door sheet metal after installation. The original position is in the mirror base as shown below.

3. Remove the positioning clip and discard.
