2013 – 2015 SENTRA; MIL ON WITH DTC P0101

NTB16-027a

APPLIED VEHICLE: 2013 – 2015 Sentra (B17)

The MIL is ON with DTC P0101 (MAF SEN/CIRCUIT-B1) stored.

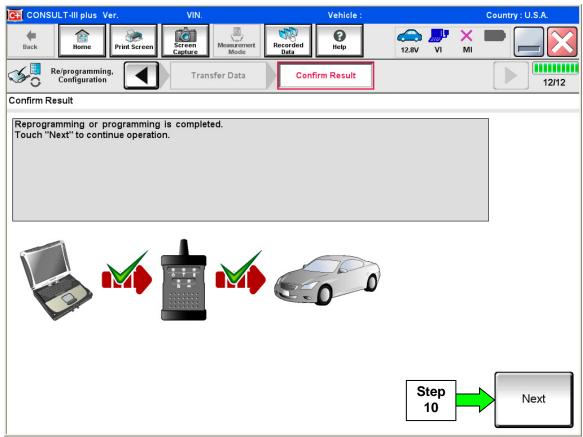
8. When the screen in Figure 4 displays, reprogramming is complete.

NOTE: If the screen in Figure 4 does <u>not</u> display (indicating that reprogramming did <u>not</u> complete), refer to the information on page 12.
