SERVICE BULLETIN

Classification: EC16-025	Reference: NTB16-076	Date: August 8, 2016
-----------------------------	-------------------------	-------------------------

2016 MAXIMA; MIL ON WITH DTC P0116

APPLIED VEHICLES: 2016 Maxima (A36)

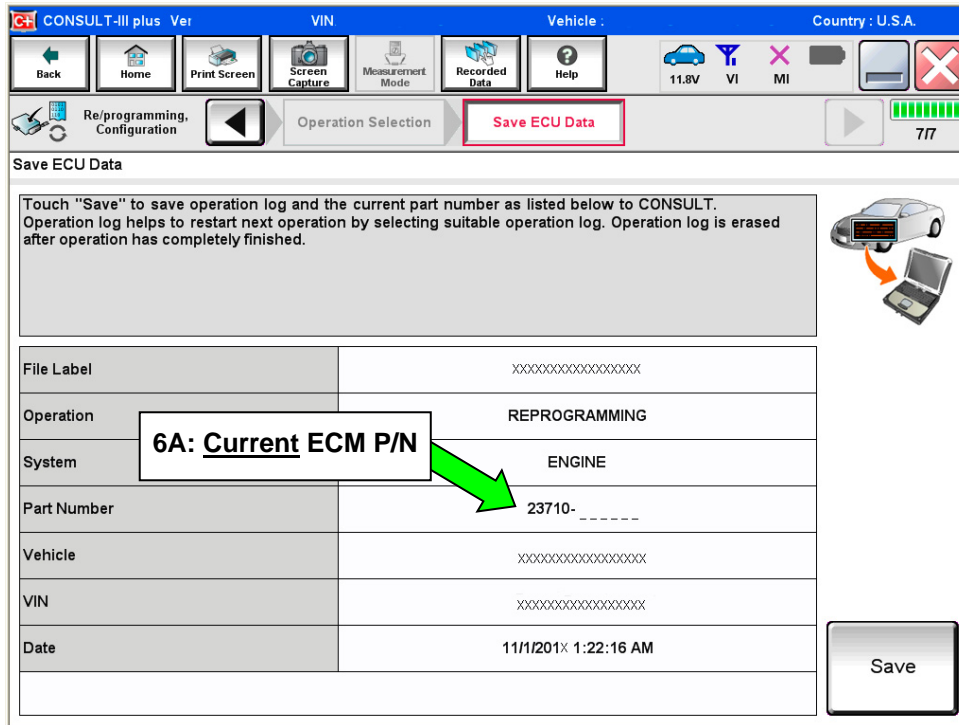
Figure 2

6. When you get to the screen shown in Figure 2, confirm this bulletin applies as follows:

A. Find the ECM **Part Number** and write it on the repair order.

NOTE: This is the current ECM Part Number (P/N).

B. Compare the P/N you wrote down to the numbers in the **Current ECM Part Number** column in **Table A** below.

- If there is a match, this bulletin applies. Continue with the reprogramming procedure.
- If there is not a match, this bulletin does not apply. Close C-III plus and refer to ASIST for further diagnostic information.

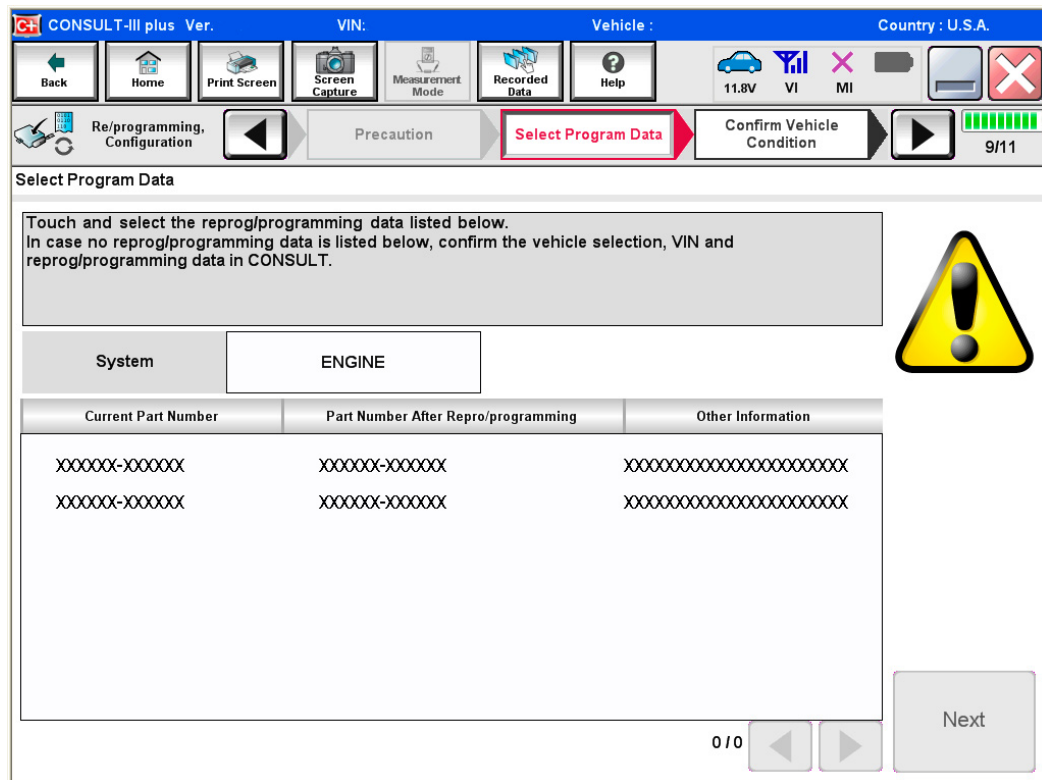
- In some cases, more than one new P/N for reprogramming is available.
 - If more than one new P/N is available, the screen in Figure 3 displays.
 - Select and use the reprogramming option that **does not** have the message “Caution! Use ONLY with NTBXX-XXX”.
- If you get this screen and it is blank (no reprogramming listed), it means there is no reprogramming available for this vehicle. Close C-III plus and refer back to ASIST for further diagnosis.
