# SERVICE BULLETIN

BT16-012

## 2013-2015 ALTIMA WITH 4-CYL ENGINE; CABIN “BOOM” AND/OR STEERING/FLOOR VIBRATION WHILE DRIVING

**APPLIED VEHICLE:** 2013-2015 Altima Sedan (L33)

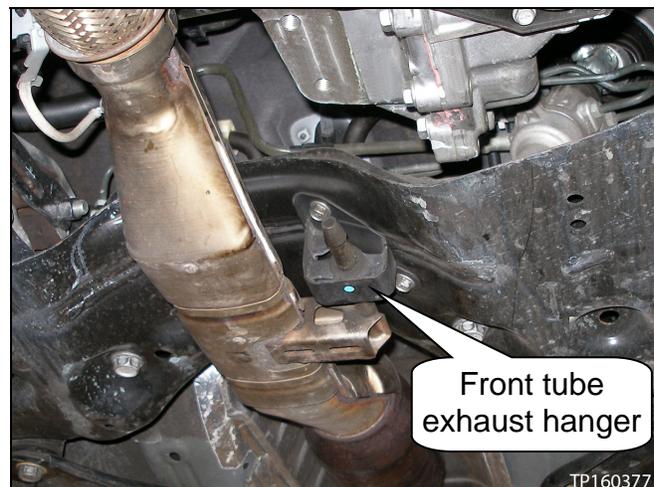
A “boom” or drone sensation is heard in the cabin area

A vibration is felt in the floor and/or steering wheel

Driving and the engine is approximately 1,800 RPM.

1. Check the gap between the rubber and metal portions of the front tube exhaust hanger (see Figure 1 and page 2, Figure 2).
2. If less than 1 mm (0.04 inch) gap, add shims (flat washers) between the front suspension member and front exhaust tube hanger. See page 2, Figure 2 and 3.
  - Maximum shim thickness:  
4.6 mm (0.18 inch)
