# SERVICE BULLETIN

Classification:	Reference:	Date:
EC16-026	NTB16-086	August 25, 2016

## 2013-2015 SENTRA; ENGINE TURNS OFF OR HESITATES WHEN ACCELERATING FROM A STOP DURING HOT AMBIENT TEMPERATURES (+100° F)

**APPLIED VEHICLE:** 2013-2015 Sentra (B17)

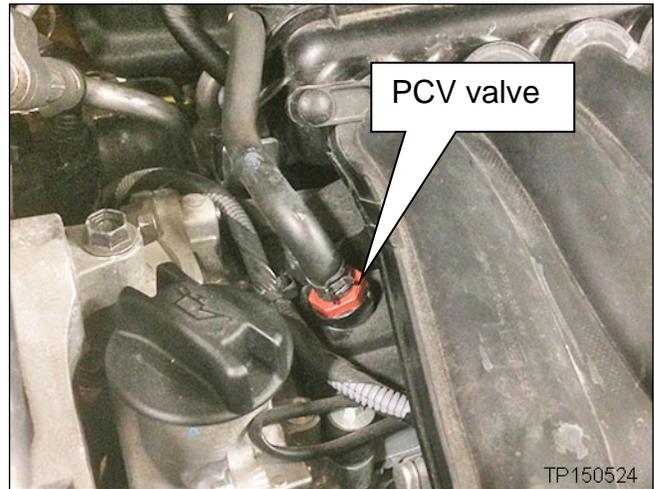
1. For 2013 and 2014 Sentra only:
  - Inspect the color of the PCV valve, and replace if the color is orange (see Figure A on page 2).
2. For all Applied Vehicles, if needed, reprogram the ECM.
  - Refer to step 6 in the ECM Reprogram section of the SERVICE PROCEDURE to confirm if reprogramming is needed.

**If PCV valve is orange, as shown in Figure A:**

- Replace the PCV valve.
- If needed, refer to the Electronic Service Manual ESM, section EM-Engine Mechanical, for replacement information.
- Use the new PCV valve listed in the Parts Information.
- The new PCV valve is “black” color.
