SERVICE BULLETIN

Classification: EC16-027	Reference: NTB16-087	Date: September 6, 2016
-----------------------------	-------------------------	----------------------------

2015 JUKE; ENGINE TURNS OFF OR HESITATES WHEN ACCELERATING FROM A STOP DURING HOT AMBIENT TEMPERATURES (+100° F)

APPLIED VEHICLES: 2015 Juke (F15)

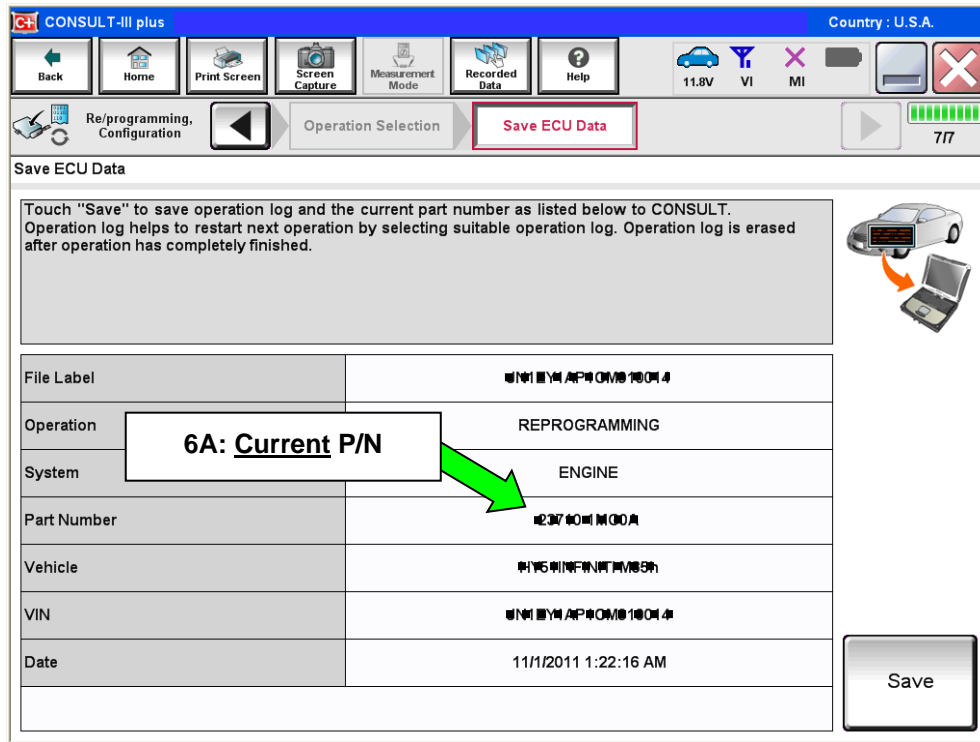
Figure 2

6. When you get to the screen shown in Figure 2, confirm this bulletin applies as follows:

A. Find the ECM **Part Number** and write it on the repair order.

NOTE: This is the current ECM Part Number (P/N).

B. Compare the P/N you wrote down to the numbers in the **Current ECM Part Number** column in **Table A** below.

- If there is an ECM P/N match, this bulletin applies. Continue with the ECM reprogramming procedure.
- If there is not an ECM P/N match, this bulletin does not apply.

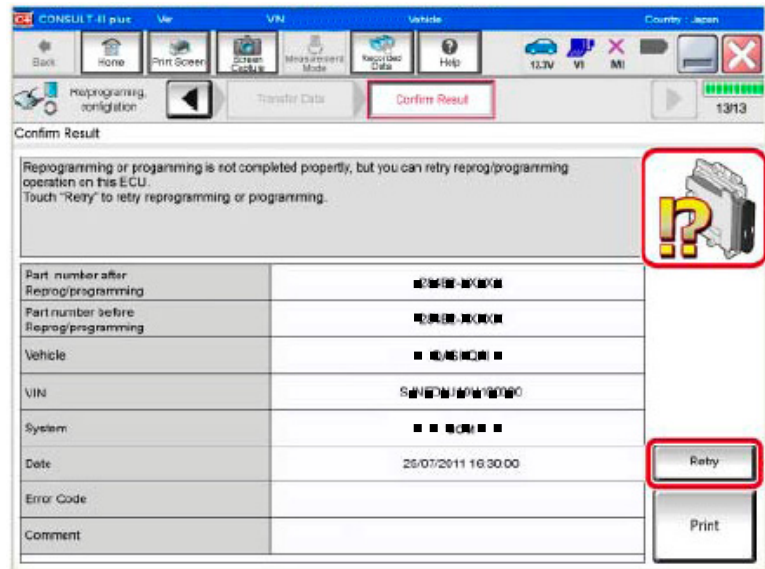
Figure 5

If reprogramming does not complete and the “!?” icon displays as shown in Figure 5:

- Check battery voltage (12.0–15.5 V).
- Ignition is ON, engine OFF.
- External Bluetooth® devices are OFF.
- All electrical loads are OFF.
- **Select retry and follow the on screen instructions.**
- “Retry” may not go through on first attempt and can be selected more than once.

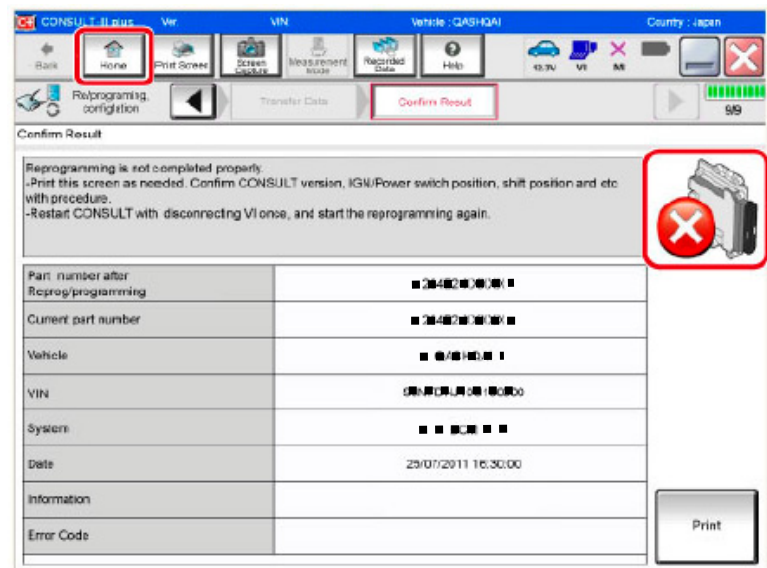
Figure 6

If reprogramming does not complete and the “X” icon displays as shown in Figure 6:

- Check battery voltage (12.0 – 15.5 V).
- CONSULT A/C adapter is plugged in.
- Ignition is ON, engine OFF.
- Transmission is in Park.
- All C-III plus / VI cables are securely connected.
- All C-III plus updates are installed.
- **Select Home, and restart the reprogram procedure from the beginning.**
