Subject: DIFFICULT TO ANCHOR CHILD SEAT ON THE REAR SEAT	Bulletin No: 09-042/16
	Last Issued: 7/1/2016

2016 CX-3 vehicles with VINs lower than JM1 DK ***** 134520 (produced before February 01, 2016)

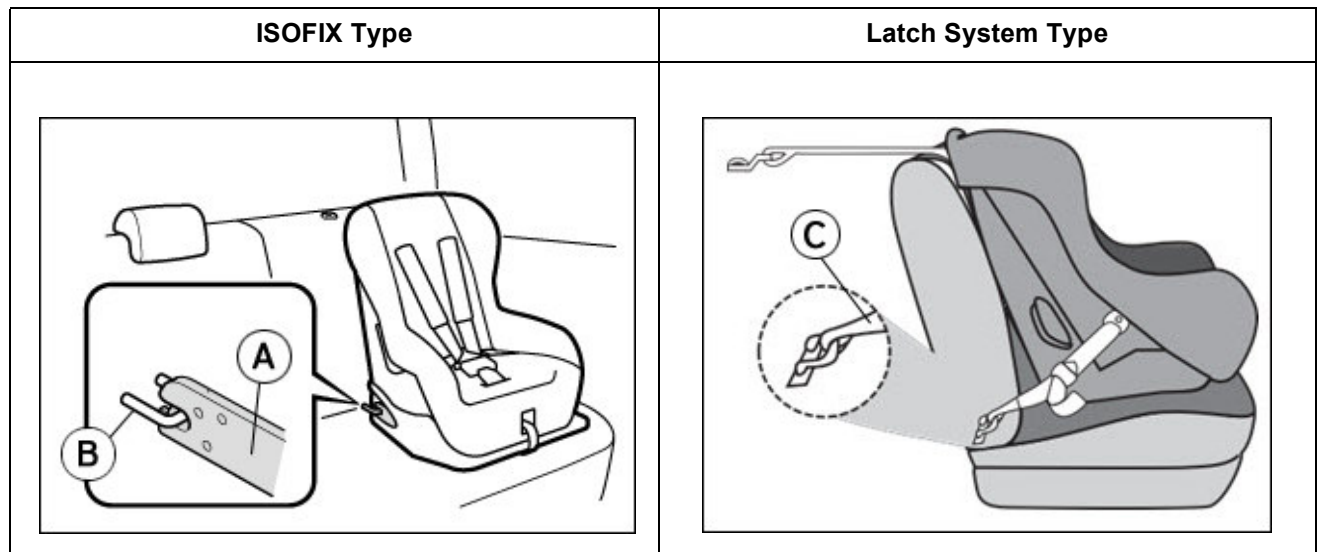
Some customers may complain that it is difficult to locate the anchors to install an ISOFIX type or Latch System type child seat on the rear seat. The ISOFIX connector(s) (A) or Latch System tether strap (C) of the child seat does/do not catch the anchor(s) (B) in the vehicle. The anchor(s) is/are obstructed by the rear seat cushion. The rear edge trimming material (D) of the rear seat cushion is positioned incorrectly obstructing the anchor(s).

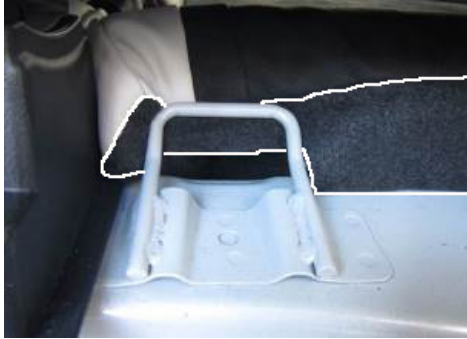
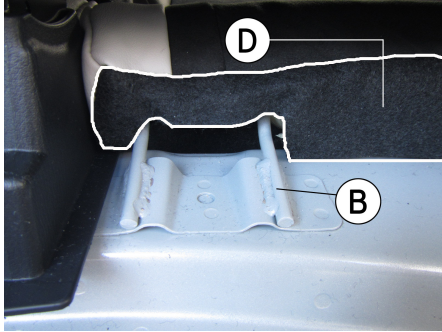
NG		Good	
Rear edge trimming material (D) is positioned <u>under</u> Anchor (B).		Rear edge trimming material (D) is positioned <u>on top of</u> Anchor (B).	
Front

3. Adjust the position of the rear edge trimming material so that it is located on top of each of the four anchors.
