Technical Service Bulletin

01 MIL on; DTC P20E8 and/or P218F are stored or AdBlue residue found on injector

01 16 70 2044927/1 July 27, 2016.

Model(s)	Year	VIN Range	Vehicle-Specific Equipment
A3	2015	All	TDI engine

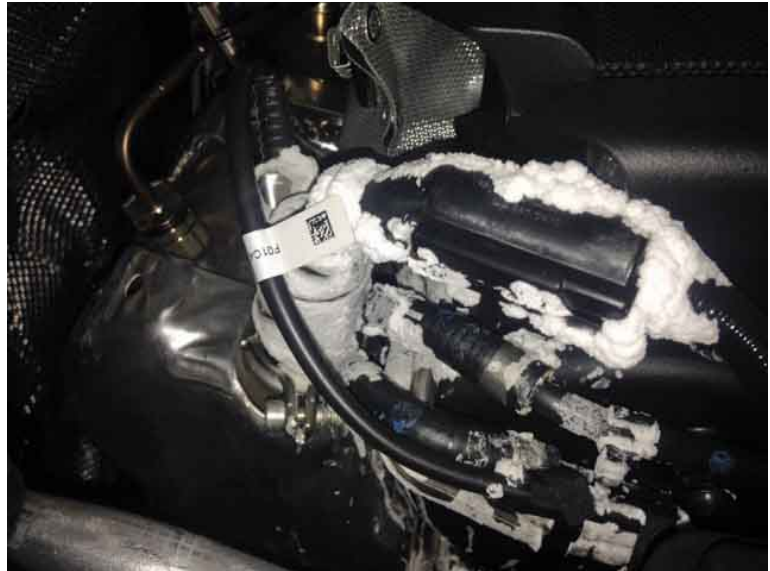
AdBlue supply lines may have a quality deviation that causes a leak near the AdBlue injector.

Figure 1. Evidence of leak –AdBlue residue.

1. Before replacing pump or performing additional diagnosis for these faults, verify if any signs of leakage are found near the AdBlue injector.
2. If any leakage is found (Figure 1), replace AdBlue supply line according to the Elsa Repair Manual and check system operation. Dried AdBlue residue on any additional components can be cleaned off with warm water and a soft brush, and allowed to air dry.
