Subject: LIFTGATE HARD TO LATCH IN COLD TEMPERATURES BELOW FREEZING	Bulletin No: 09-044/16
	Last Issued: 07/14/2016

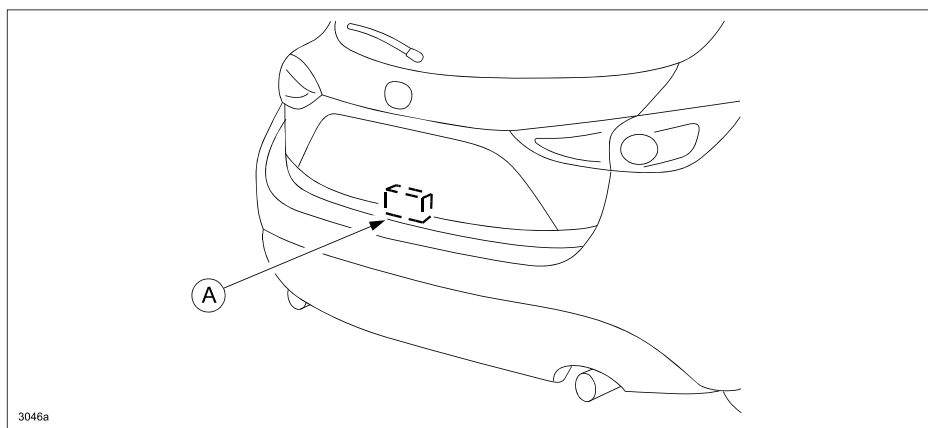
Some vehicles may exhibit a condition in extremely cold temperatures (below freezing) where the hatchback will not latch (half latch) when closing. This is caused by the stopper rubber, a component of the liftgate latch and lock actuator (A), hardening when the temperature drops below freezing. The stopper rubber has now been improved to eliminate this concern.

1. Verify customer concern.
2. Replace the liftgate latch and lock actuator with a modified one. Refer to MS3 online instructions or Workshop Manual section 09-14.
 - For Mazda3: LIFTGATE LATCH AND LOCK ACTUATOR REMOVAL/INSTALLATION.
 - For CX-5: LIFTGATE LATCH AND LOCK ACTUATOR REMOVAL/INSTALLATION.
3. Verify repair.
