Technical Service Bulletin

39 All-wheel drive coupling does not work (DTC C111204)

39 16 16 2043144/2 July 22, 2016. Supersedes Technical Service Bulletin Group 30 number 16-20 dated February 1, 2016 for reasons listed below.

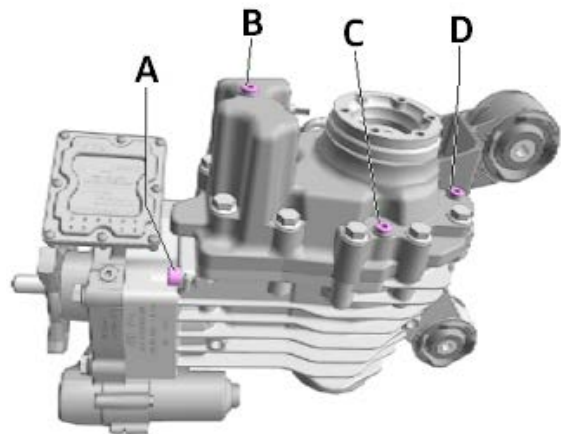
- The BorgWarner Clutch uses high performance oil for clutches, and the final drive uses gear oil.
- The image at right (Figure 1) shows the correct drain and fill plugs.

Figure 1. Drain plug for BorgWarner clutch oil (A), oil filler plug for BorgWarner clutch oil (B), gear oil drain plug (C), oil filler plug for gear oil (D).

The final drive and the BorgWarner clutch have separate oil circuits. Refer to ETKA for information on which oil to use, and refer to the Elsa Repair Manual for draining and filling information.
