Technical Service Bulletin

46 Q5 squealing from front brakes, 2.0T, & 3.2L (PR-1LA)

46 16 42 2033102/7 July 12, 2016. Supersedes Technical Service Bulletin Group 46 number 15-18 dated July 15, 2015 for reasons listed below.

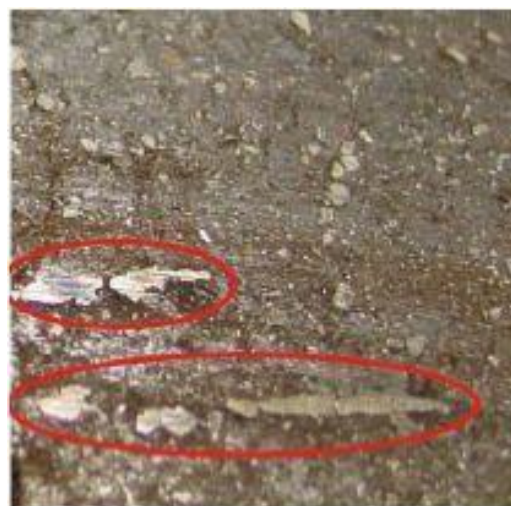
1. Front brake discs or brake pads are close to their wear limit (disc wear limit: 28 mm and pads wear limit with backing plate and dampening late: 10 mm).
2. Foreign objects between brake disc and brake pad, such as small stones, grit, rust build-up, or sand.
4. Un-ground or corroded friction materials.
5. Metallic deposits from disc material in brake pad (Figure 1).

Figure 1. Metallic deposits.

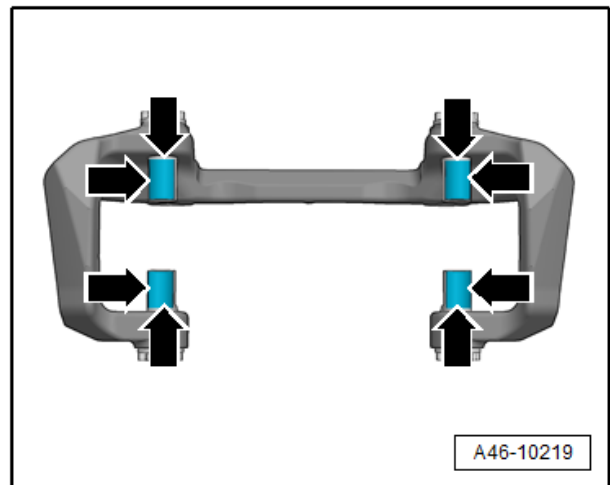
Figure 2. Caliper carrier guide pins with anti-seize (G 052560A2) lubricant applied where the pads make contact.

1. Install parts kit part number **8R0698998A** according to Elsa.
2. Apply a thin coat of anti-seize (G 052560A2) lubricant to the guide pins of the front caliper carriers prior to installing the brake pads (Figure 2).

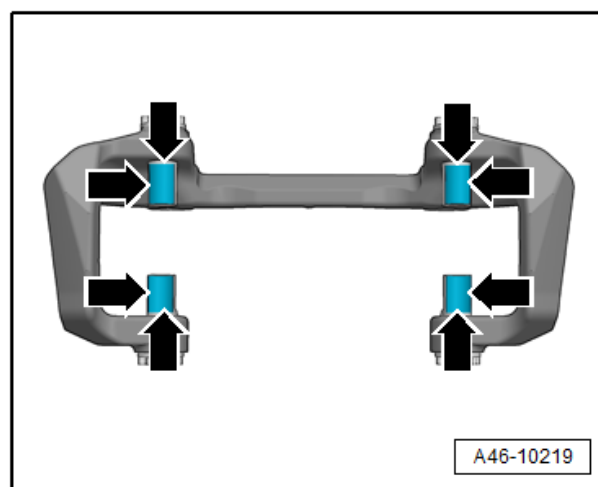
Figure 2. Caliper carrier guide pins with anti-seize (G 052560A2) lubricant applied where the pads make contact.

1. Apply a thin coat of anti-seize (G 052560A2) lubricant to the guide pins of the caliper carrier prior to installing the brake pads (Figure 2).
