<b>Subject:</b> <b>INCORRECT COLOR REAR DOOR TRIM GRIP COVER(S) INSTALLED</b>	<b>Bulletin No:</b> 09-045/16
	<b>Last Issued:</b> 07/29/2016

2016 CX-9 vehicles (equipped with Beige interior) with VINs lower than JM3KE\*\*\*\*\*111471 (produced before June 20, 2016)

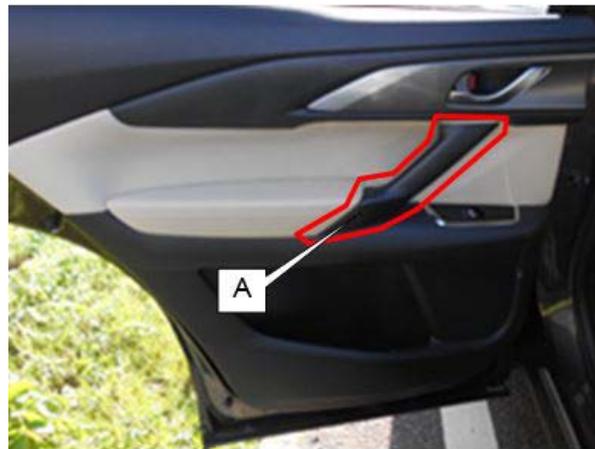
Some vehicles equipped with “Beige” interior, may have “Black” rear door trim grip cover(s) (A) installed in their vehicle by mistake. The correct color of the grip covers is “Beige” to match the color of the vehicle interior.

This concern was caused by erroneous assembly instructions at the factory, which has since been corrected.

Customers having this concern should have their vehicle repaired using the following repair procedure.
