GROUP CHA	MODEL 2014~2016MY Optima Hybrid (TF HEV)
	NUMBER 067	DATE March 2016
TECHNICAL SERVICE BULLETIN		
SUBJECT: ECU UPGRADE – MIL ON WITH DTC C1356

This bulletin provides information related to an IBAU (Integrated Brake Actuation Unit) software upgrade for some 2014~2016MY Optima Hybrid (TF HEV) vehicles, produced from December 2, 2013 through July 22, 2015, which may exhibit a Malfunction Indicator Light (MIL) ON with DTC C1356 and no drivability concerns. To resolve the concern, reprogram the IBAU using the GDS/KDS download, as described in this bulletin. For confirmation that the latest reflash has been performed, verify ROM ID using the tables in this TSB.

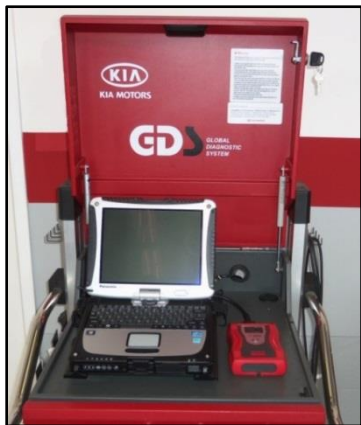
DTC C1356 Pressure Sensor (Wh2)
