GROUP BOD	MODEL 2016MY Optima (JFa)
	NUMBER 134	DATE March 2016
TECHNICAL SERVICE BULLETIN		
SUBJECT: SERVICE ACTION: HEADLINER INSPECTION AND/OR REPLACEMENT (SA 225)

This issue number is SA 225.

SERVICE ACTION: HEADLINER INSPECTION AND/OR REPLACEMENT (SA 225)

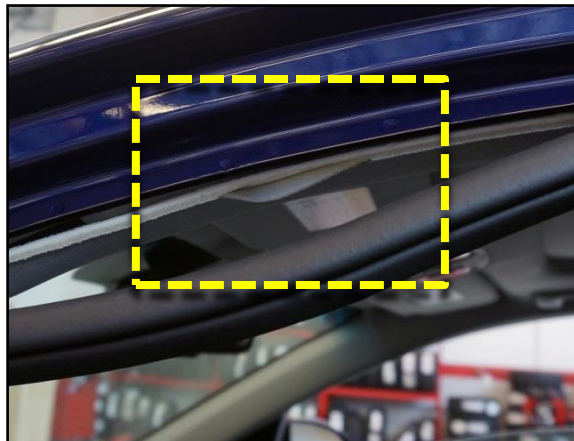
This bulletin provides the procedure to inspect or replace the headliner on some 2016MY Optima (JFa) vehicles, produced from February 8, 2016 through February 17, 2016, which may exhibit a delaminating headliner. Follow the inspection procedure in this bulletin, and if necessary, replace the headliner assembly to correct the condition. Kia is requesting the completion of this Service Action on all affected vehicles. Before conducting the procedure, verify the vehicle is included in the list of affected VINs.

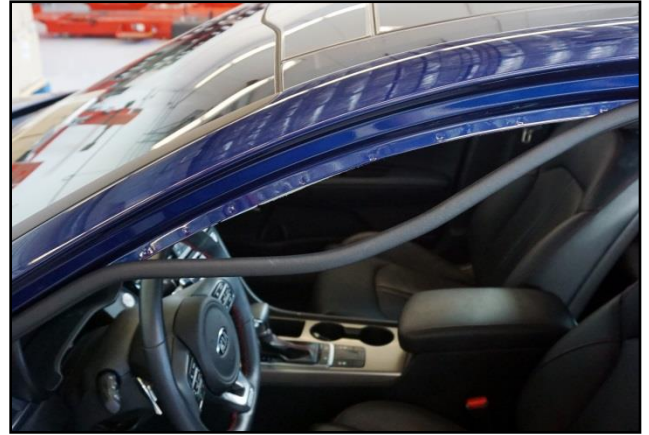
1. Open the driver's side door and pull the weather strip down approximately 10-12", as shown.

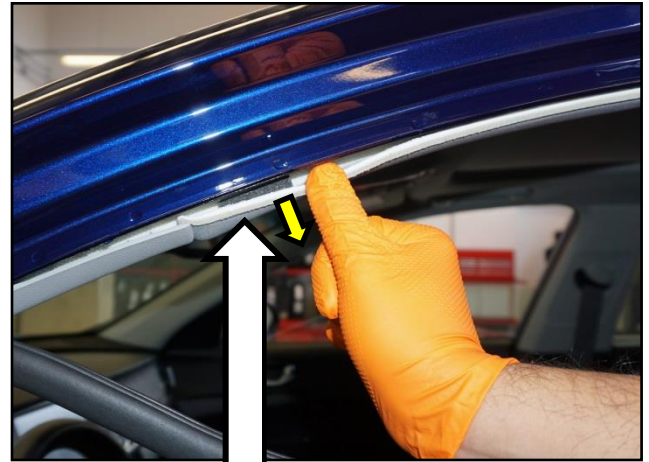
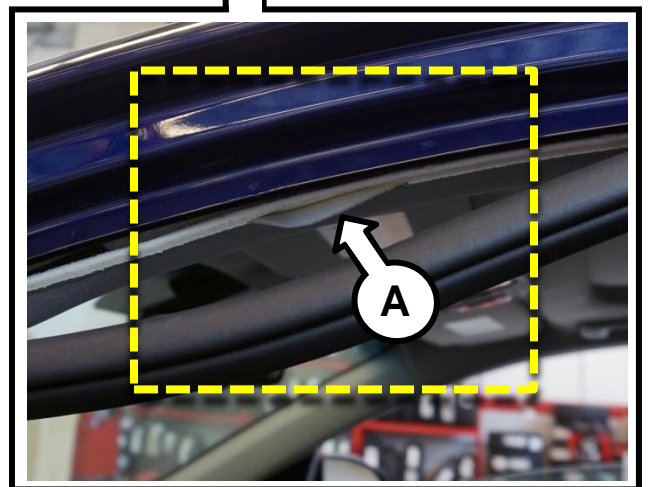
2. Use your thumb to rub the edge of the headliner 3 or 4 times in a downward direction, as shown. **NOTE: Only light force is required to identify a defective headliner. Do NOT apply excessive force when inspecting the headliner.**

- If the headliner shows signs of delamination (A), proceed to the Service Procedure on Page 3.
- If the headliner remains intact, reinstall the weather strip. No further action is required.
