GROUP BOD	MODEL 2014~2015MY Sorento (XMa)
NUMBER 117 (REV 1, 03/17/2016)	DATE February 2016

TECHNICAL SERVICE BULLETIN

SUBJECT: COMBINED TSB /SERVICE ACTION: EXTERIOR REAR DOOR HANDLE TRIM CAP(S) REPLACEMENT (SA 200)

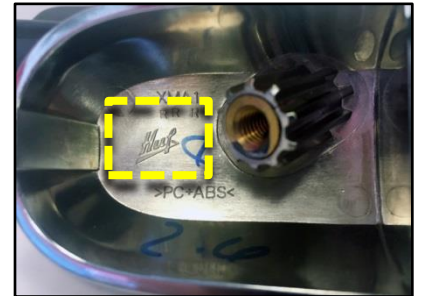
For vehicles not on the Affected Vehicles list but with a customer concern, remove and inspect both exterior rear door handle caps to verify the name of the manufacturer. If the door cap has a “Huf” logo embossed on the inside, as shown, replace the cap(s) as outlined in this bulletin. **If the door cap does NOT have a “Huf” logo and is not exhibiting any fitment concerns, reinstall the door cap as replacement is NOT required.** Additionally, if a door cap without a “Huf” logo is exhibiting a fitment concern, open a Techline case for further instructions.

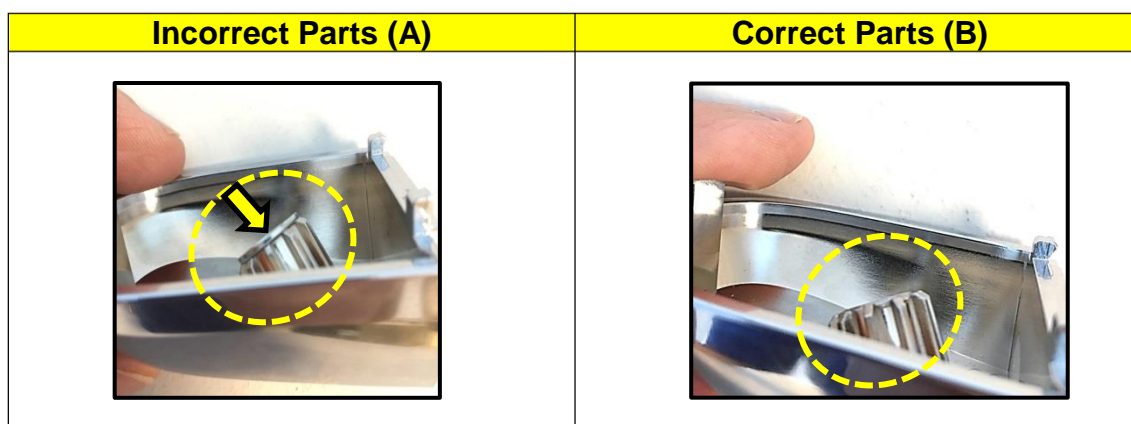
Some dealers may have received the incorrect parts for SA200 (P/N 83652 1U010QQK and 83662 1U010QQK, COVER-RR DR O/S HDL, RH and LH). The incorrect parts (A) will have an additional flange that will cause an interference with the handle base when installed. The correct parts do not have the additional flange (B).
