GROUP BOD	MODEL 2016MY Optima (JFa)
	NUMBER 131	DATE March 2016
TECHNICAL SERVICE BULLETIN		
SUBJECT: SERVICE ACTION: REAR SEAT LATCH CABLE INSPECTION AND/OR REPLACEMENT (SA 219)

This bulletin describes the procedure to replace the rear seat latch manual release cable on some 2016MY Optima (JFa) vehicles, produced from August 28, 2015 to December 15, 2015, which may experience deterioration of the plastic handle on the rear seat release latch. Follow the procedure outlined below to inspect and, if necessary, replace the affected seat release latch assembly with an improved part. Kia is requesting the completion of this Service Action on all affected vehicles. Before conducting the procedure, verify the vehicle is included in the list of affected VINs.

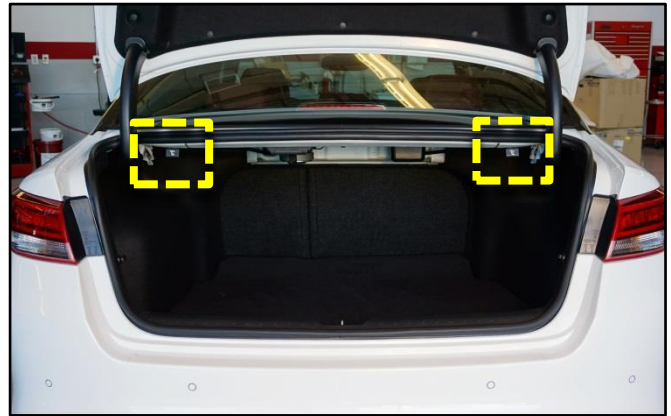
1. Open the trunk and locate the two (2) rear seat release cables.

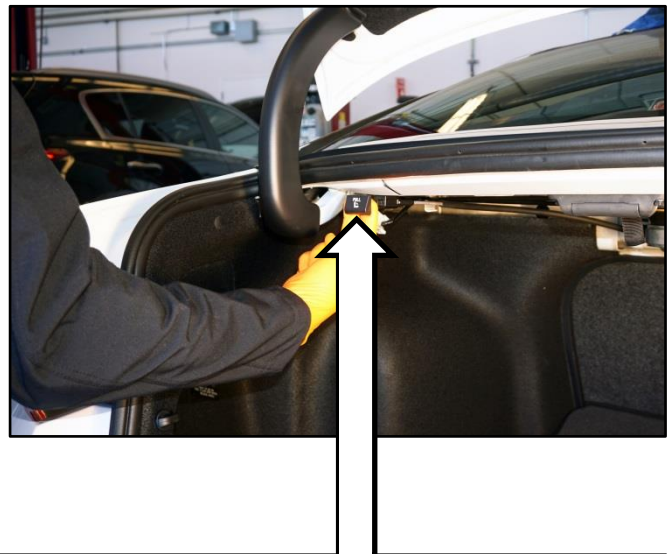
2. Pull the release cable towards the rear and rotate the handle left or right while applying moderate twisting force.

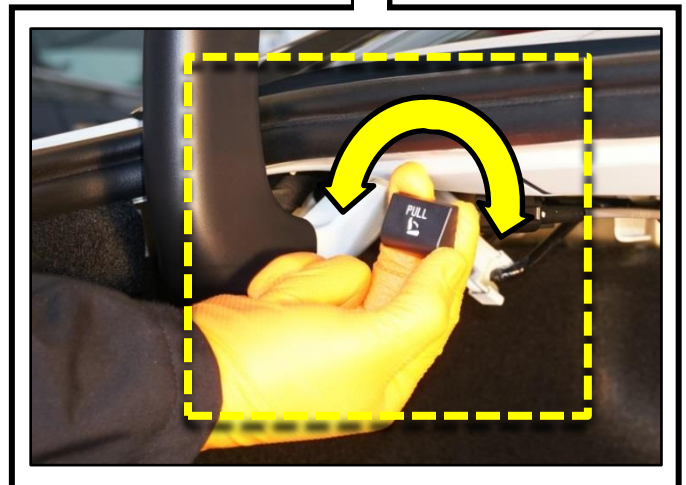
3. If the handle stays intact, no further action is required. If either of the release cable handles break during inspection, proceed to the Service Procedure on Pg. 3.
