# Technical Service Bulletin

## 91 MMI3G+ GPS navigation location inaccurate or navigation takes a very long time to acquire location

91 16 56 2040406/5 July 7, 2016. Supersedes Technical Service Bulletin Group 91 number 15-22 dated October 16, 2015 for reasons listed below.

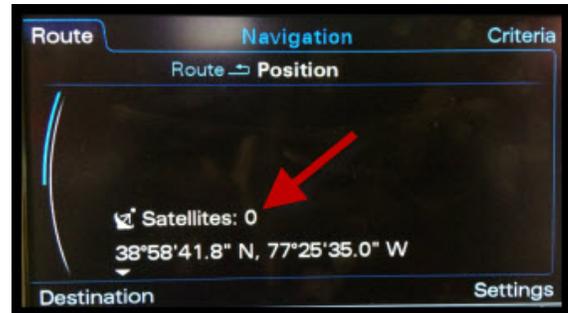
**Figure 1.** No satellite reception.

- When the issue occurs, the GPS navigation system satellite reception shows 0 satellites. Due to the infrequency of the issue, this might not be verifiable. (To view the number of satellites being received, go to *Nav >> Route >> Select Current Position* (first item in list) and scroll up (Figure 1)).

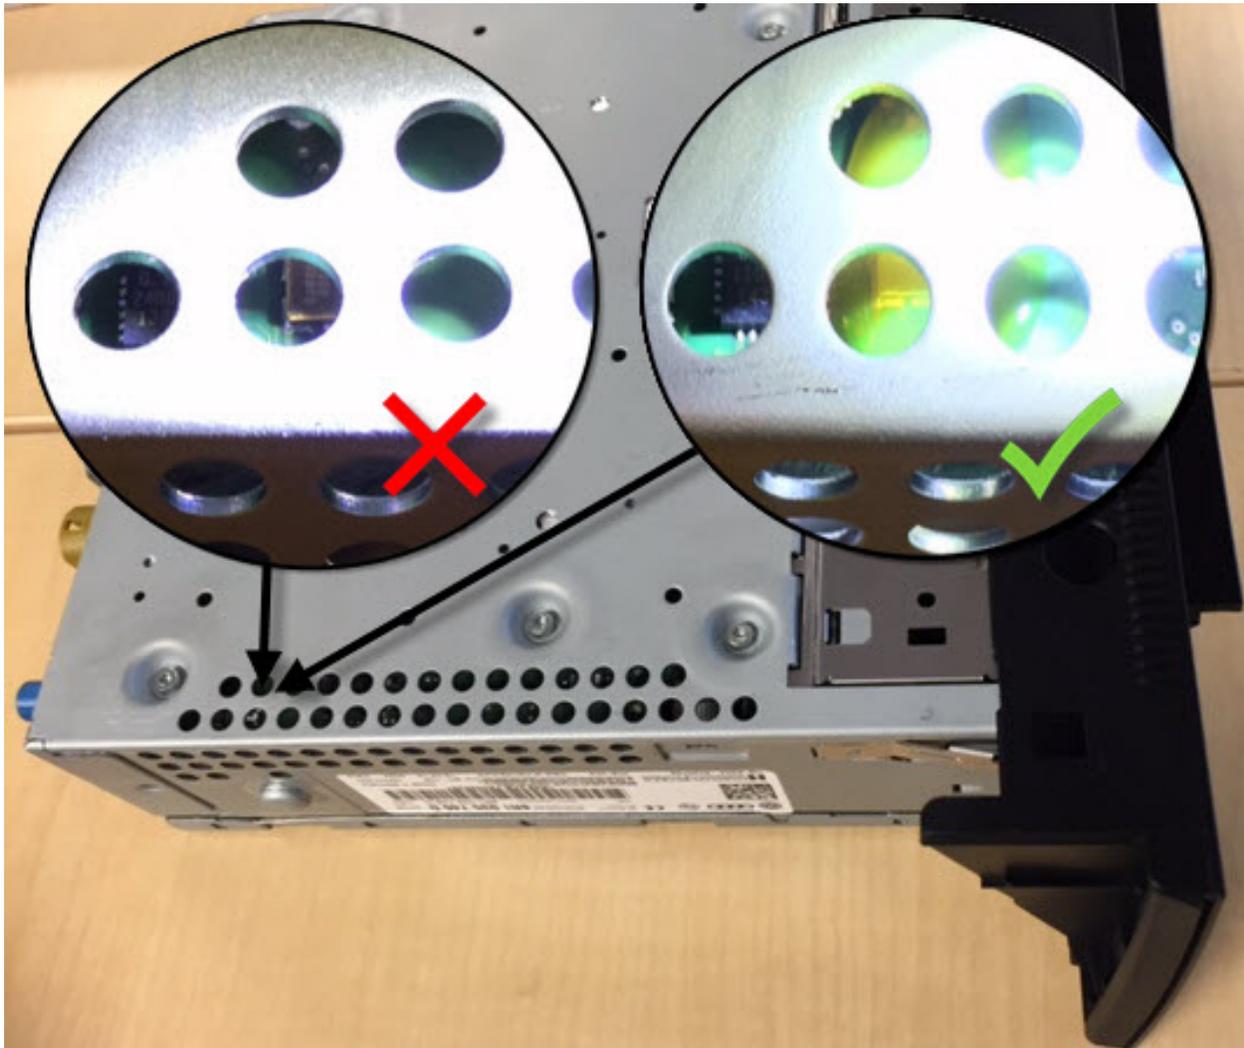
**Figure 2.** Example of integrated circuit chip without coating (left) and with coating (right). Parts without the coating over the integrated circuit chip are not okay and should be replaced.

Some early service parts did not have the coating despite the updated hardware part number (G suffix) and build date. All parts built after November 08, 2014 should have the coating over the integrated circuit chip. If the part does not have the coating over the integrated circuit chip, return the part and order a replacement.

3. Order a replacement MMI main unit using the applicable part number listed in the parts table below. There are different variants of main units that have support for a SIM card slot and some variants that do not. Once the new part arrives, check the integrated circuit chip of the GPS oscillator on the internal circuit board. The chip should have a translucent yellow coating (Figure 2).

If the parts department has problems getting updated parts with the integrated circuit chip coating, contact TAC. A small amount of specially modified parts are available for shipping directly from Audi of America.

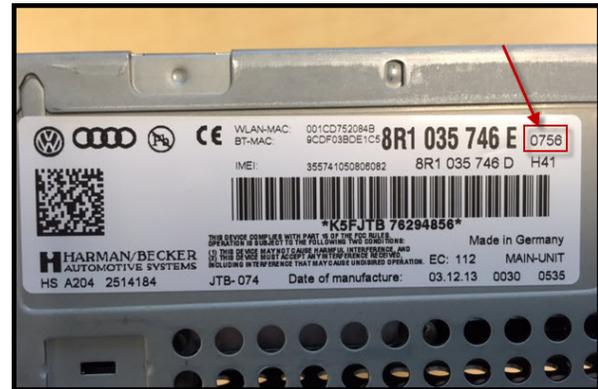
Figure 3. Main unit part label.

4. Check the label (Figure 3) on the side of the new part to verify that it contains software at level 0901 or higher. Install the replacement MMI main unit (information electronics control module 1, J794 (address word 5F)).

5.
  - If the software level is less than 0901, perform component protection removal, **repeat steps 1 and 2** and then move to step 6.
  - If the software is at 0901 or above (A6, A7, and A8 can have 0902), perform component protection removal and **repeat step 2**, then move to Step 6. Repeating step 2 will allow SVM to accept the new control unit with the updated part number.
