Technical Service Bulletin

91 Apple CarPlay or Android Auto complaints (blank MMI screen, no audio, does not connect, etc.)

91 16 63 2044024/2 July 26, 2016. Supersedes Technical Service Bulletin Group 91 number 16-42 dated May 6, 2016 for reasons listed below.

Model(s)	Year	VIN Range	Vehicle-Specific Equipment
A4	2017 - 2019	All	Audi smartphone interface
Q7	2017 - 2019	All	Audi smartphone interface

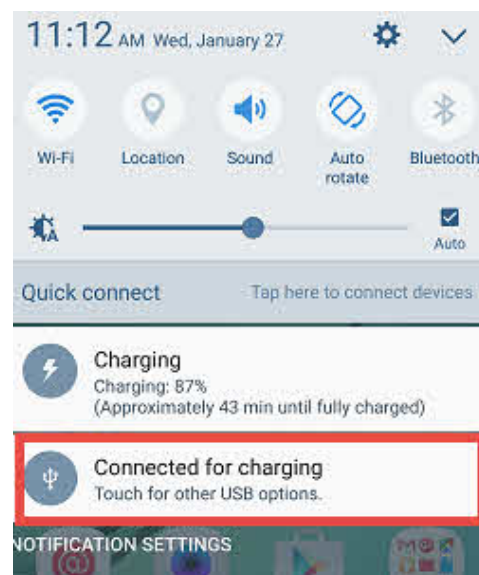
Figure 3. USB options in notification window.

Issue: Android Auto does not automatically start when the phone is connected to the USB port.

Cause: Some Android devices (including Samsung Galaxy/Note devices) require the USB MTP mode to be manually enabled after the device is connected to the USB port. This is a fault of the device firmware.

Solution: Ask the customer to update the smartphone device firmware. As of June 2016, Samsung has provided a firmware update to fix this concern. If there is no firmware update available, ask the customer to manually enable USB MTP mode after connecting the device to the USB port of the vehicle.

- For most Android devices, this can be done from the notifications window from the top swipe-down menu (Figure 3).
- Find the USB notification that indicates "Connected for Charging".
- Select this notification to bring up the USB connection options.
- Select the mode that connects as "MTP – Media Transport

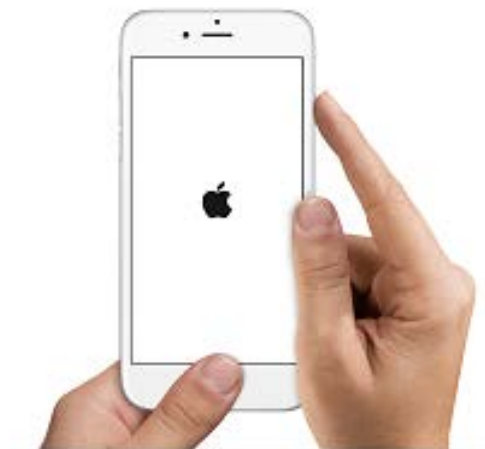
Figure 5. Force iOS reset.

Issue: Apple CarPlay does not automatically start when the phone is connected to the USB port.

Cause: Some versions of iOS have known software bugs that can cause the phone to freeze. If CarPlay does not start, ask the customer to check the phone by unlocking the phone to confirm that the top of the screen is blue and shows the CarPlay icon.

Solution: If the phone is not in a valid state with CarPlay running, ask the customer to force a restart by holding down the home and sleep/power buttons simultaneously (Figure 5) for at least ten seconds until the Apple Logo appears. This will close any misbehaving apps that may prevent the phone from being restarted using the normal shutdown method. The customer may want to consider uninstalling all non-essential apps.

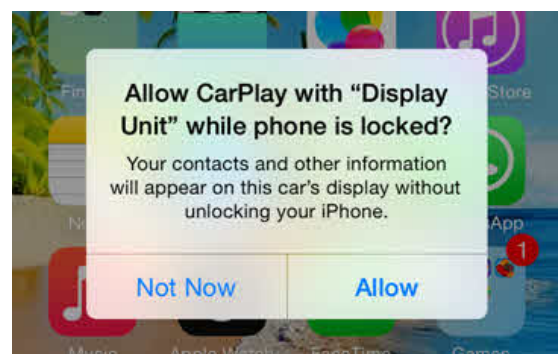
Figure 6. Allow CarPlay when screen is locked.

Issue: The MMI sporadically displays an “Unlock Phone” message to allow ASI to be used.

Cause: When a new iPhone is first connected to the ASI, iOS provides a popup notification window to ask the user to allow the Audi MMI to use the iPhone while the screen is locked (Figure 6). It is easy to miss this notification window, especially if the phone is already unlocked when it is connected. If the customer does not allow CarPlay to access the phone while it is locked, the warning message will appear in the MMI every time the phone is connected (Figure 7). The customer may subsequently unlock the iPhone using the Touch ID/fingerprint sensor every time without knowing there is an option to remove this step.

Solution: Ask the customer to enable the Audi MMI to access CarPlay with the phone screen locked. To change this setting on the iPhone, go to *Settings*>>*General*>>*CarPlay*>>*Audi MMI*.

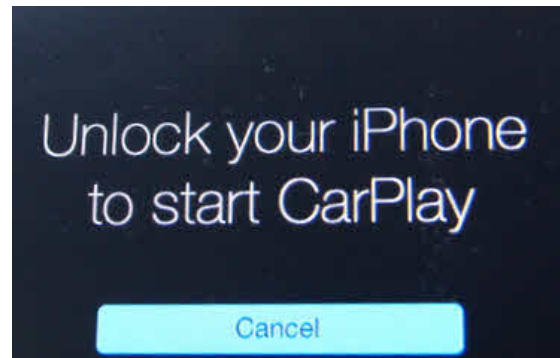
Figure 7. Unlock iPhone message in MMI.

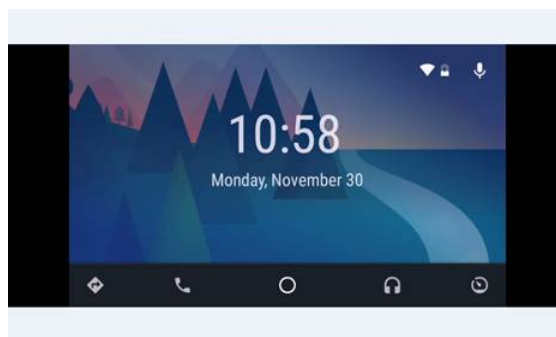
Issue: The Android Auto screen does not fill the complete area of the MMI display.

Cause: There is an MMI software concern that prevents the MMI display from showing the full widescreen mode of Android Auto (Figure 10 and Figure 11).

Figure 10. Android Auto screen not in widescreen.

Solution: Only vehicles built before calendar week 07/16 can have this concern. Inform the customer that a solution is pending, and sign the customer up for Pending Service Solution (PSS) 2044860: 91 PSS Android Auto display does not fill entire MMI screen. After the customer is signed up for the PSS, the dealer will be notified when the MMI software is available.

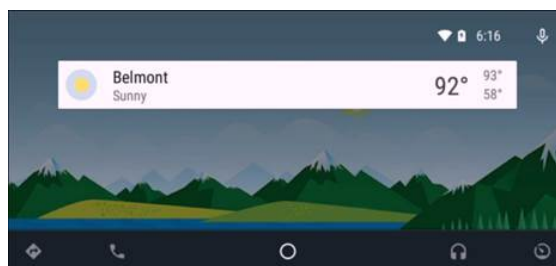
Figure 11. Android Auto screen correctly using widescreen.
