Subject: RUST/PAINT BLISTER ON TRUNK LID AROUND LICENSE PLATE LIGHT	Bulletin No: 09-037/16
	Last Issued: 06/06/2016

2014-2016 Mazda3 vehicles with VINs lower than JM1BM*****348039 (produced before April 18, 2016)

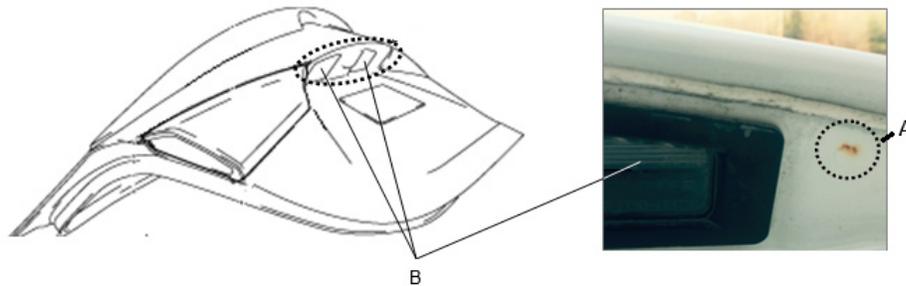
Some vehicles may exhibit rust/paint blister (A) on the trunk lid around the license plate lights (B). This is caused by the paint coating on the welding spots not being thick enough. To correct this problem, a process to grind down the welding spots prior to painting has been added.

1. Verify the customer concern
2. Repair the concern using ordinary bodyshop rust/paint blister damage procedures.

NOTE: Repair affected area(s) only. There is no need to repaint the whole trunk lid.
