Subject: RATTLE NOISE FROM FRONT DOOR GLASS	Bulletin No: 09-038/16
	Last Issued: 06/09/2016

APPLICABLE MODEL(S)/VINS

2014-2016 Mazda6

2014-2016 Mazda3

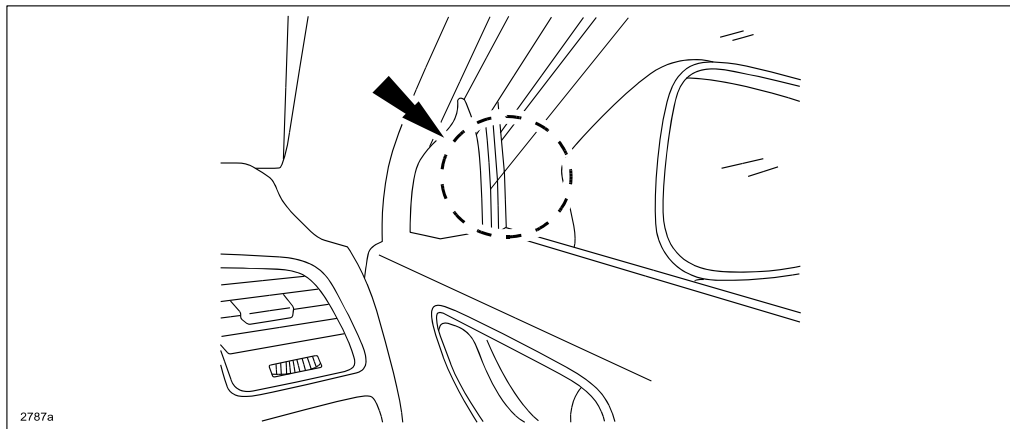
Some vehicles may experience a rattle noise from the front door glass when driving with the window open approx. 1/2 to 4 inches (1 - 10 cm).

The rattle noise may be caused by insufficient holding force of the glass run channel. To increase the holding force, the shape of glass run channel has been changed and non-woven pads have been attached to the glass run channel.

Customers having this concern should have their vehicle repaired using the following repair procedure.

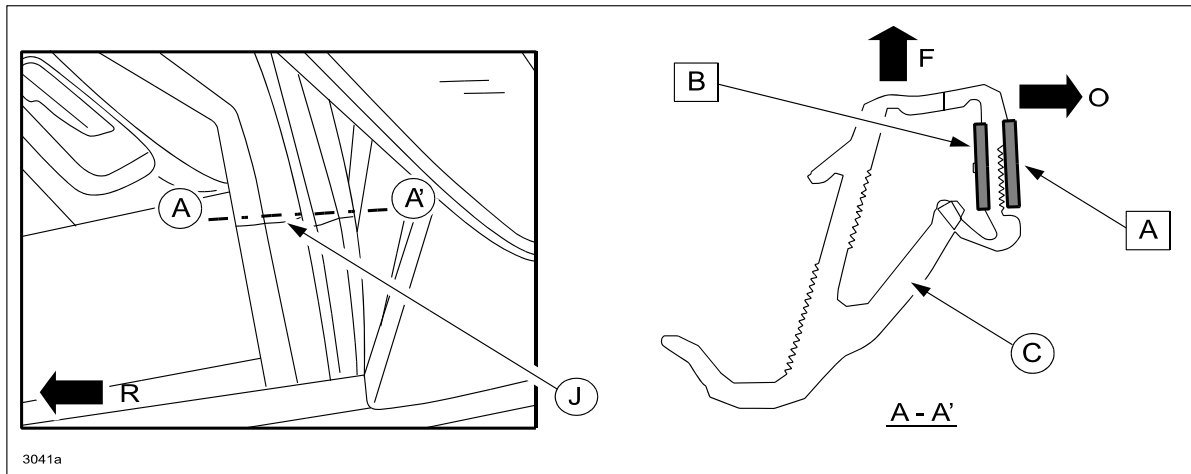
(O = Outer, F = Front, J = Molded Joint Line, R = Rear)

1. Verify the customer concern. The rattle noise should go away when holding the slightly opened window by hand or when the window is completely closed.

- If the noise goes away, proceed to the next step to attach non-woven pads to **Positions A and/or B** of the glass run channel as shown below.
