| <b>Subject:</b><br><br><b>CHECK ENGINE LIGHT ON WITH DTC P0300-P0304</b> | <b>Bulletin No:</b> 01-014/16 |
| | <b>Last Issued:</b> 06/10/2016 |

## APPLICABLE MODEL(S)/VINS

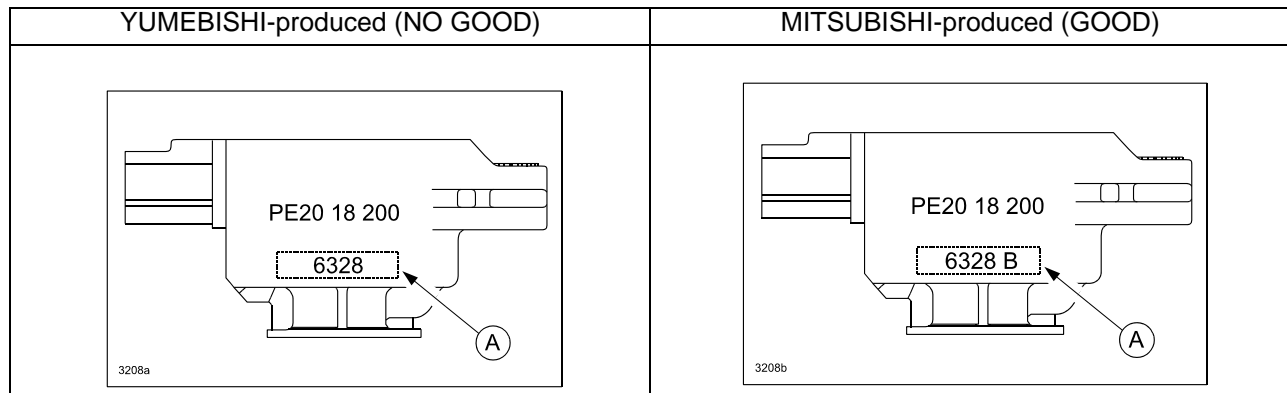
To distinguish between YUMEBISHI and MITSUBISHI ignition coils, look at their lot numbers (A). YUMEBISHI have 4 digit lot numbers and MITSUBISHI have 5 digit lot numbers as shown.

| 6 | Year (4=2014, 5=2015, 6=2016) |
| 3 | Month (1=Jan, 2=Feb, 3=Mar...X=Oct, Y=Nov) |
| 2 | Day |
| B | MITSUBISHI-produced only (A=Daytime, B=Nighttime) |

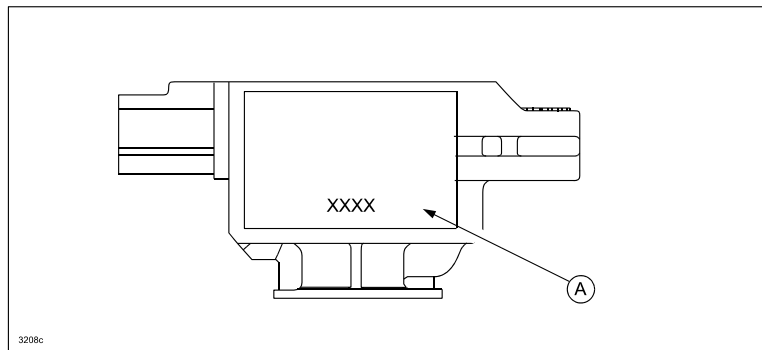
**NOTE:** There is no part number change. Differentiate the new modified ignition coil (YUMEBISHI-produced) from the old one by the lot number on the ignition coil. Ignition coils with the lot number of 6328 (March 28, 2016 production) or higher are modified.

4. Check if any of the other non-defective coils are YUMEBISHI-produced and made before lot number 6328 (March 28, 2016 production). If any were made before this date, replace them with modified one(s) as well.
